Draft Final Report • National Institute of Standards and Technology (NIST)

Technical Investigation

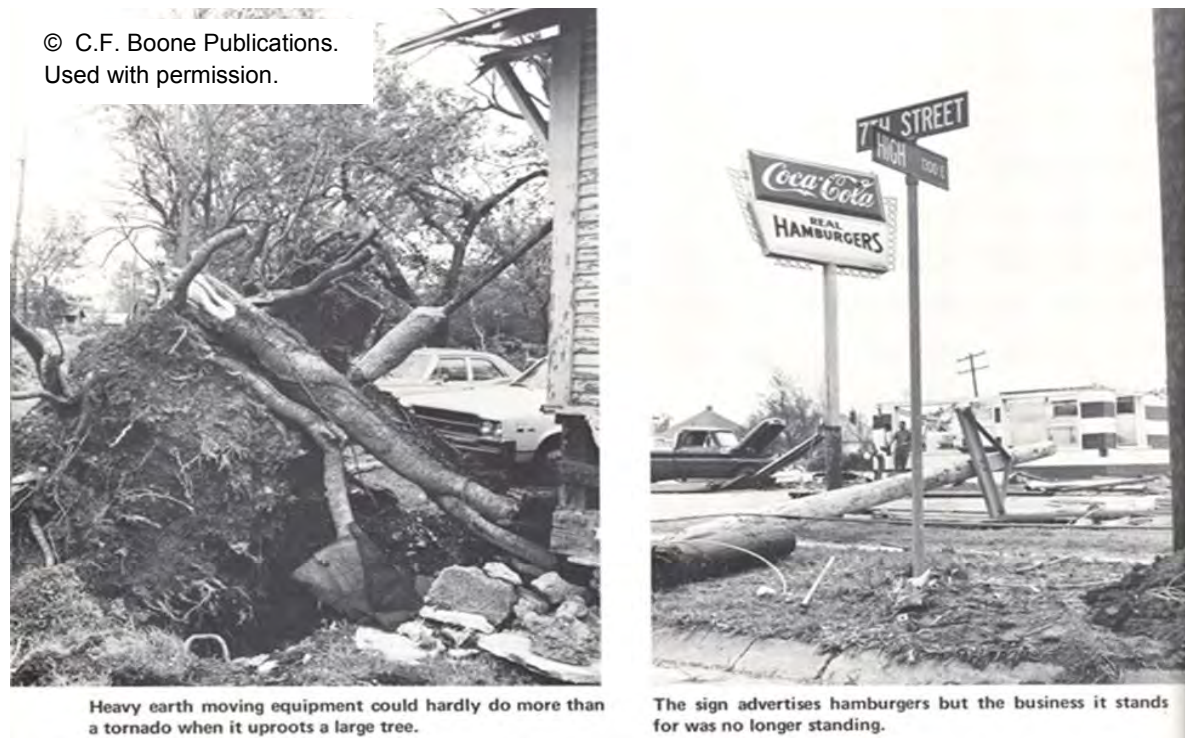
Figure 1–3. Damage from the 1971 Joplin tornado.³¹

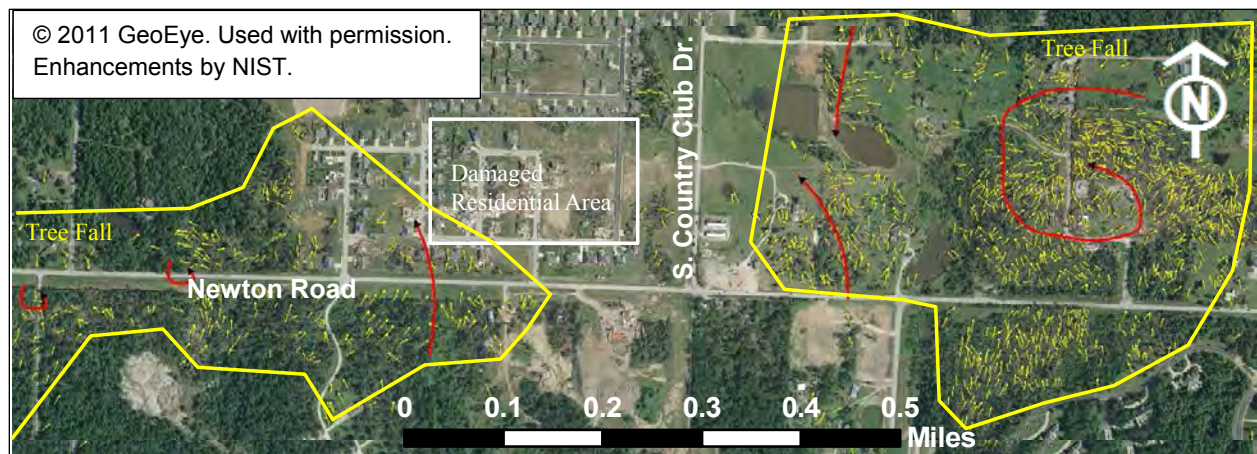
Figure 1–4. Initial damage in the Joplin tornado. Yellow arrows indicate directions of treefall. Possible multiple vortices shown by red arrows.

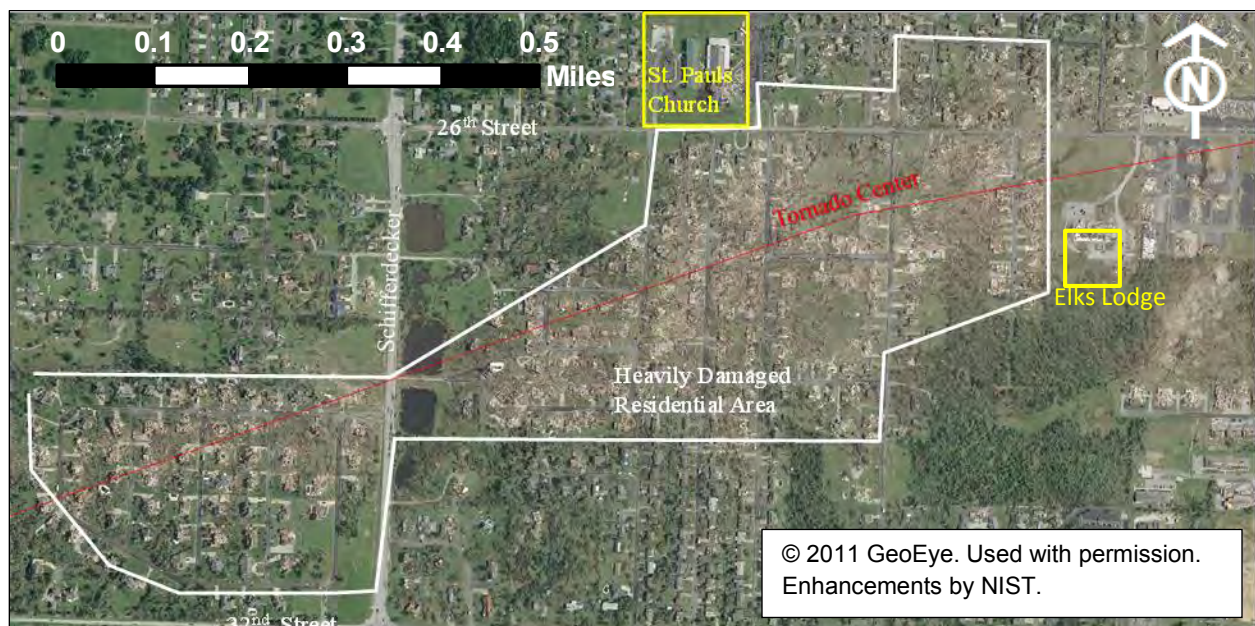
Figure 1–5. Damage on the west side of Joplin.

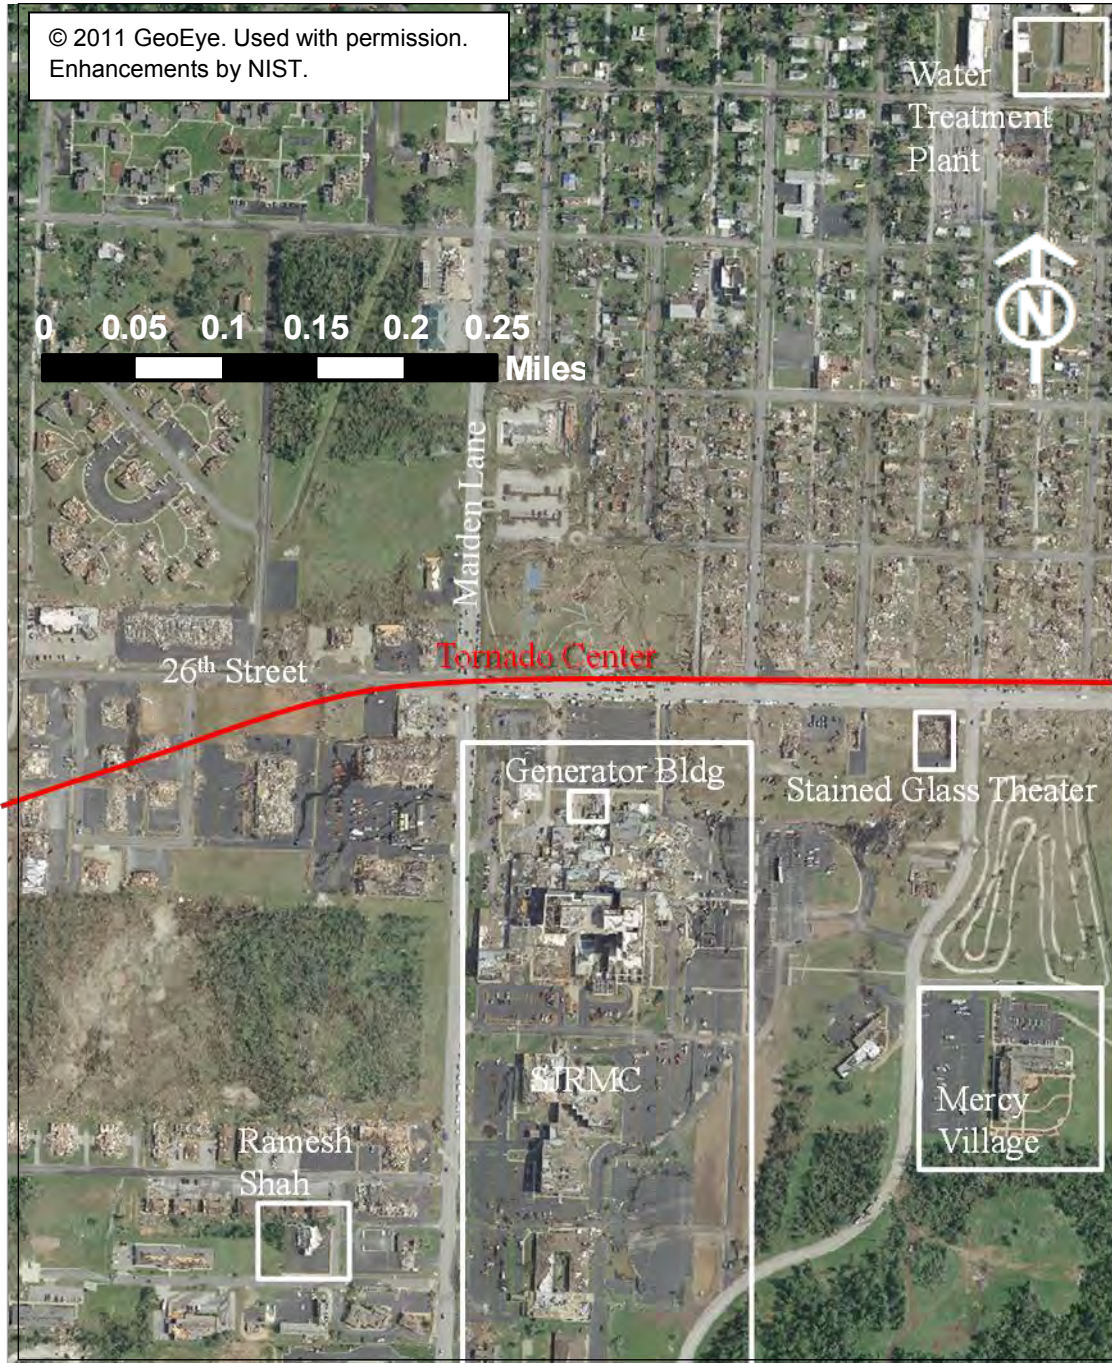
Figure 1-6 . Aerial photo showing damage to SJRMC and the surrounding area.

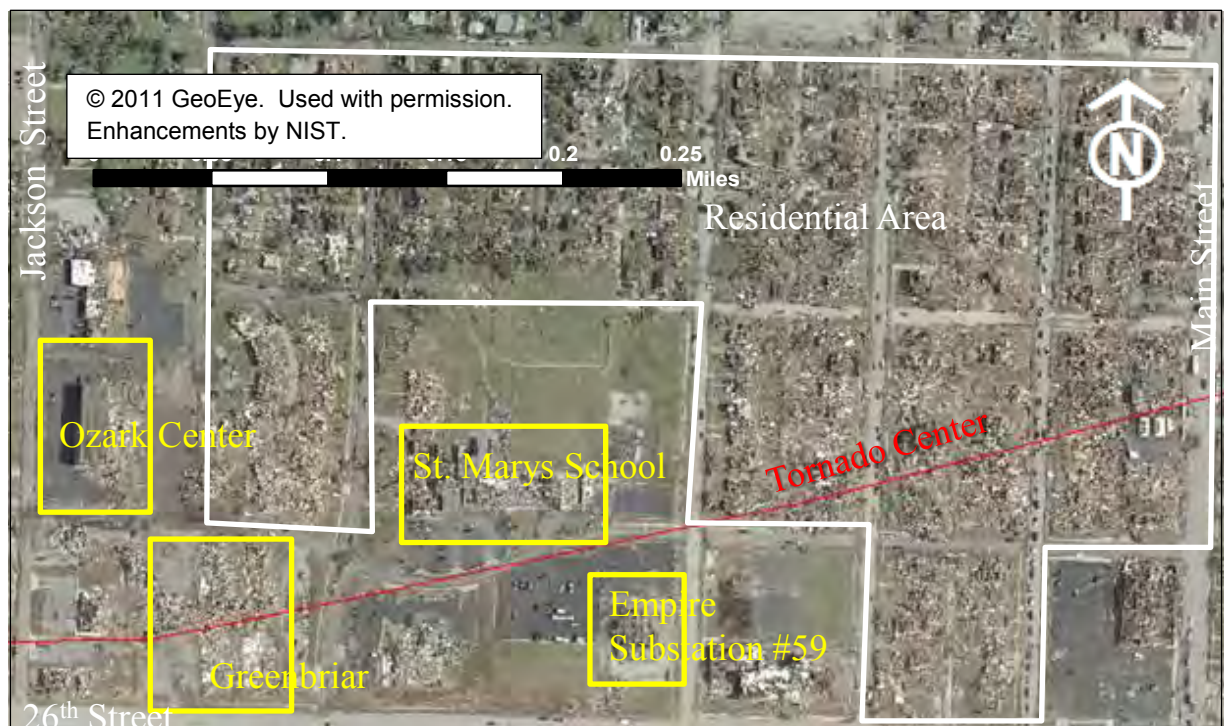
Figure 1–7. Aerial photo showing locations of the Ozark Center for Autism, Greenbriar Nursing Home, St. Mary’s Catholic Elementary School, and EDE substation 59 (from west to east). Residential area is outlined in white.

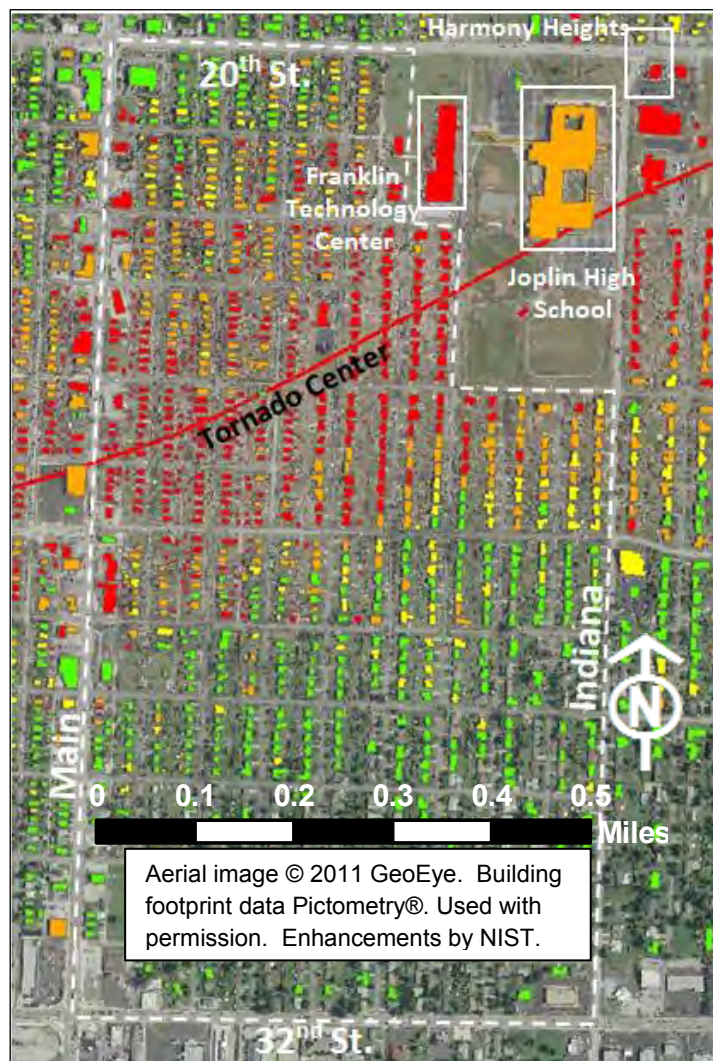
Figure 1–8. Aerial photo showing the locations of a heavily damaged residential area, Franklin Technology Center, Joplin High School, and Harmony Heights Baptist Church. The color of each building footprint shows the level of damage to that structure.

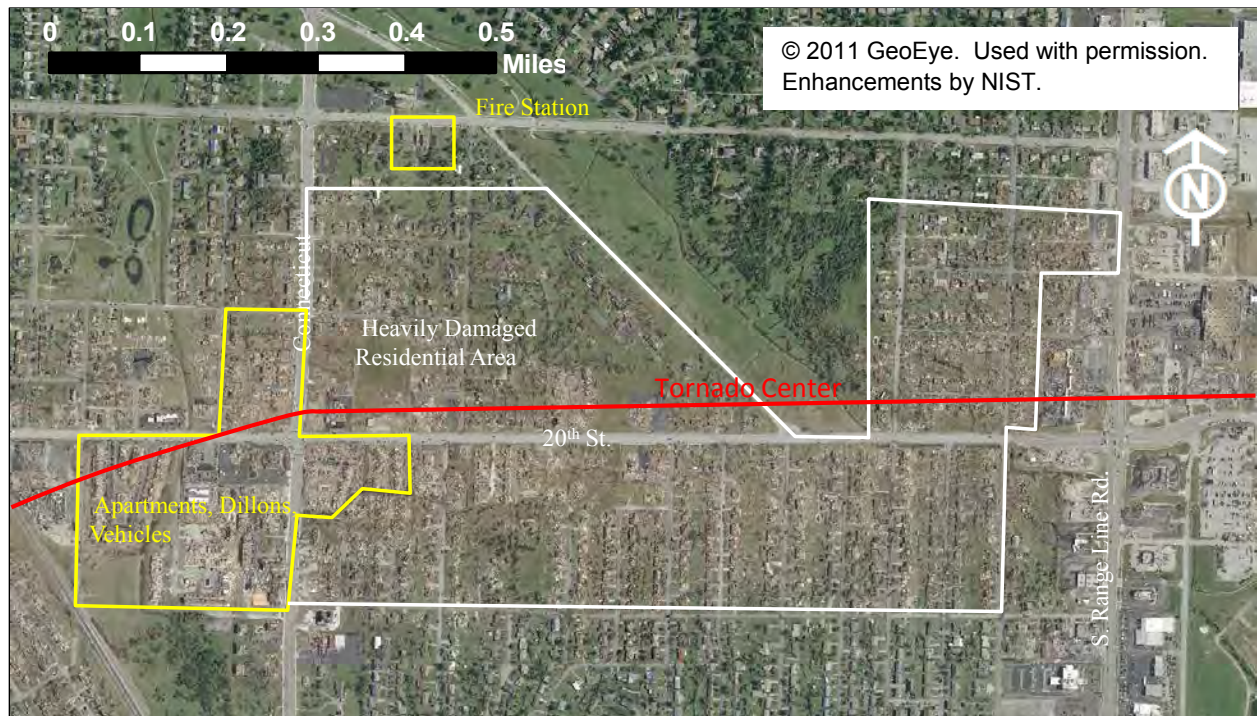
Figure 1–9. Aerial photo of damaged residential areas (including apartment complexes) in Joplin near the intersection of 20th and Connecticut.

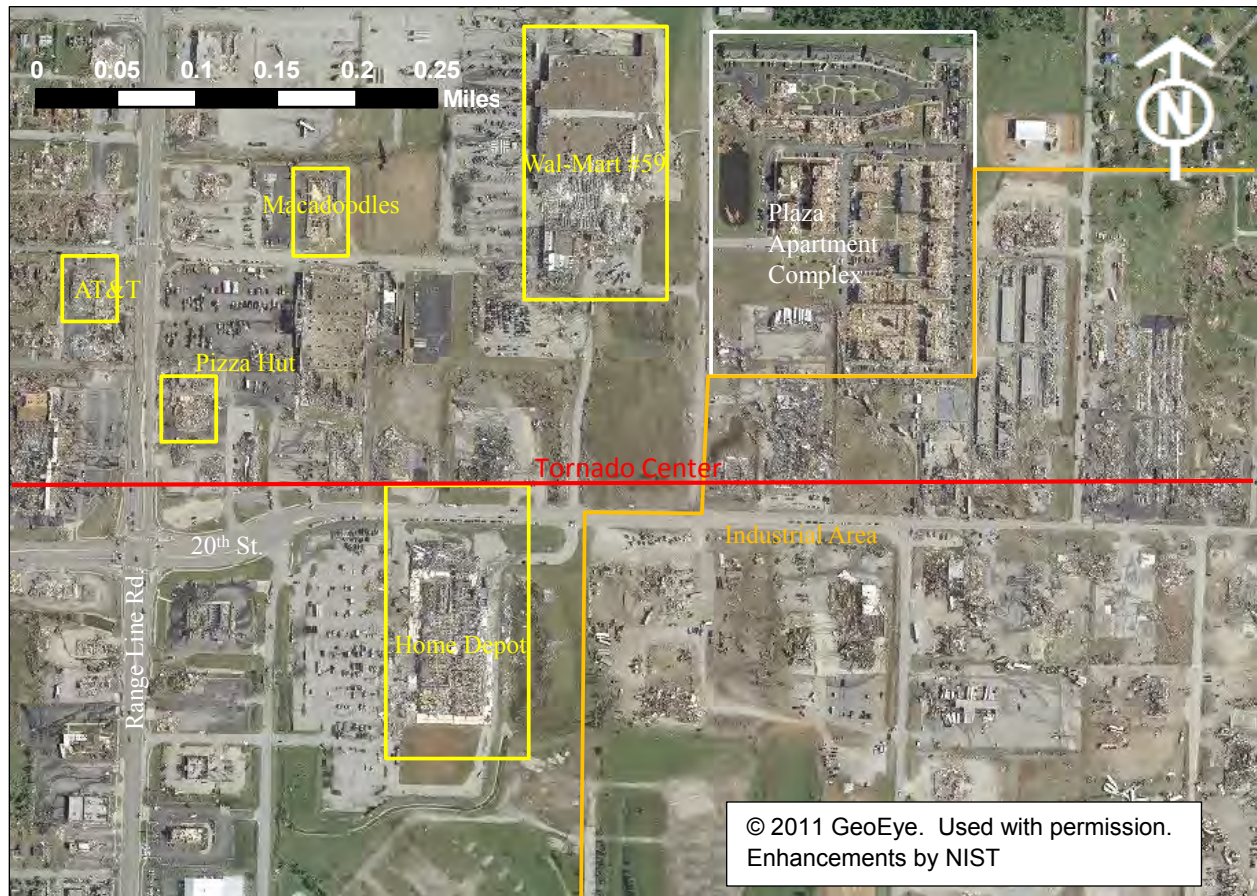
Figure 1–10. Aerial photo showing damage to a commercial area on the eastern side of Joplin near the intersection of Range Line Road and 20th Street.

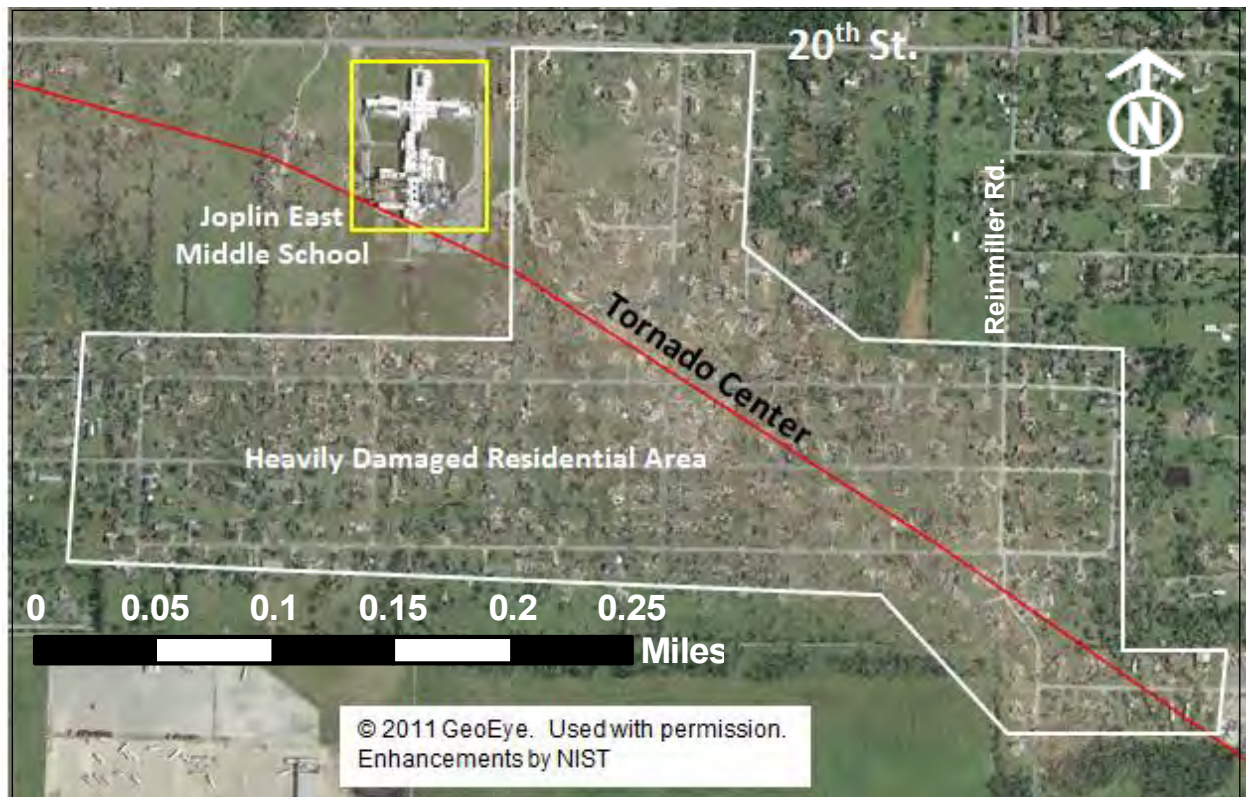
Figure 1–11. Aerial photo of damage to a residential area and Joplin East Middle School.

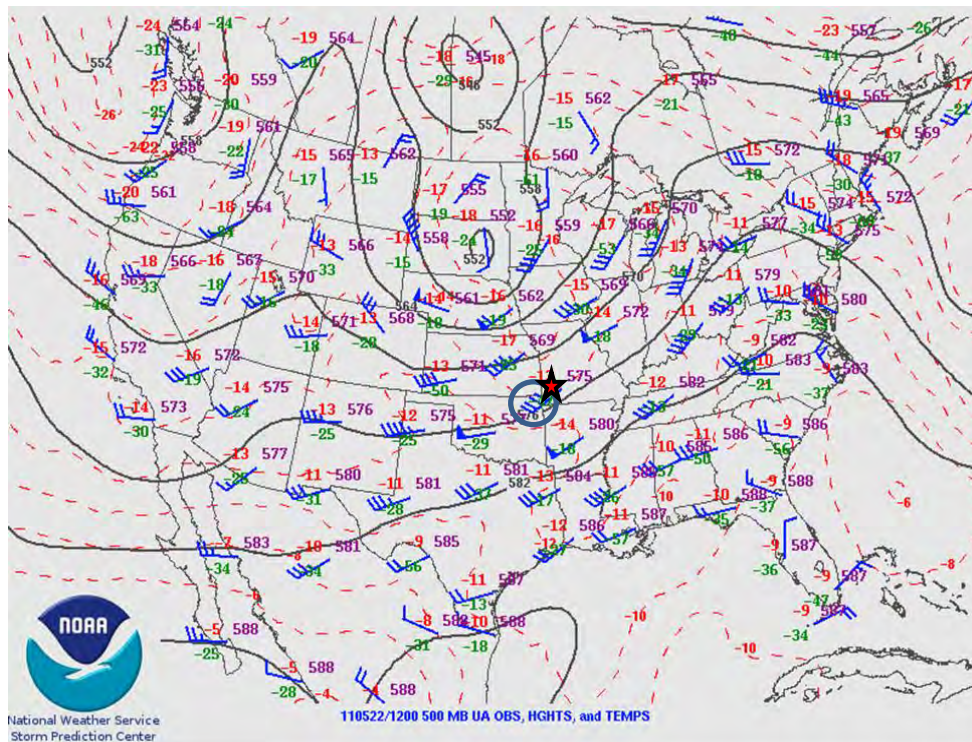
Source: NOAA. Enhancements by NIST.

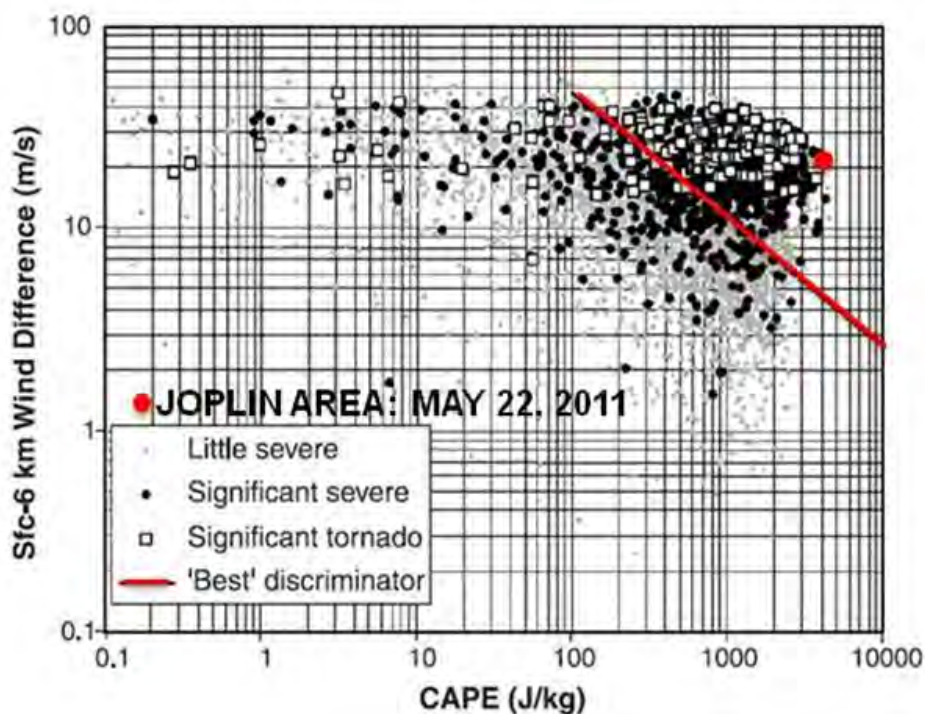
Source: Brooks et al. (2003b). Enhancements by NIST.

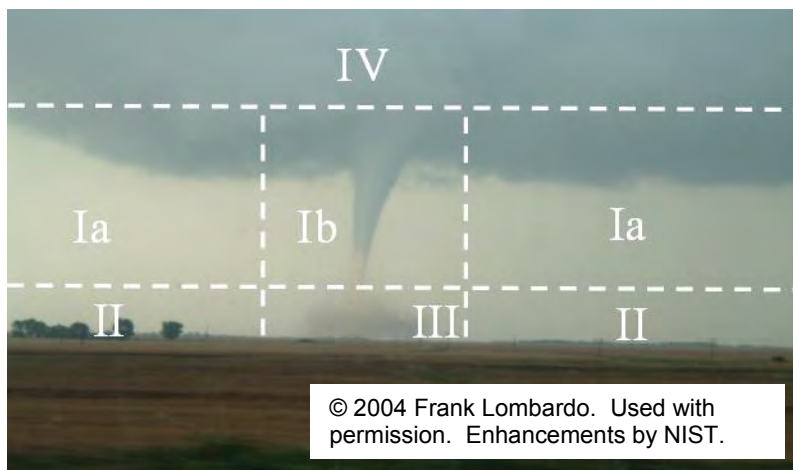
Figure 2–9. General tornado flow regions.

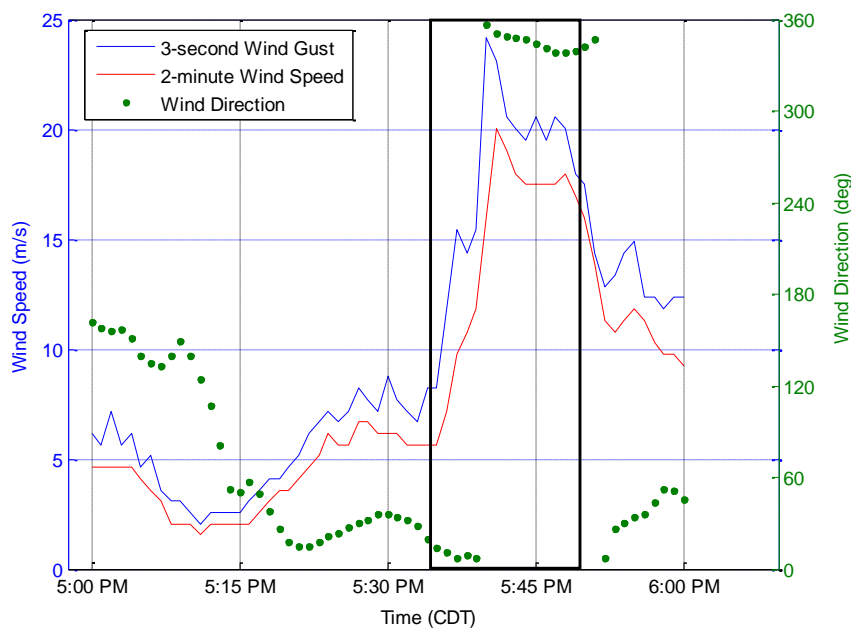
Data Source: NOAA. Analysis by NIST.

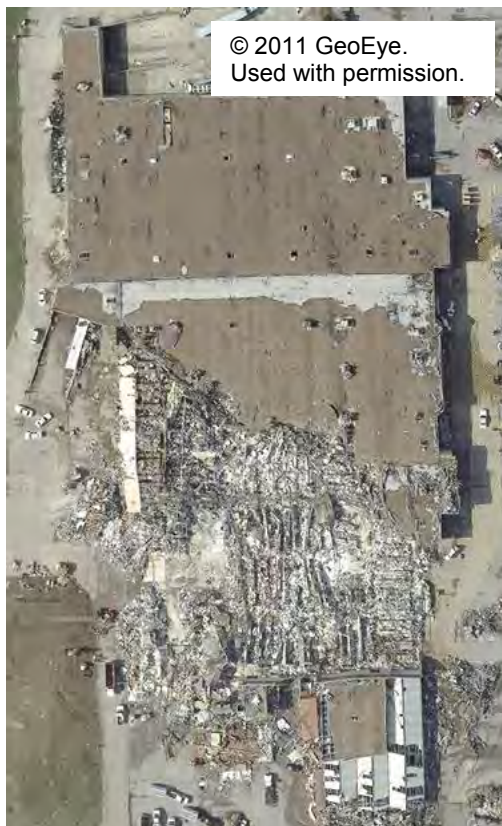
Figure 2–13. Aerial photo of Walmart Store #59 showing extensive damage to the southern (bottom) half of the building.

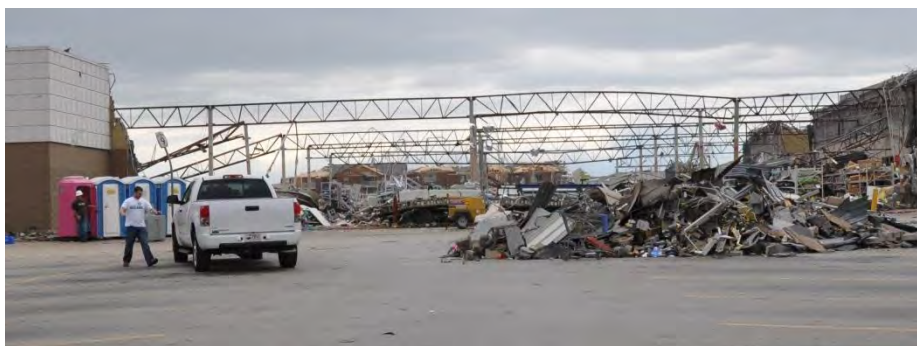
Figure 2–14. Elevation view of southwest-facing wall of Walmart Store #59.

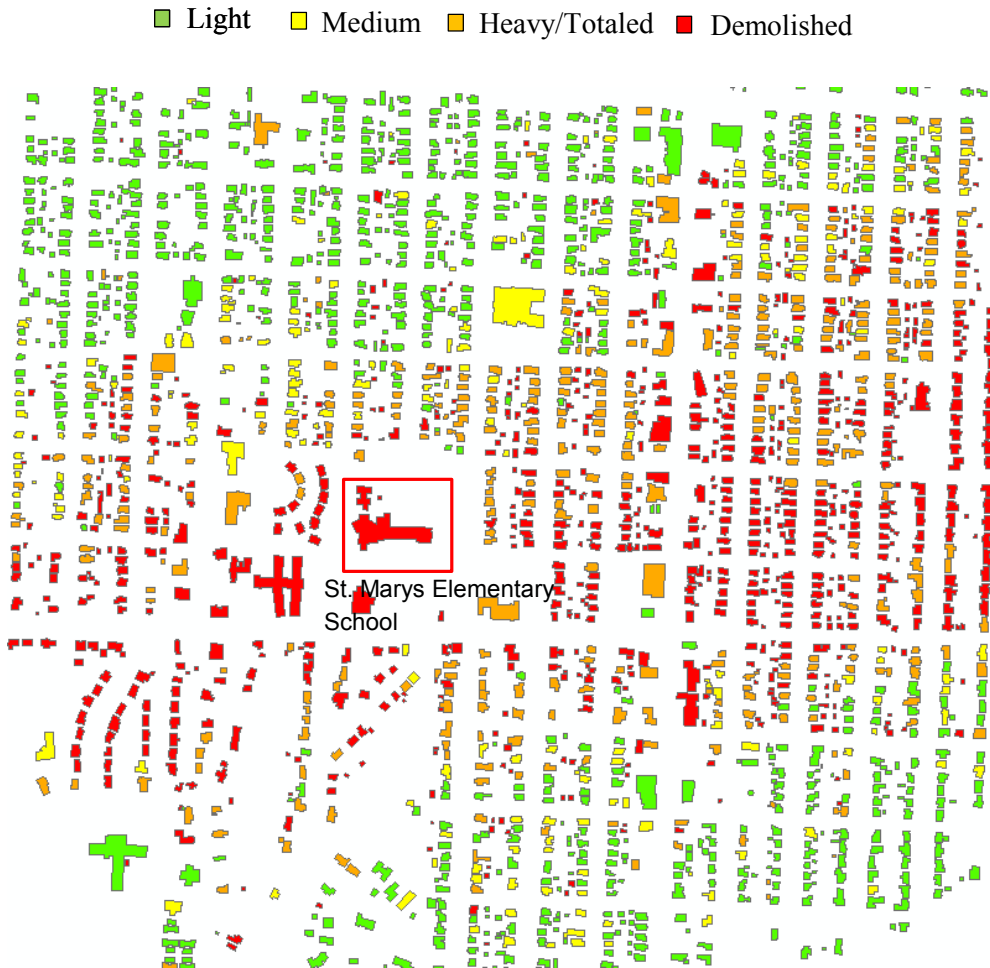
Data Source: Pictometry®. Used with permission.

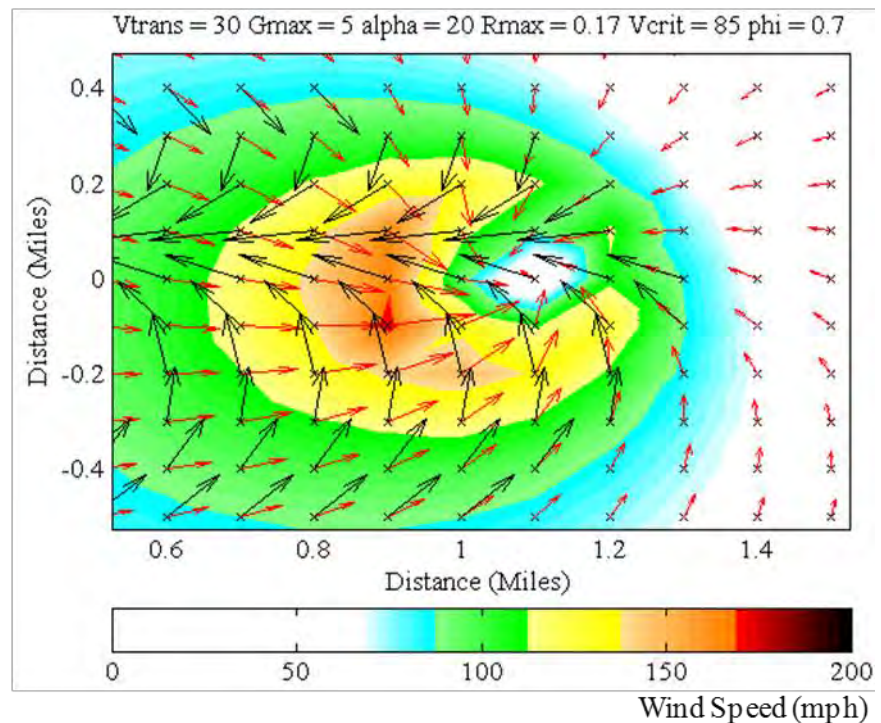
The directions of tree fall for approximately 5,000 felled trees throughout the tornado path were drawn digitally using post-storm aerial photos. Figure 2–18 shows the tree fall patterns observed between 20th and 32nd streets just east of Schifferdecker Avenue. A non-exhaustive list of the types of trees that fell in the Joplin tornado, as determined by field surveys, aerial photos, and interview transcripts, is as follows: American and Chinese elm, American sycamore, yellow poplar, shagbark hickory, white oak, and Bradford pear.

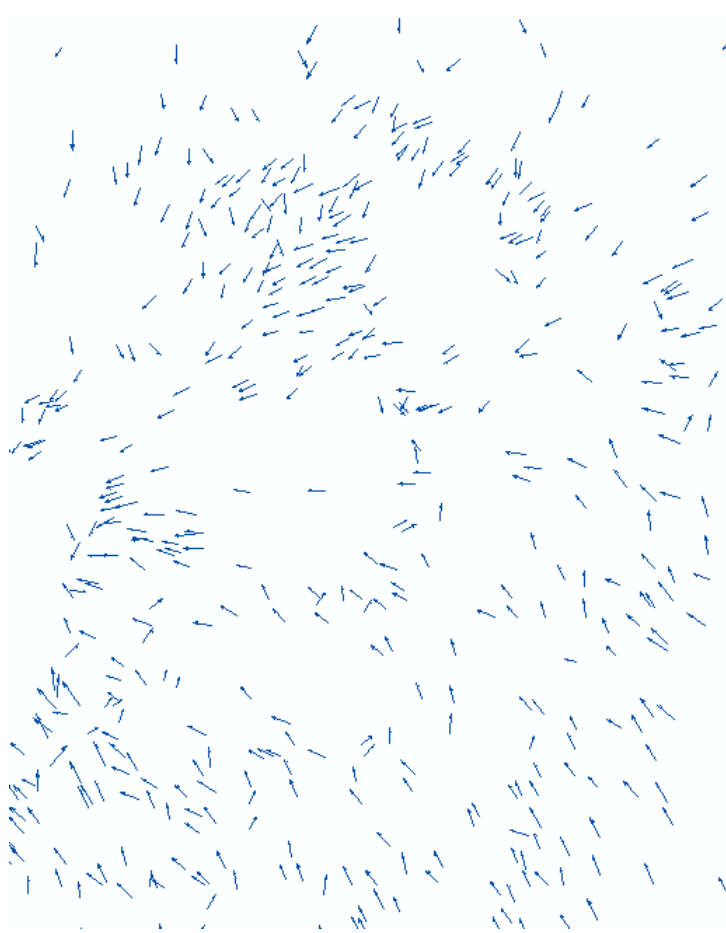
Figure 2–18. Observed tree fall pattern between 20th and 32nd streets just east of Schifferdecker Ave. Area is approximately 0.5 miles west to east by 1.0 miles north to south.

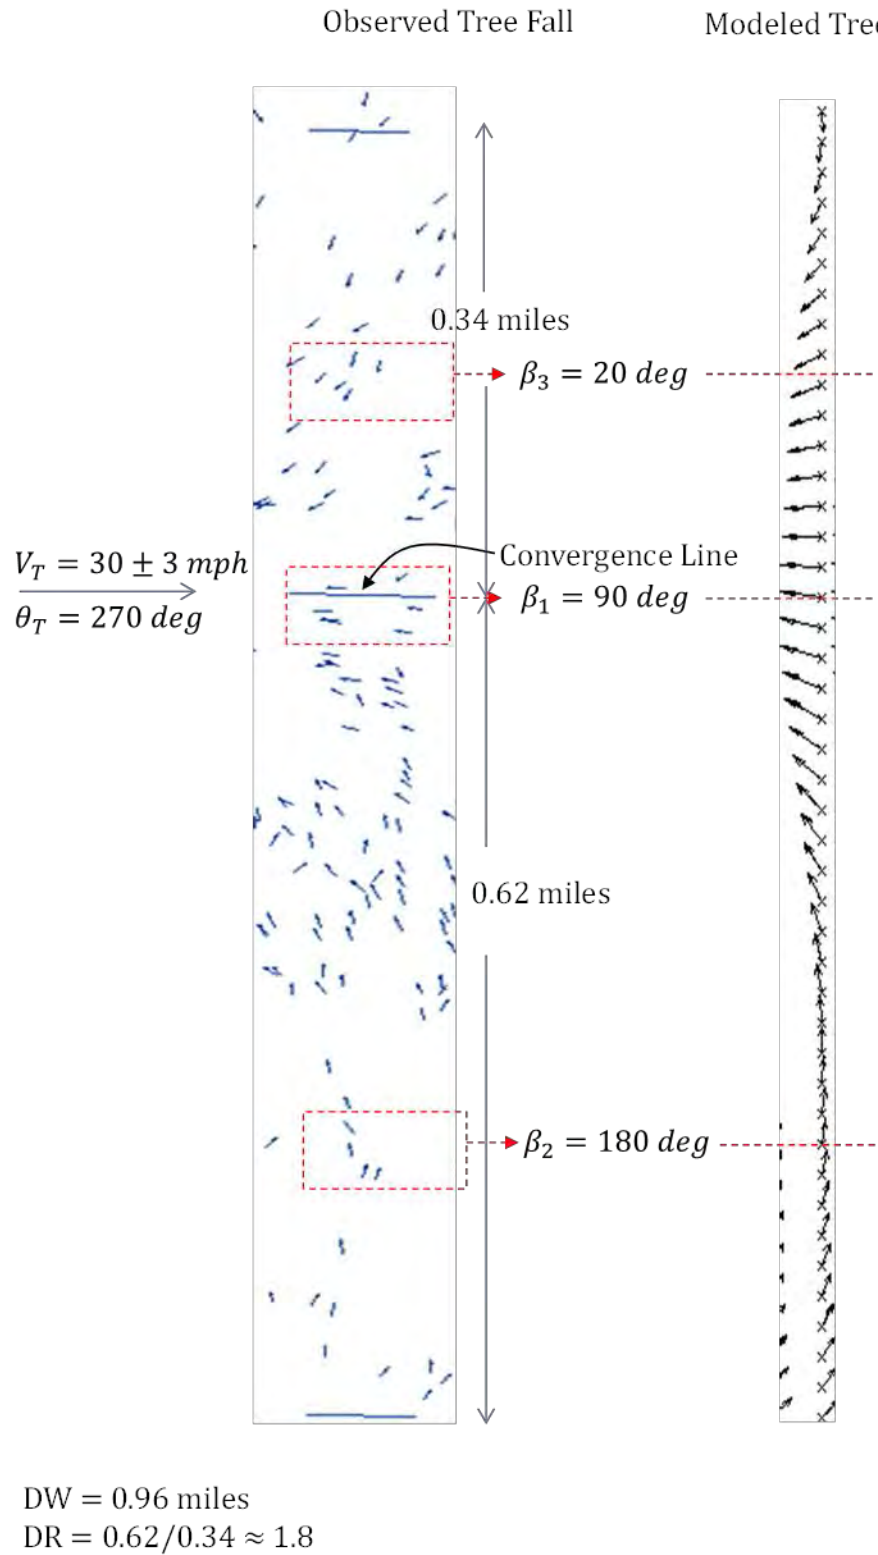
Figure 2–19. Example of procedure for comparing observed tree fall to modeled tree fall. Output parameters are also listed.

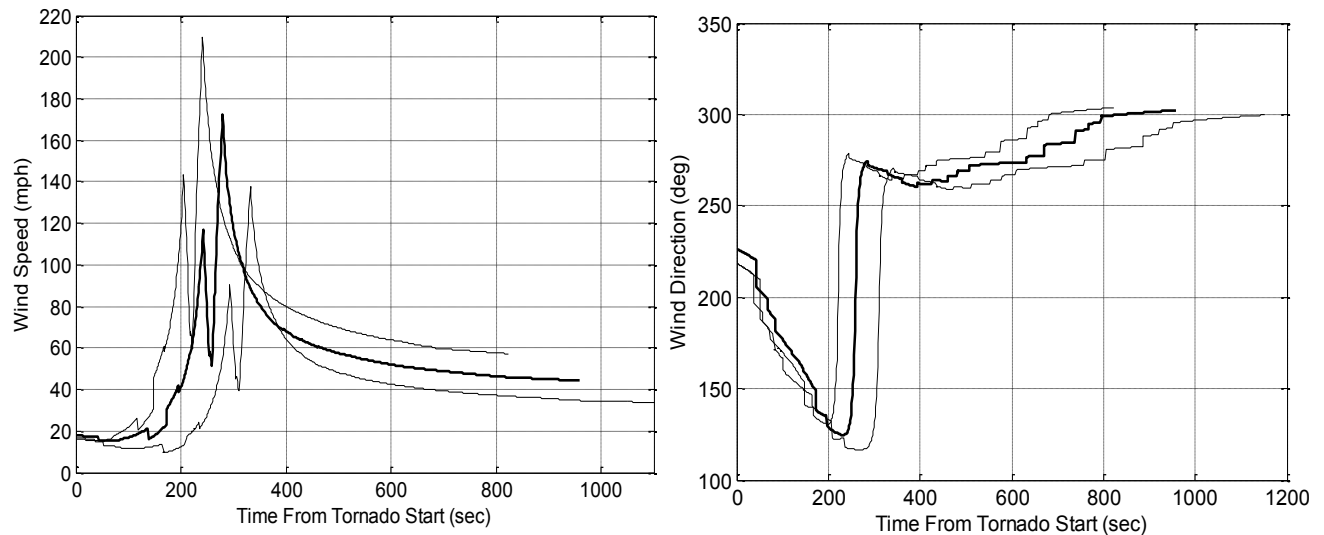
Figure 2–20. Ranges and best estimate of wind speed (left) and associated wind direction (right) for X = 2781933 ft, Y = 326052 ft; Grid Point #1175. Best estimates are the bold traces on each plot.

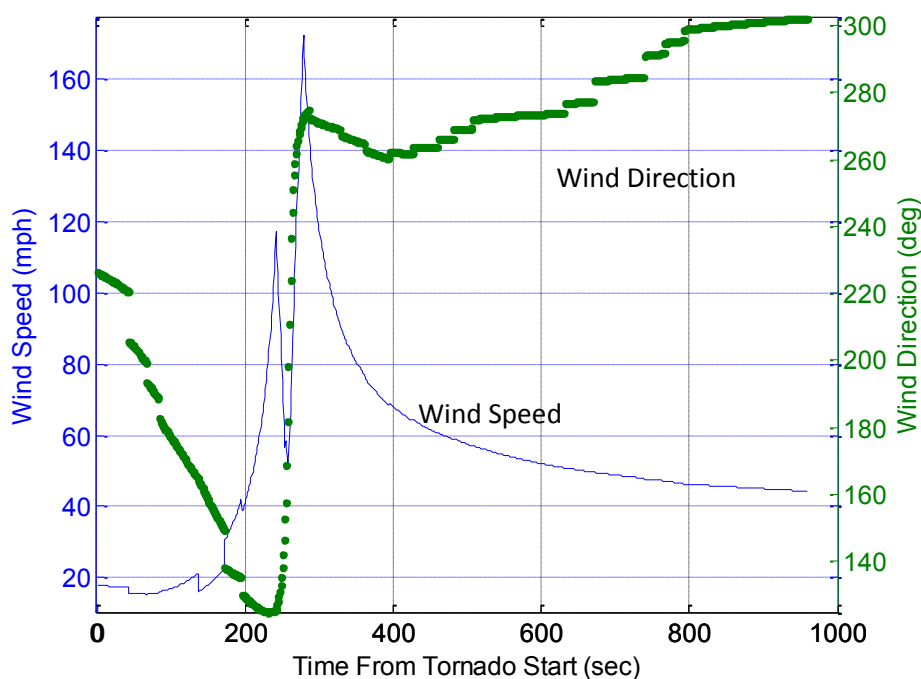
Figure 2–22. Example of a modeled best estimate of tornado wind speed and direction time history associated with the Joplin tornado (X = 2.1, Y = 0.45).

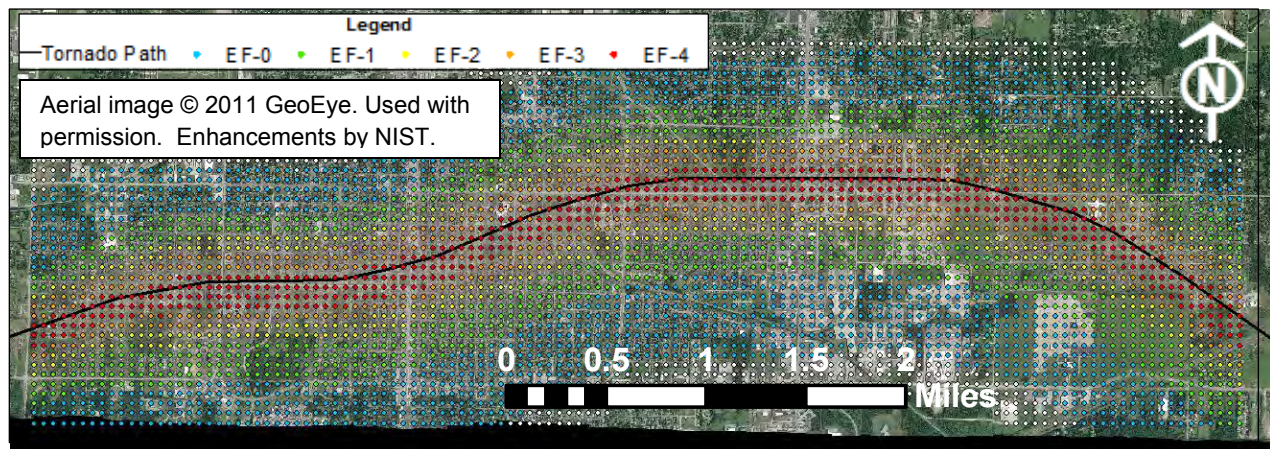
Figure 2–23. Estimated maximum wind speed grid points from tornado wind field model grid points grouped by EF Scale. The solid black line represents the estimated tornado center. The area in the figure is approximately 6.2 miles west to east and 2.0 miles north to south.

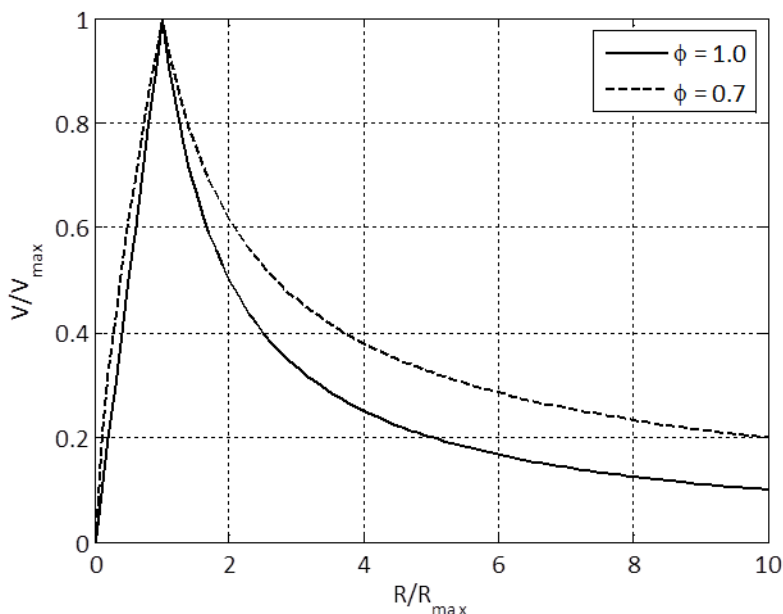
The duration of damaging winds can play a significant role in overall damage states (Kopp and Morrison 2011). Figure 2–26 shows the estimated amount of time that the modeled wind speeds were at an EF–2 level or above (≥ 49.2 m/s or 110 mph). Each time step that was at or above the EF–2 level was summed to estimate the duration. The best estimated longest duration of EF–2 or greater wind speeds in the Joplin tornado was approximately 67 seconds, with a range of 33 seconds to 107 seconds considering the uncertainty in the input parameter values used in the wind field model. The longest duration of damaging

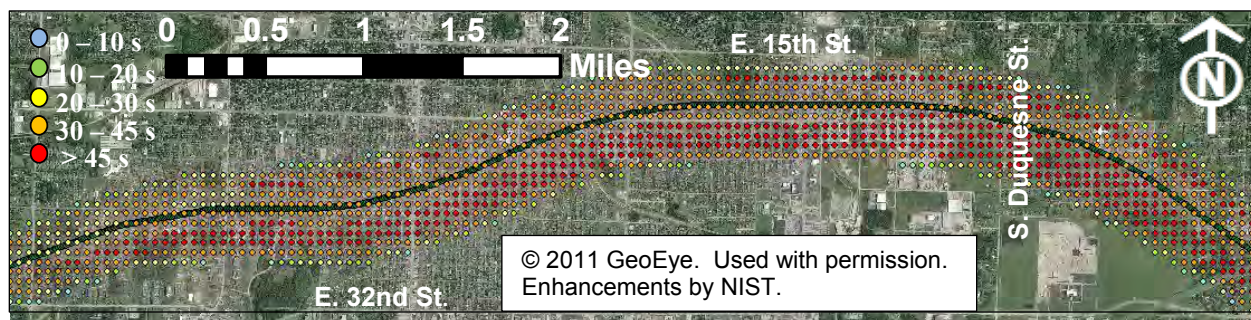
Figure 2–26. Best estimate of duration of wind speeds greater than or equal to EF–2 (≥ 110 mph). Green line shows estimated tornado center. The area in the figure is approximately 6.2 miles west to east and 2.0 miles north to south.

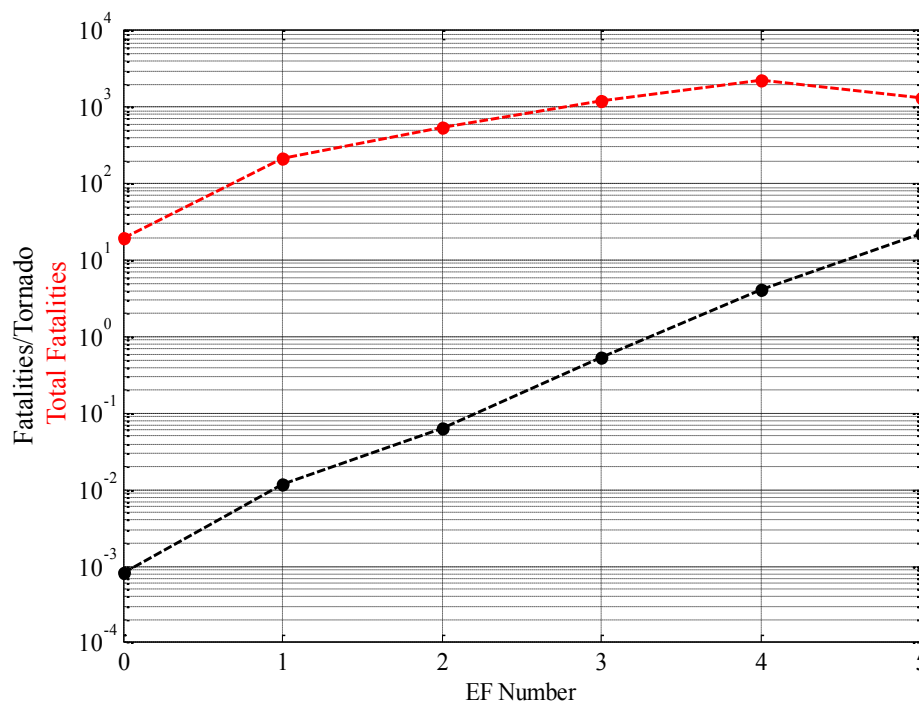
Data Source: NOAA. Analysis by NIST.

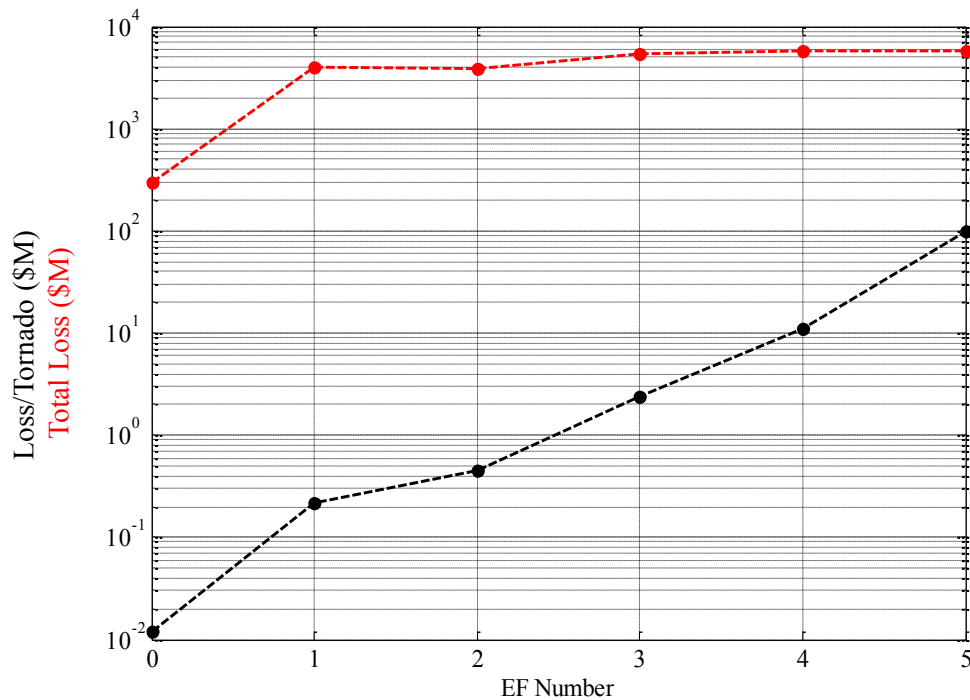
Data Source: NOAA. Analysis by NIST.

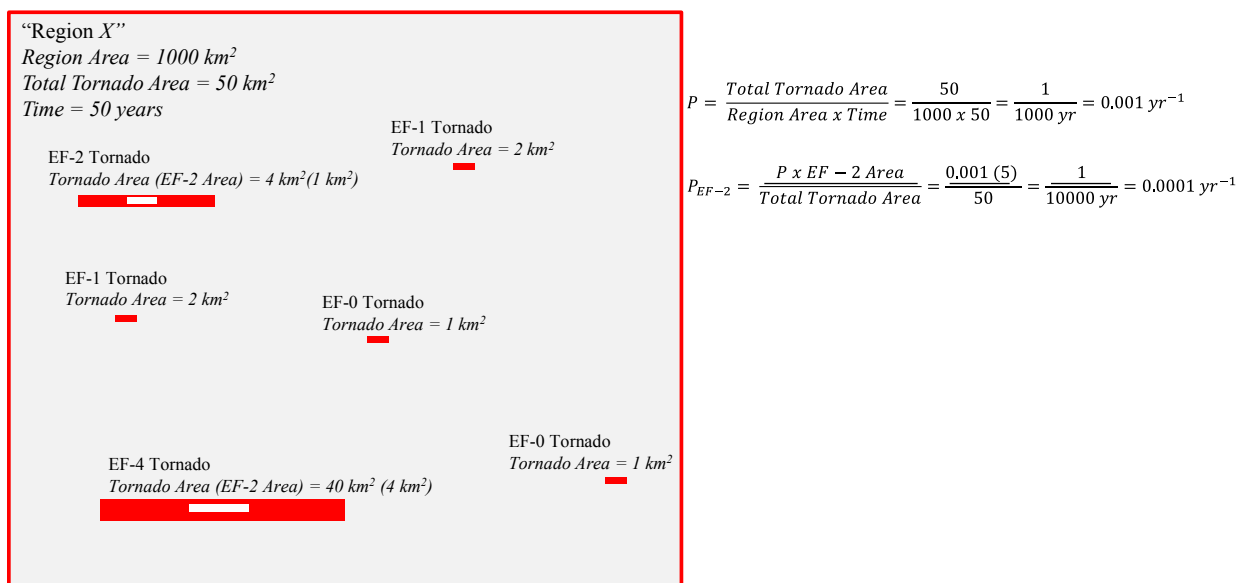
Figure 2–30. Illustration of point-based probability approach.

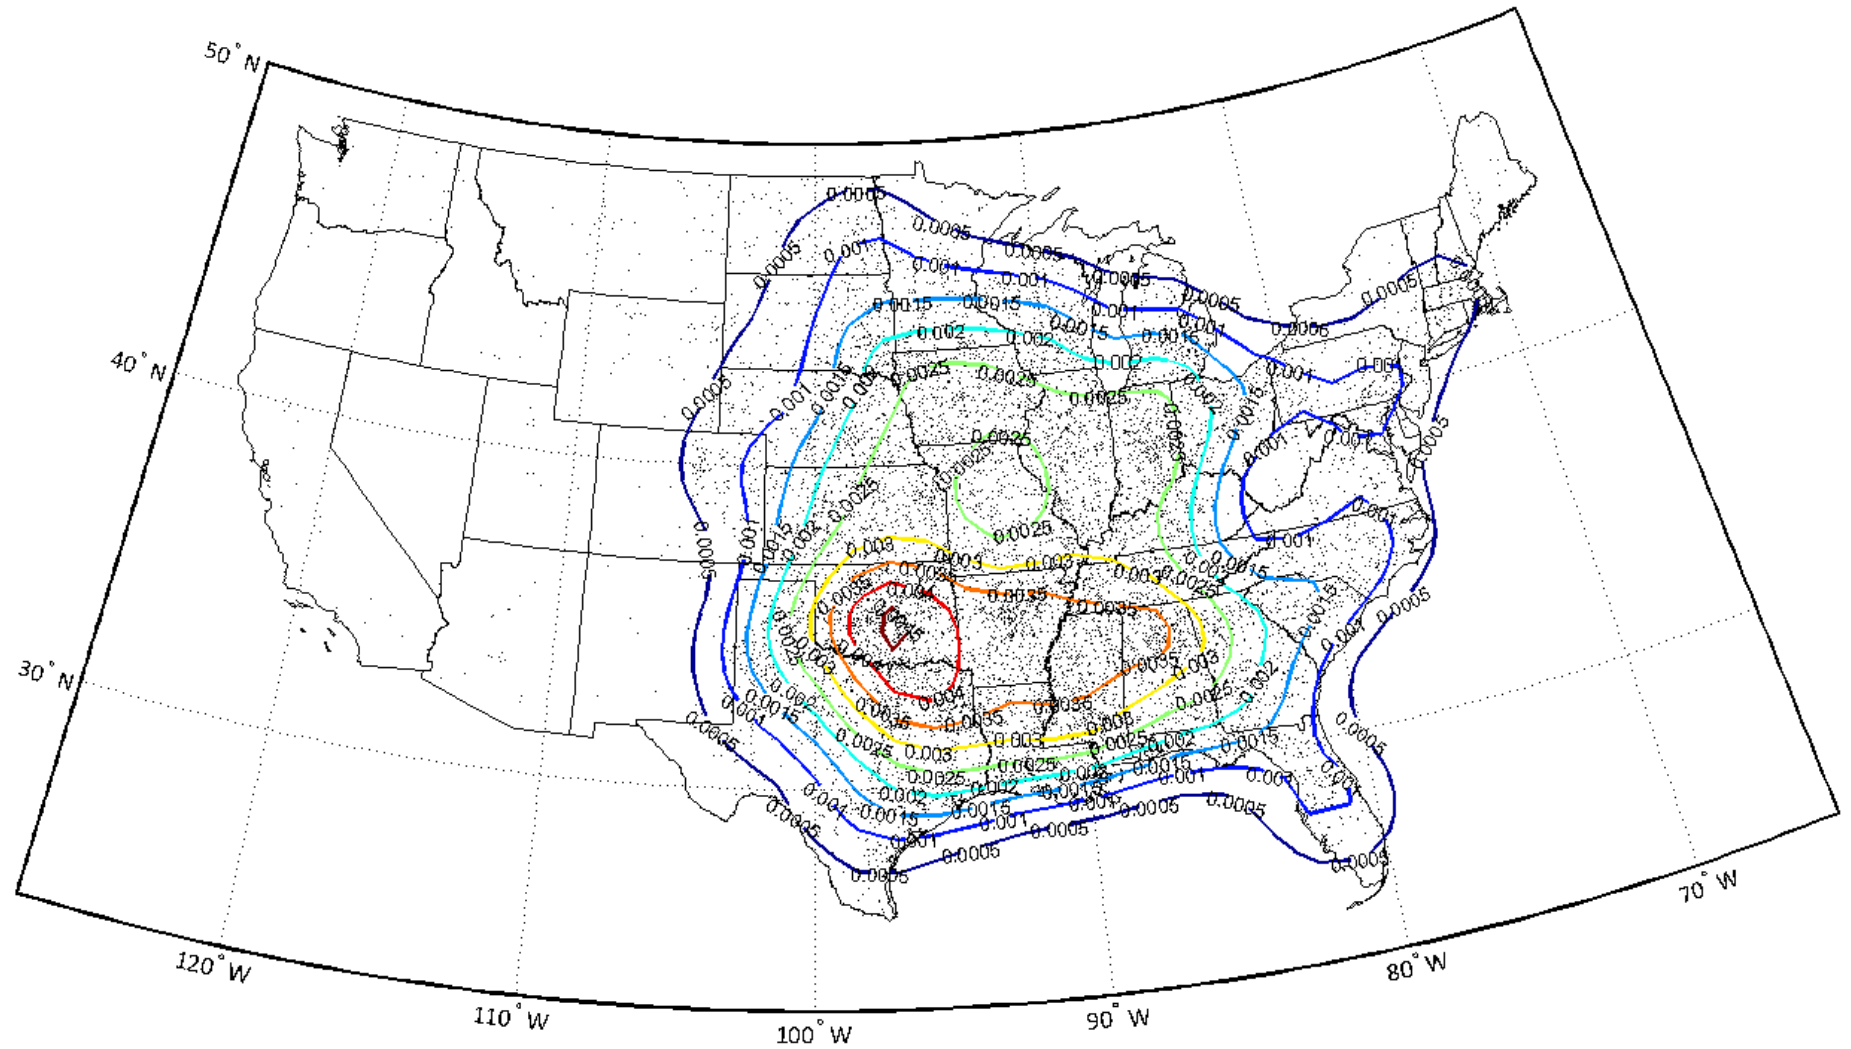
Data Source: NOAA. Analysis by NIST.
