Draft Final Report • National Institute of Standards and Technology (NIST)

Technical Investigation

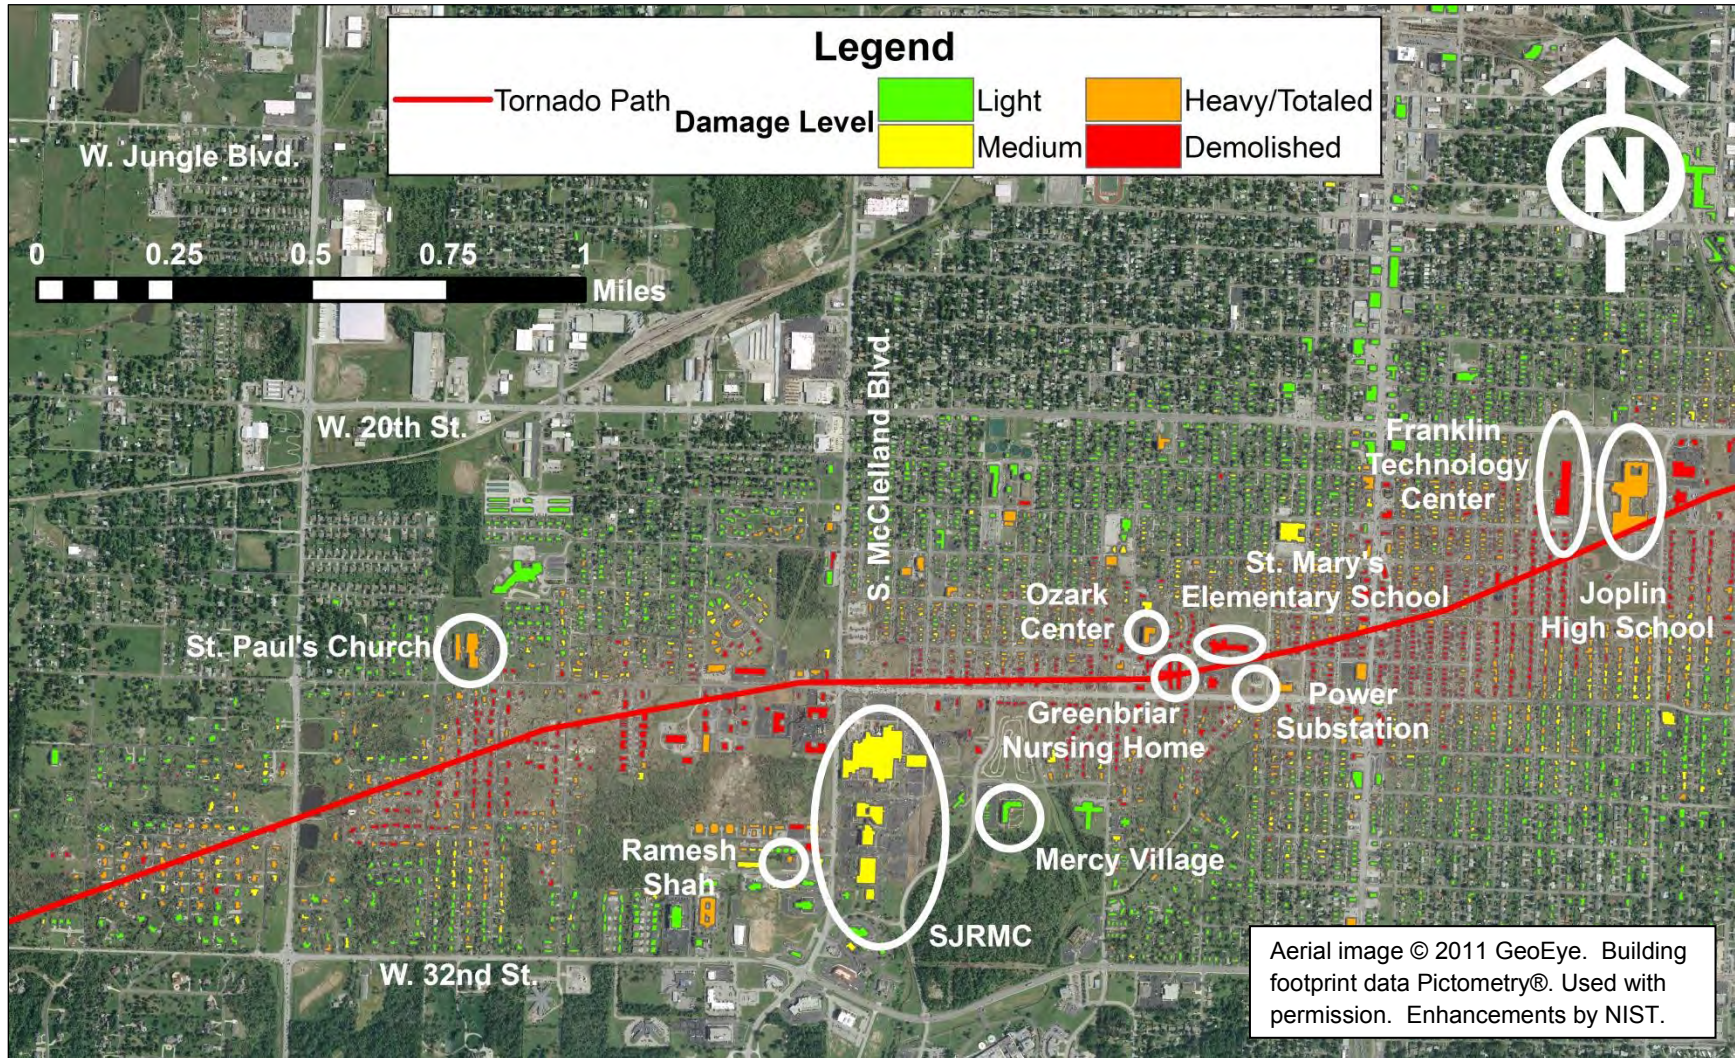
Figure 3–1. Westernmost (earliest) segment of the tornado path through Joplin, showing locations of facilities surveyed by NIST relative to the estimated center line of the tornado damage path (red solid line). The color coded building footprints indicate the estimated level of damage to individual structures (see legend above).

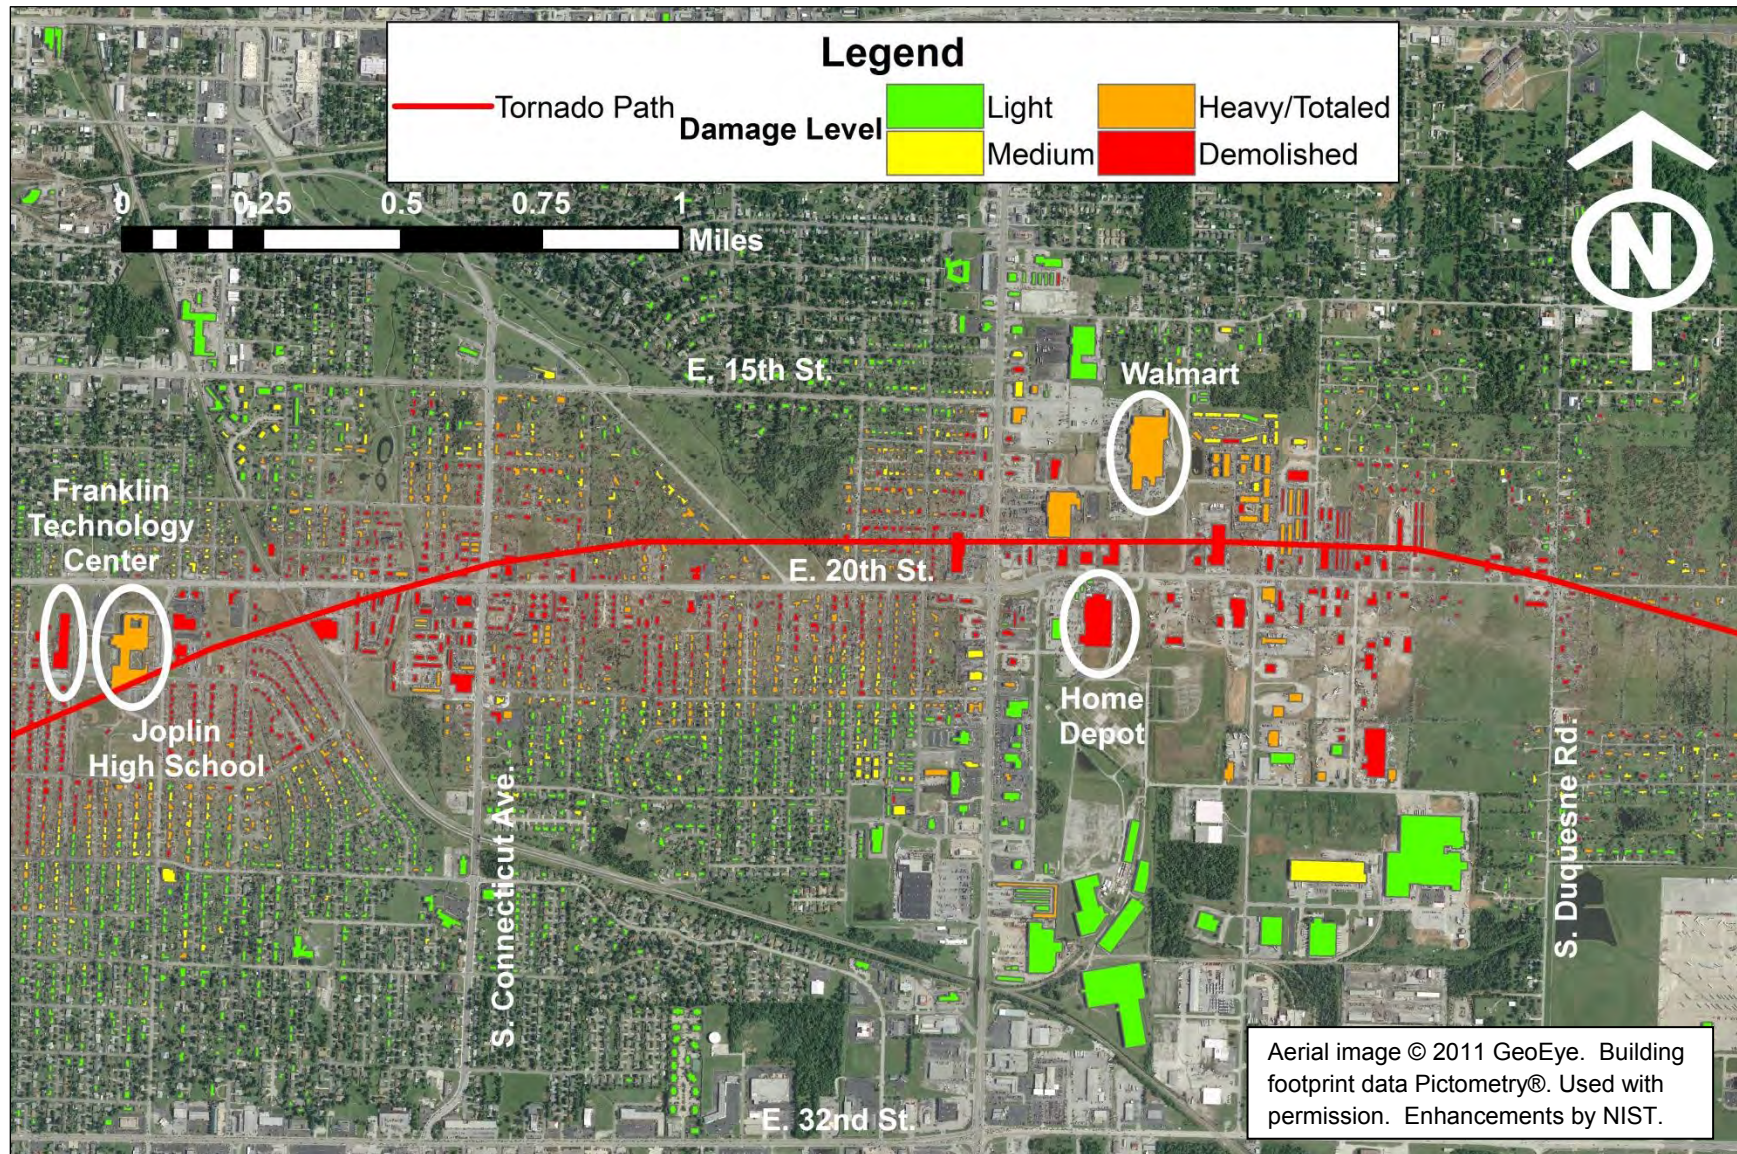
Figure 3–2. Central segment of the tornado path through Joplin, showing locations of facilities surveyed by NIST relative to the estimated center line of the tornado damage path (red solid line). The color coded building footprints indicate the estimated level of damage to individual structures (see legend above).

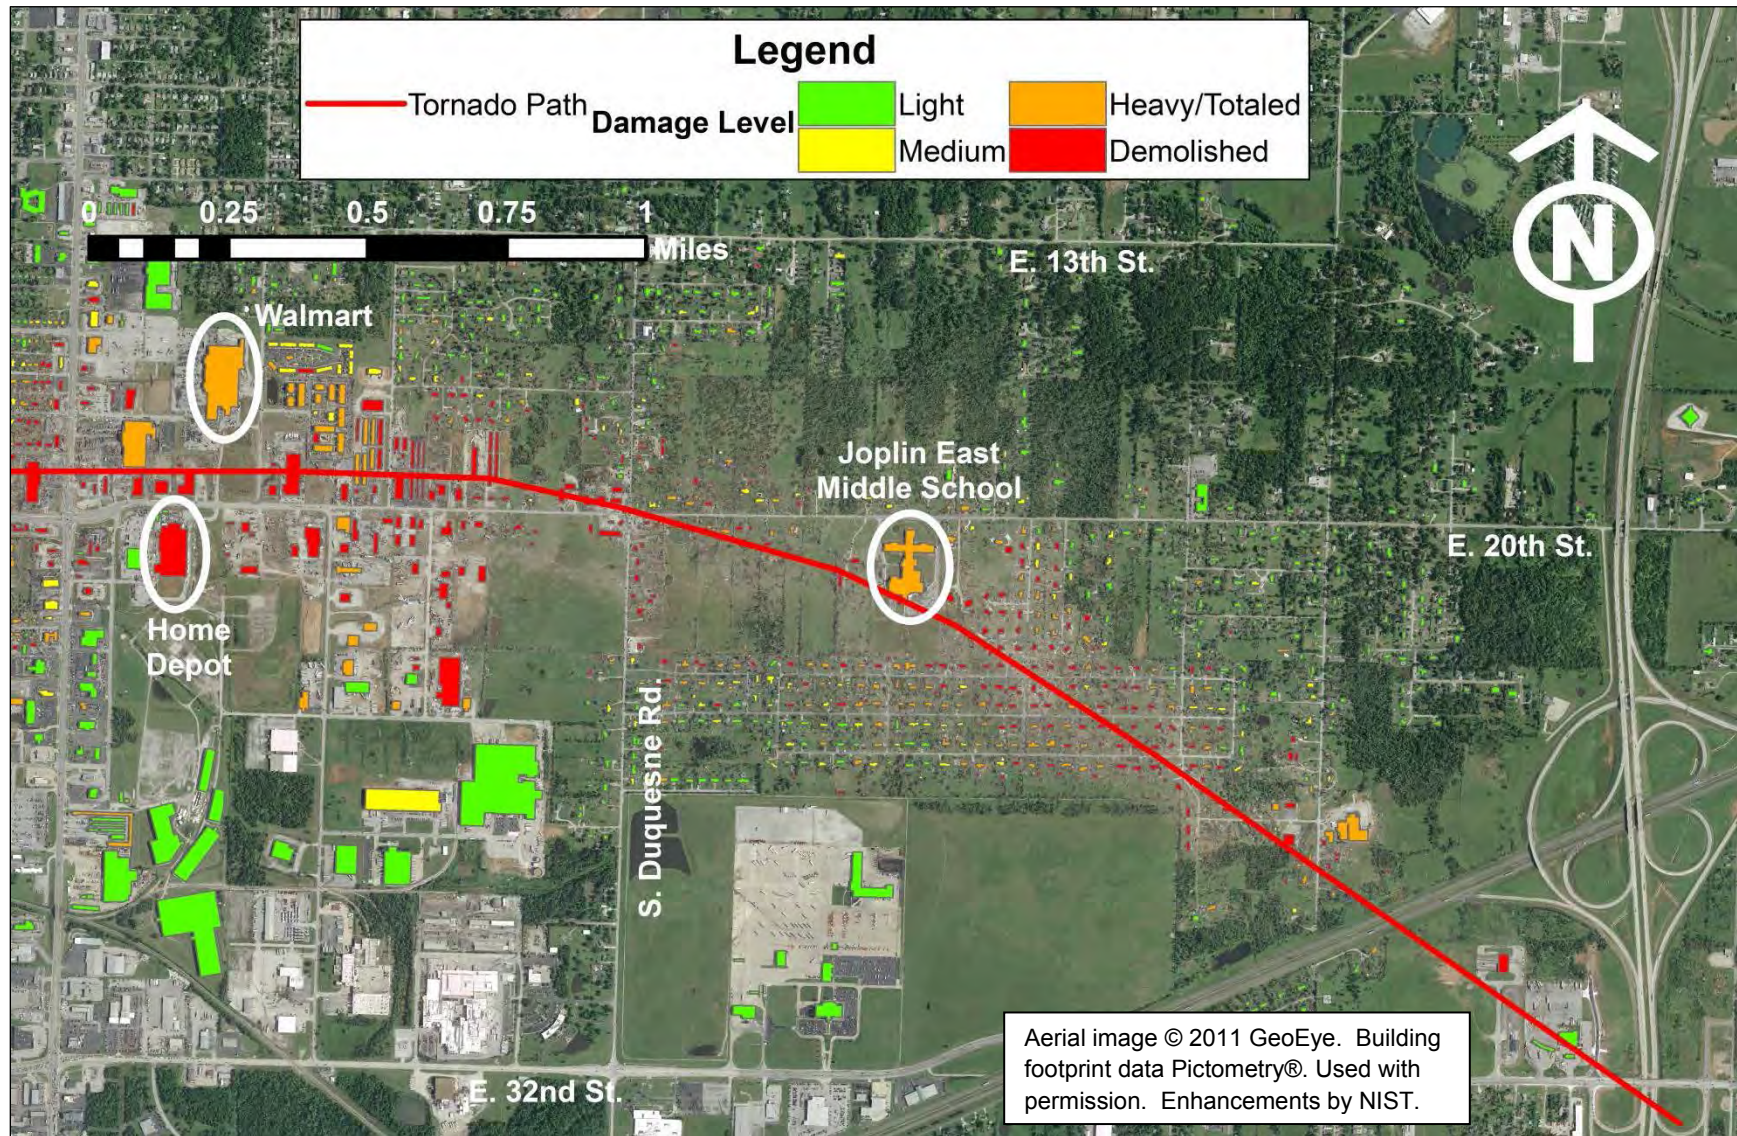
Figure 3–3. Easternmost segment of the tornado path through Joplin, showing locations of facilities surveyed by NIST relative to the estimated center line of the tornado damage path (red solid line). The color coded building footprints indicate the estimated level of damage to individual structures (see legend above).

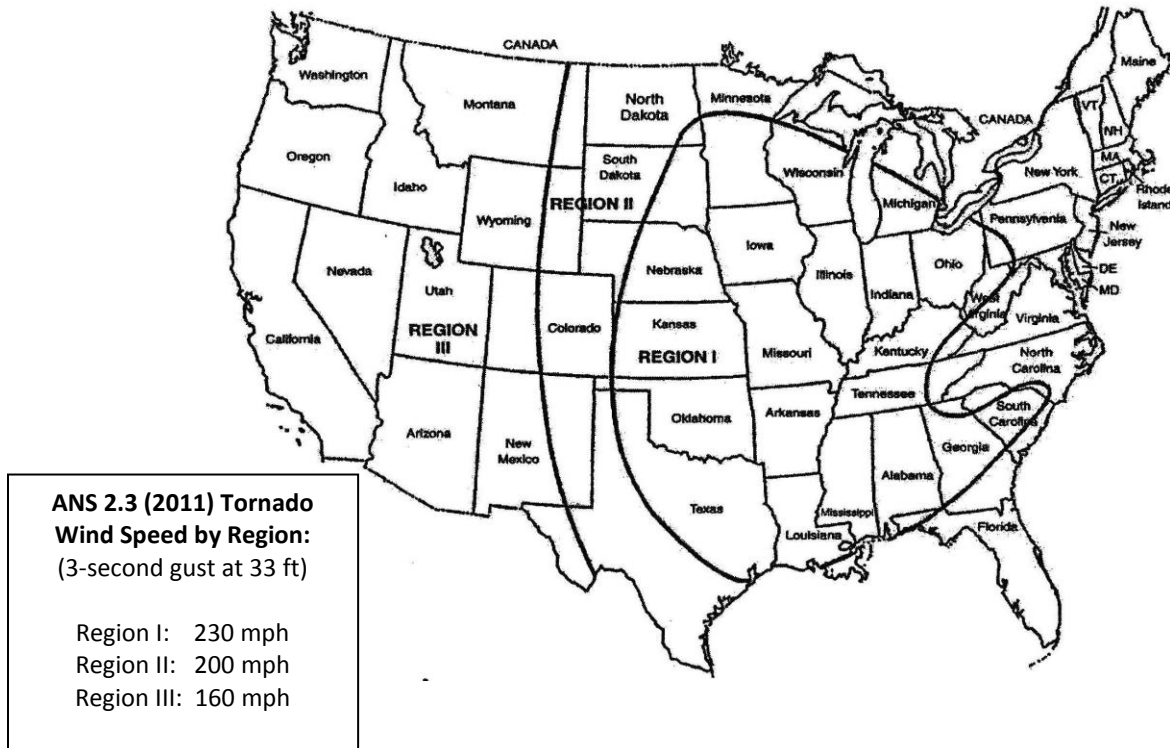
Source: Extracted from American National Standard ANSI/ANS-2.3-2011 with permission of the publisher the American Nuclear Society.

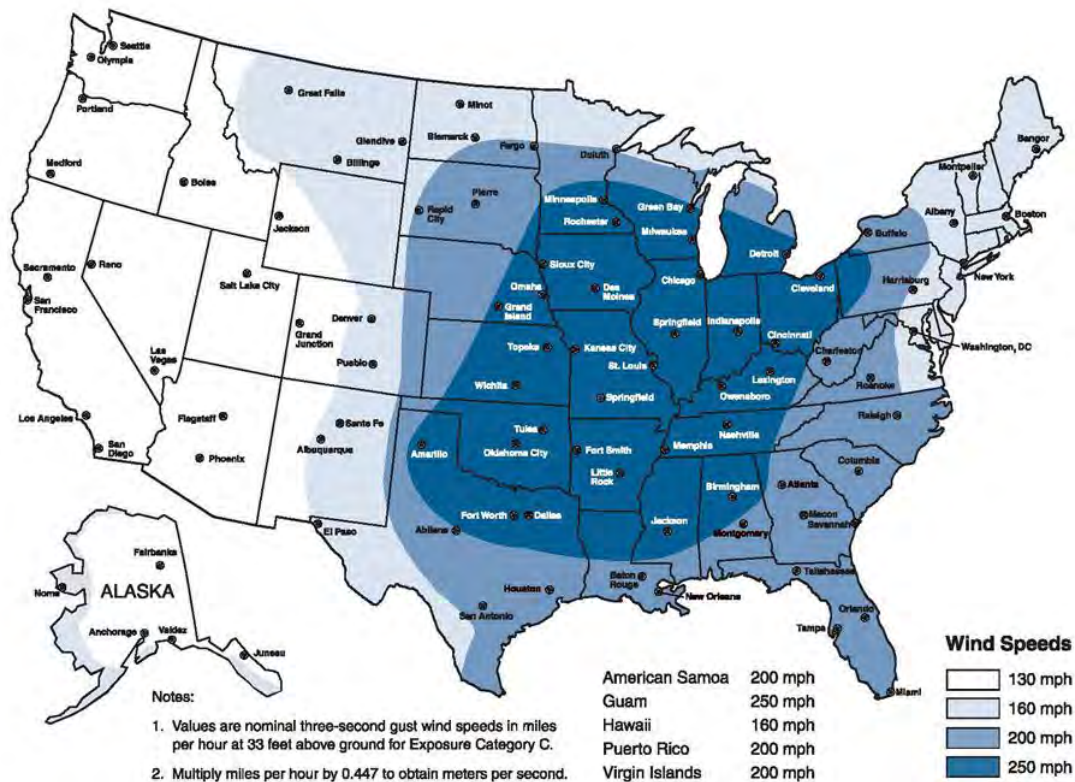
Source: FEMA (2008).

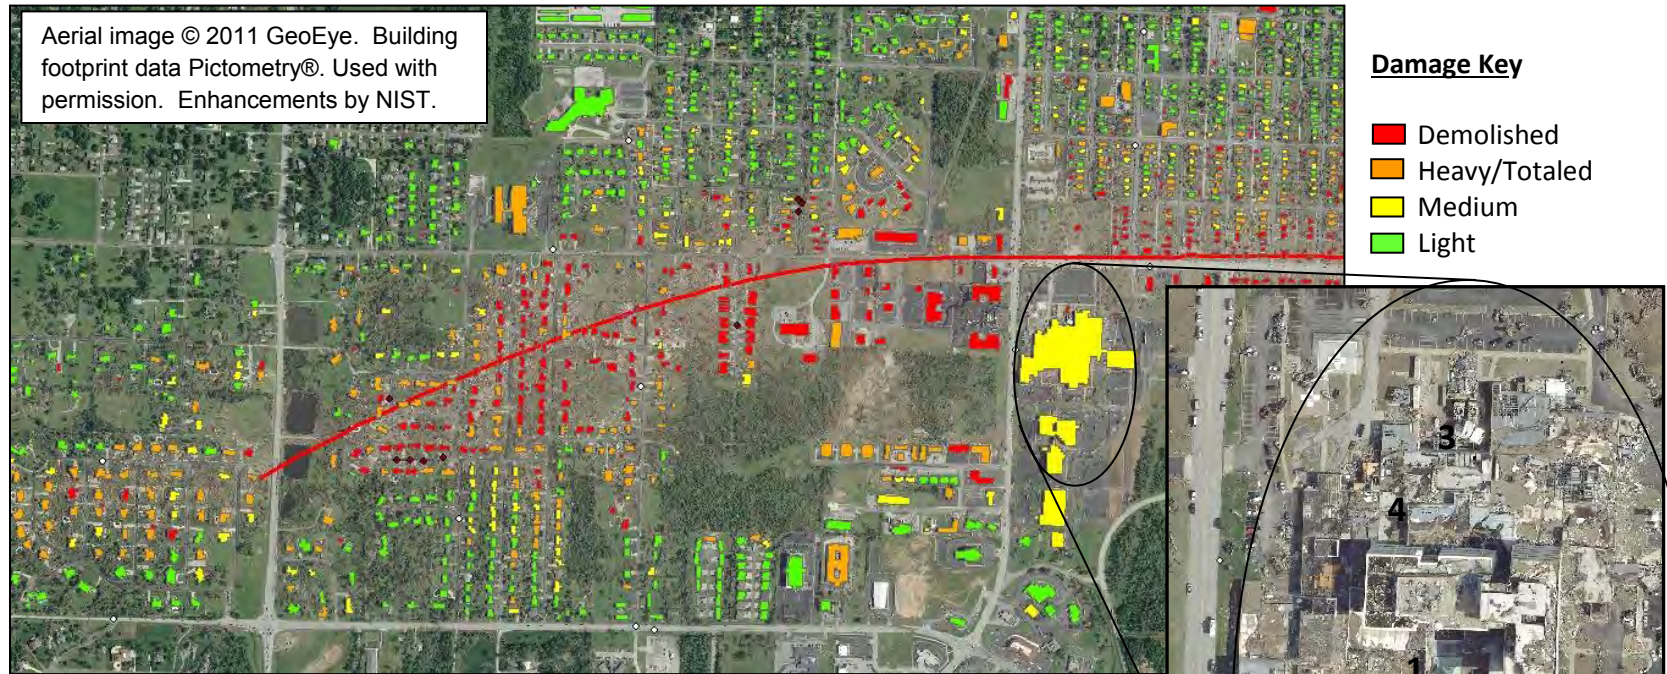
Figure 3–6. Overview of St. John’s Regional Medical Center.

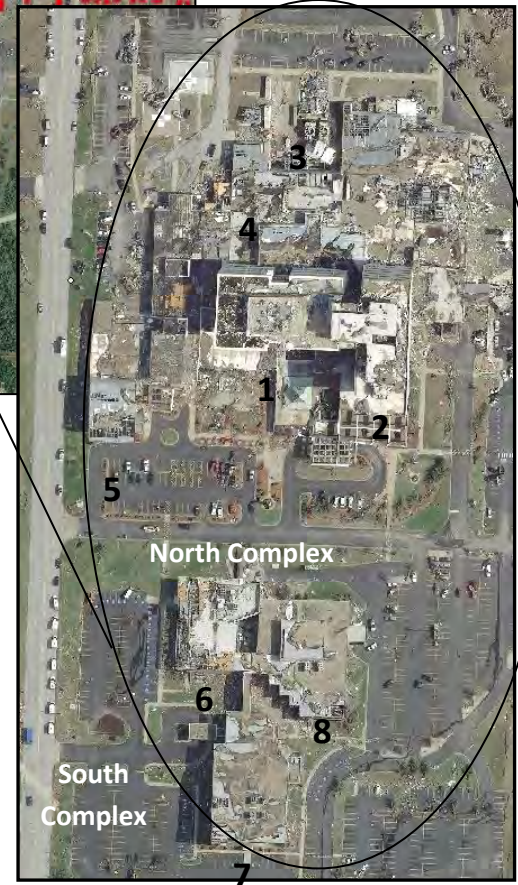
databases obtained by NIST (the others created by the U.S. Army Corps of Engineers and the SAVE⁸⁰ Coalition). SJRMC was situated immediately to the east of a mixed commercial and residential area in which the majority of buildings were demolished by the tornado (EF-4 damage based on NIST's evaluation). Thus, it was directly downstream of the debris field that resulted from the damage to buildings in this area.

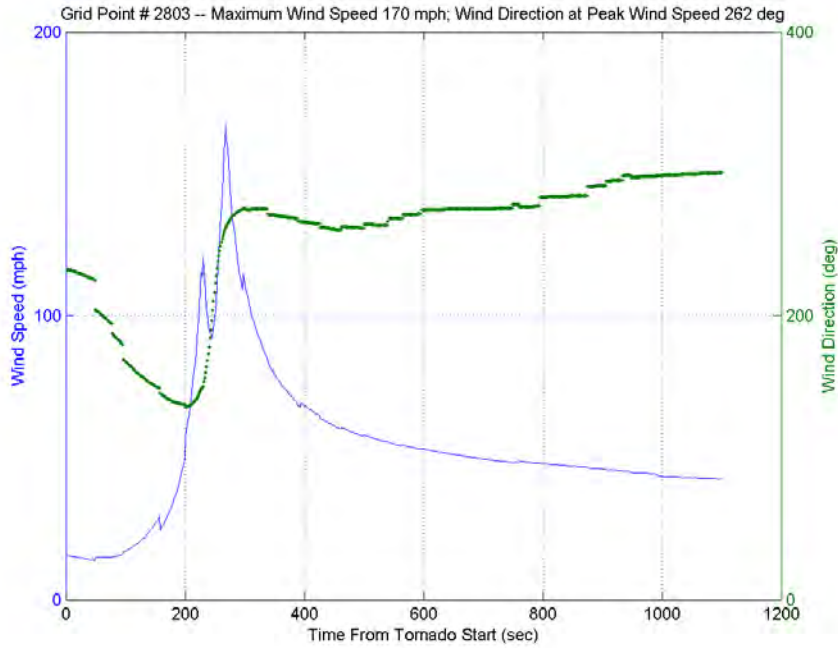
Figure 3-7. Time-history of wind speed and direction at north end of SJRMC.

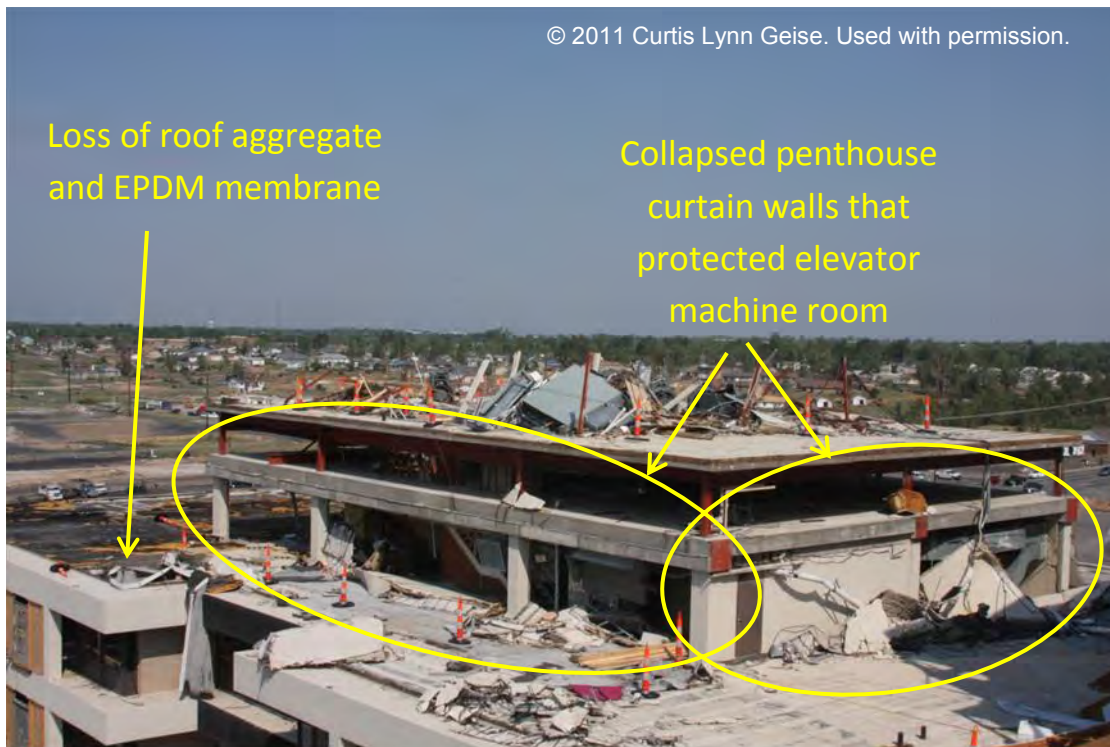
Figure 3–12. Damage to roof and penthouse walls of West Tower.

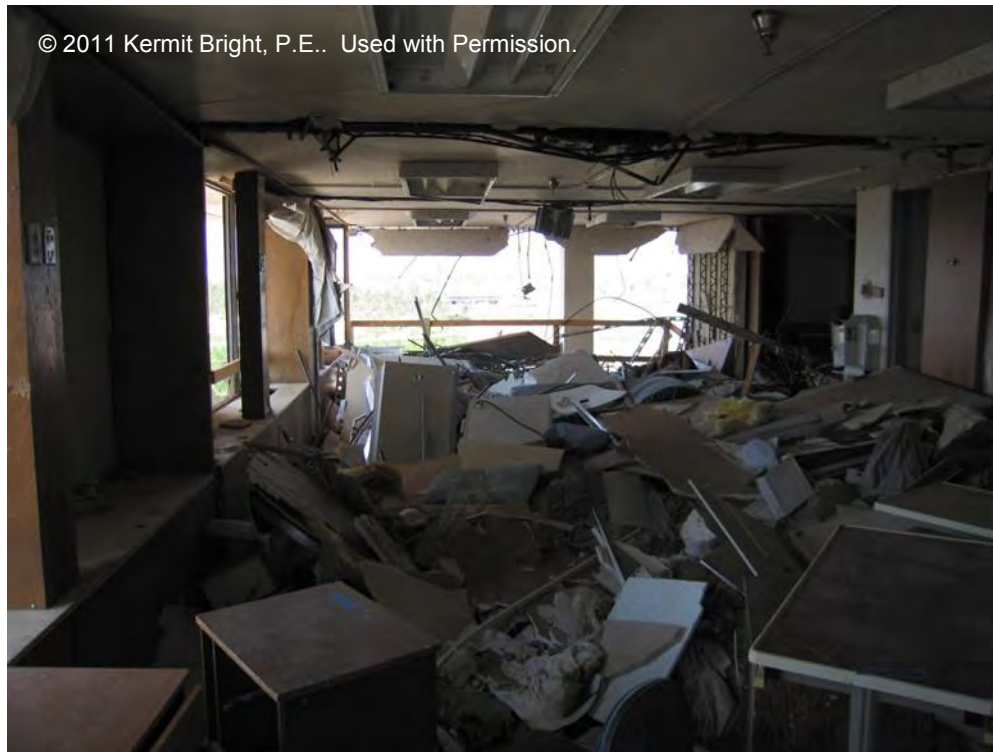
Figure 3–13. Typical damage to the interior of West Tower.

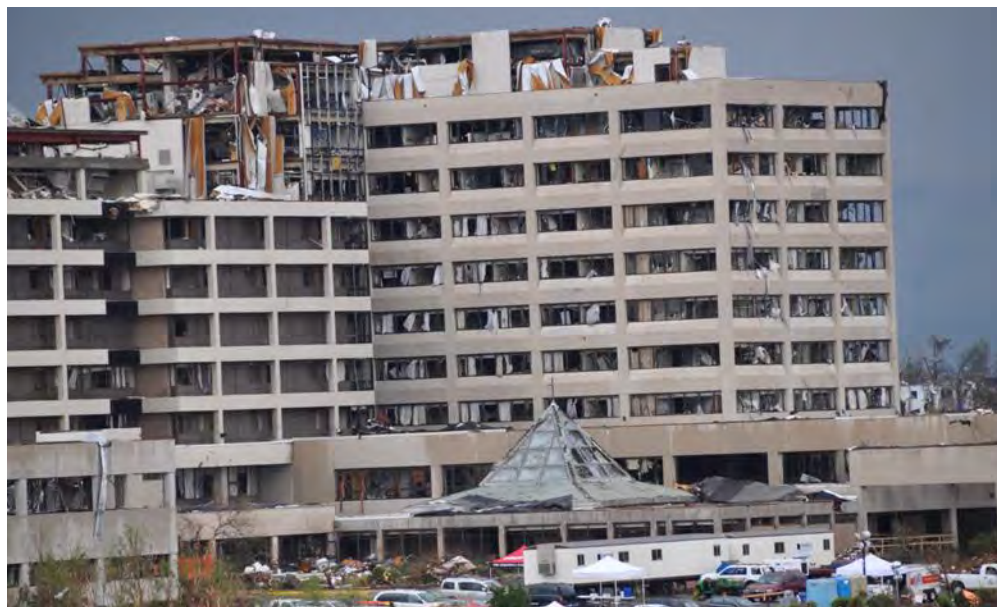
Figure 3–14. View from southwest of East Tower showing that most windows on south and west sides of building and curtain walls on connecting elevator steel frame have broken.

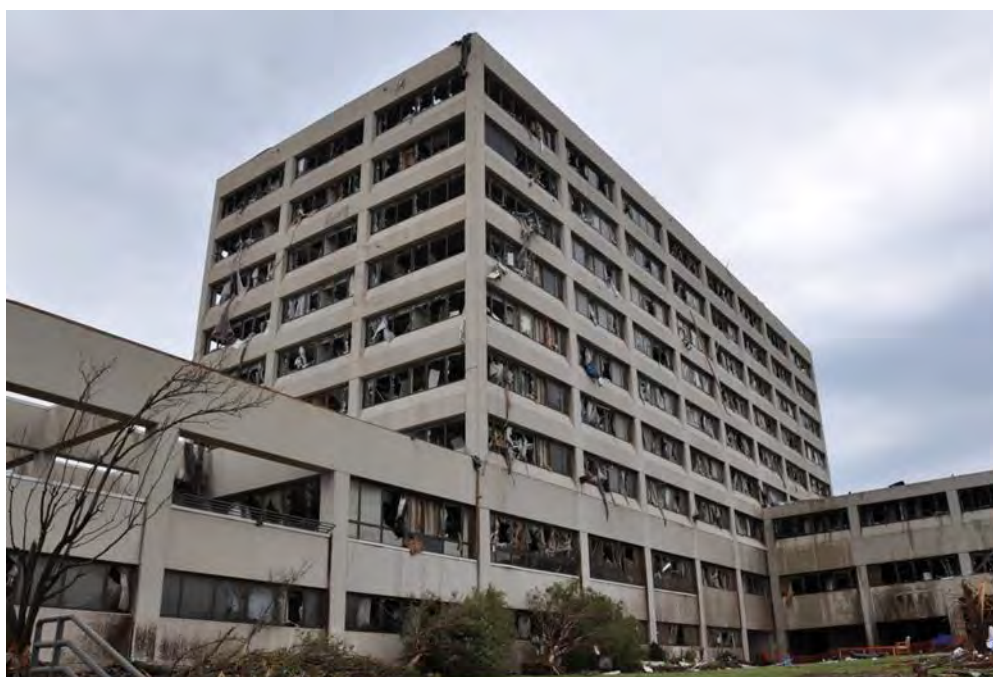
Figure 3–15. View from southeast of East Tower showing that most windows on south and east sides of building have broken.

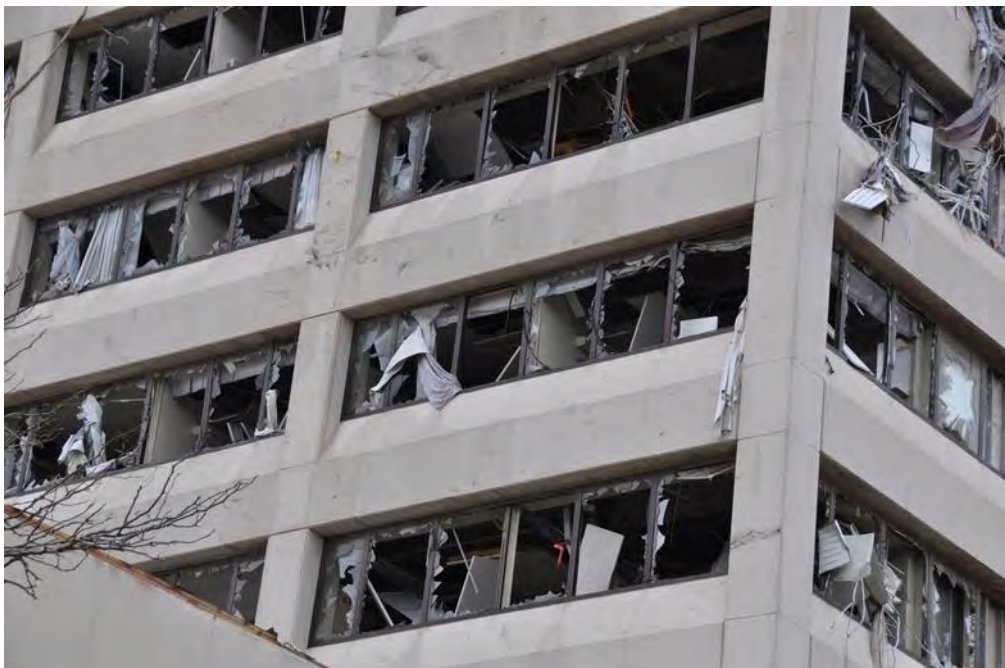
Figure 3–16. Close-up view showing minor damage to architectural precast concrete column–cover–and–spandrel system and significant damage to glass windows of East Tower.

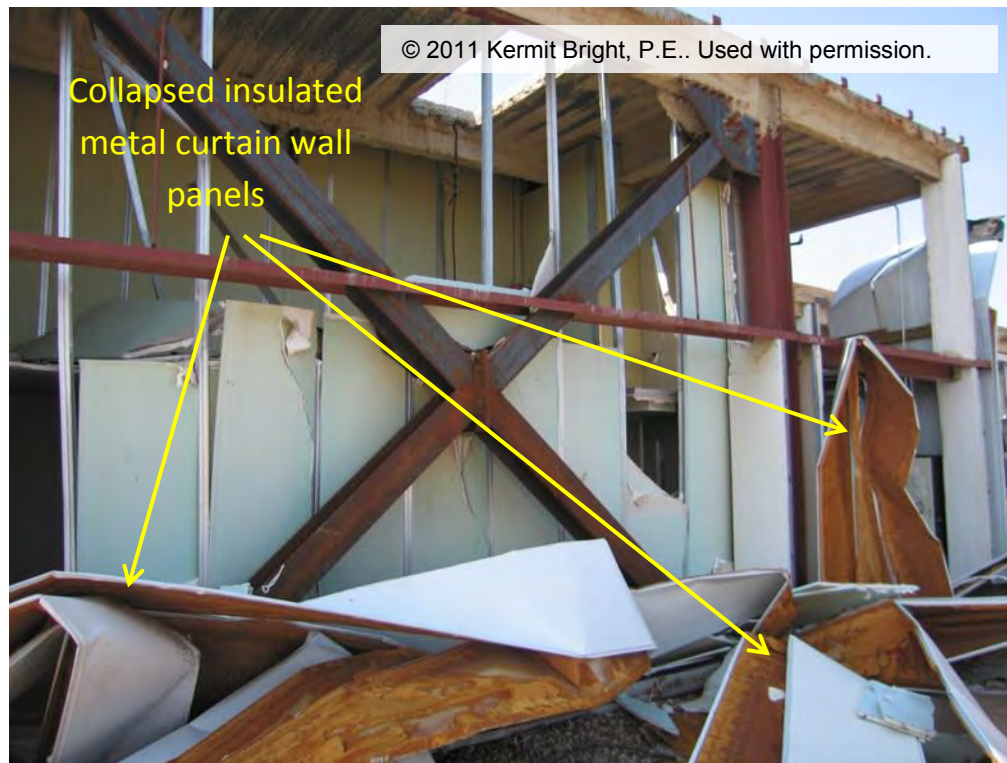
Figure 3–17. Missing/collapsed vertical insulated metal curtain wall panels of East Tower penthouse.

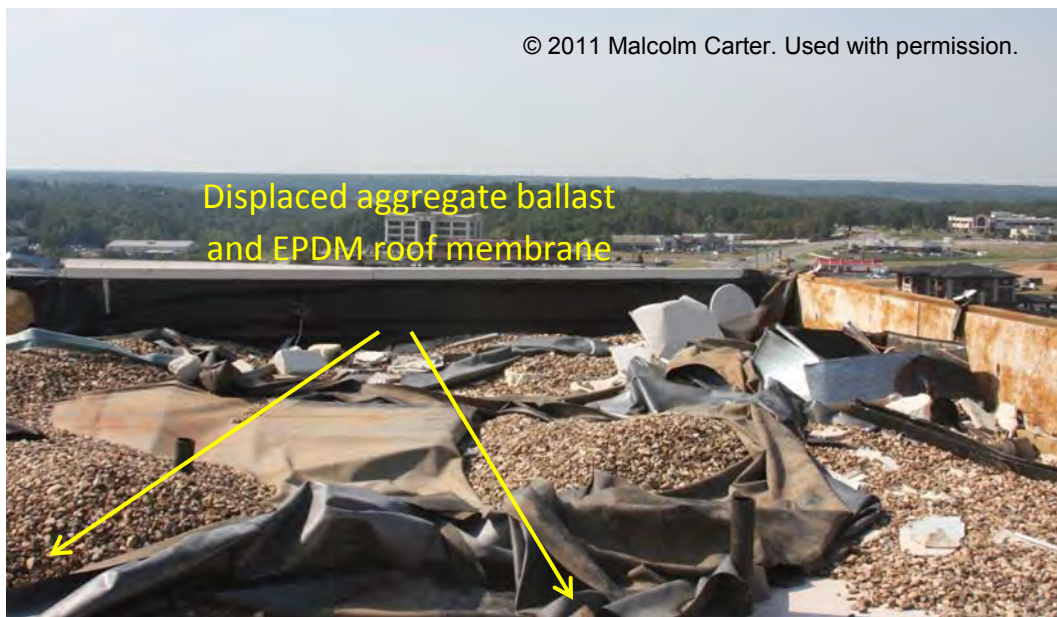
Figure 3–18. Damage to roof covering system of East Tower (peeling-off of EPDM roof membrane and rigid insulation, loss/displacement of roof aggregate ballast).

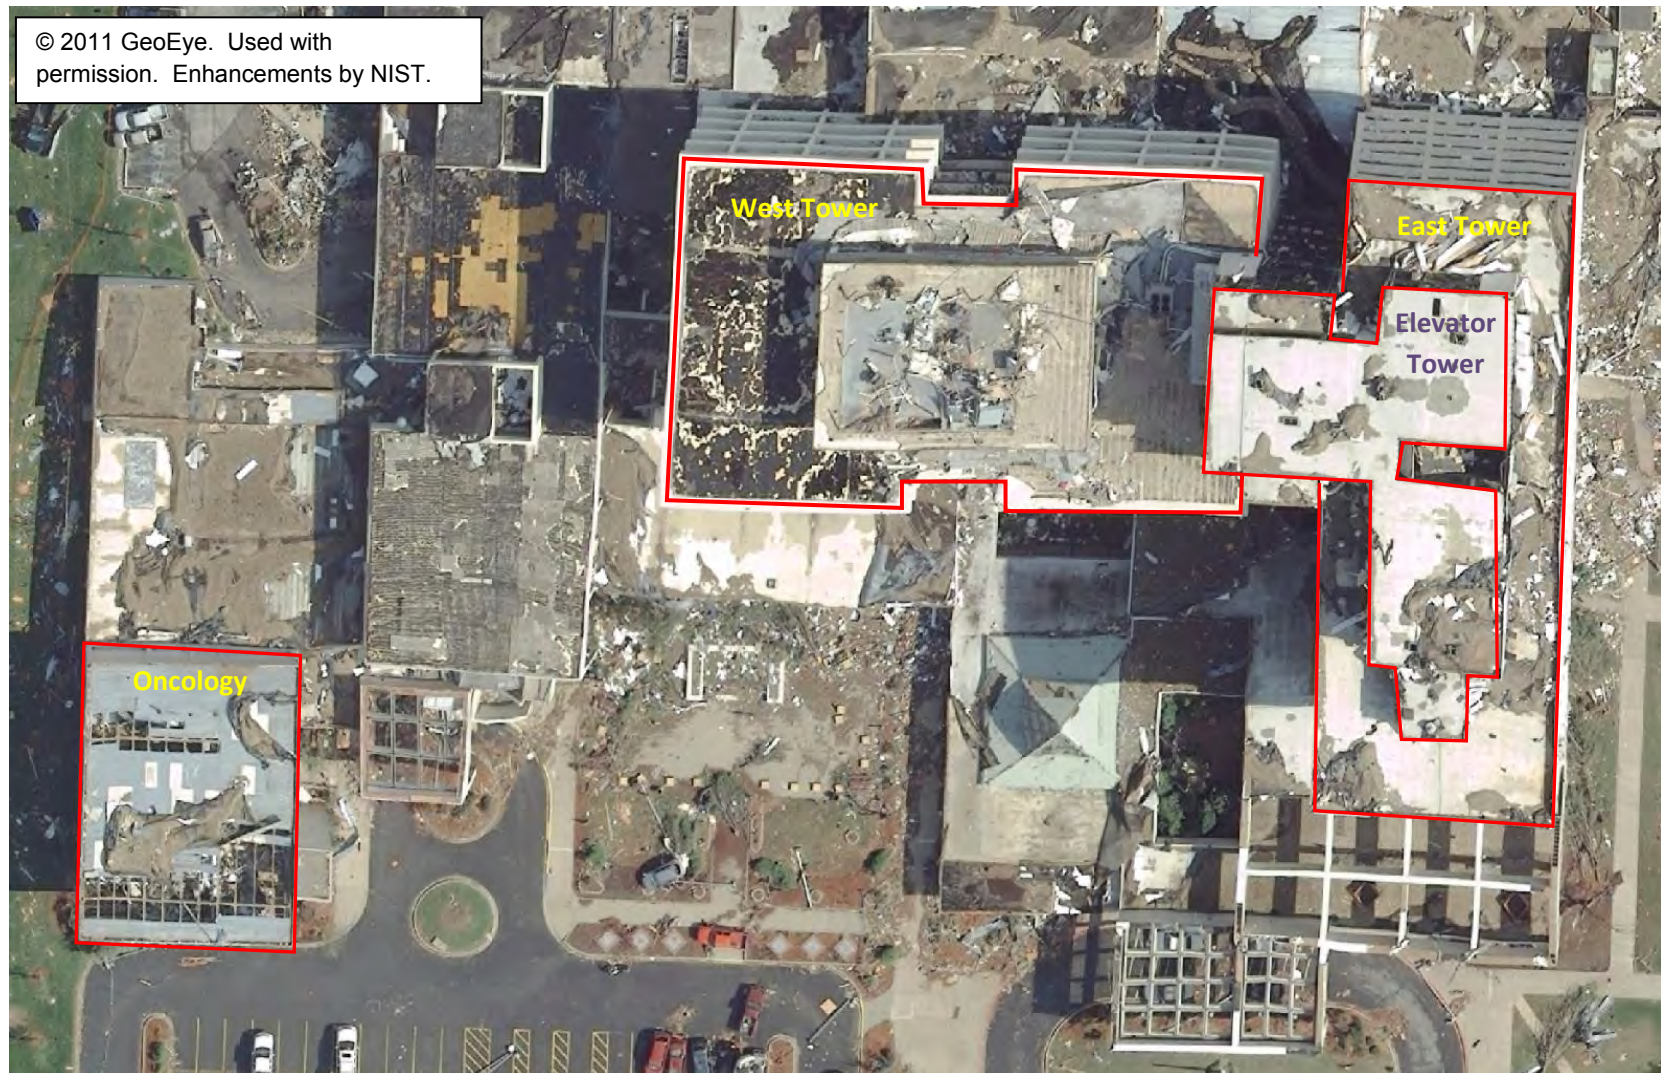
Figure 3–19. Overview of West, East, and Elevator Towers and Oncology Clinic Building showing that most of the aggregates that were used as roof ballast on these buildings are missing.

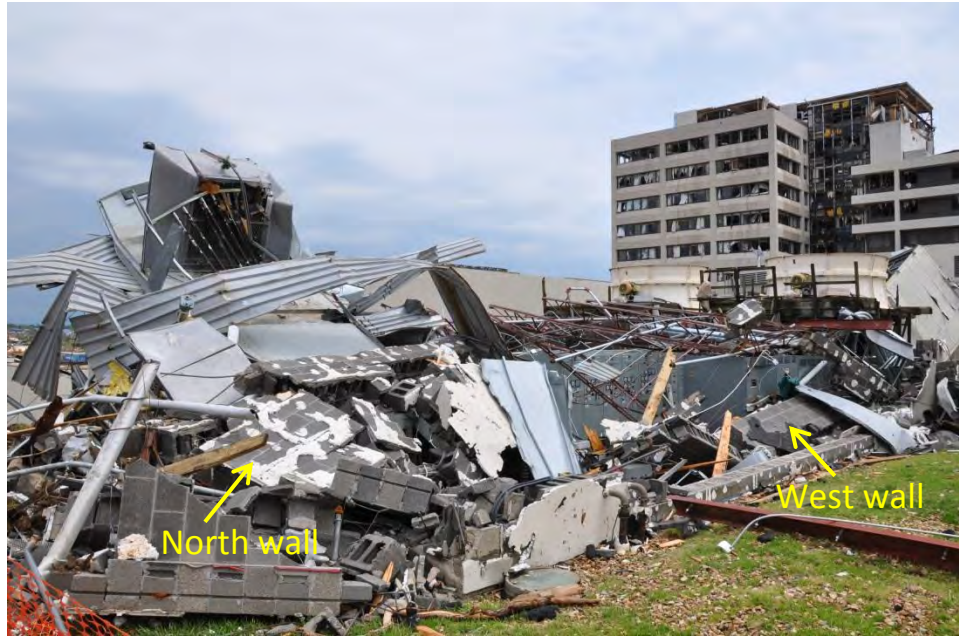
Figure 3–20. View from northwest of Emergency Generator Building. Note northward and eastward direction of wall failure, consistent with the direction of maximum wind (westerly) shown on Figure 3–7.

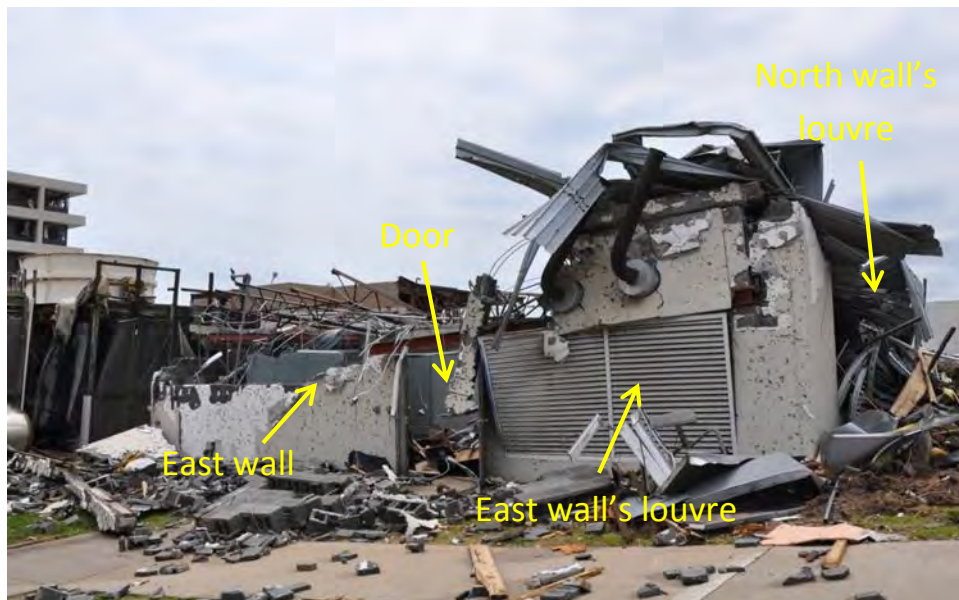
Figure 3–21. East side of Emergency Generator Building. Note eastward direction of failure on east wall (CMU wall falling outward, door opened, louver pushed outward). Also note louver on north wall pushed outward, consistent with direction of maximum westerly wind and indicative of high internal pressure.

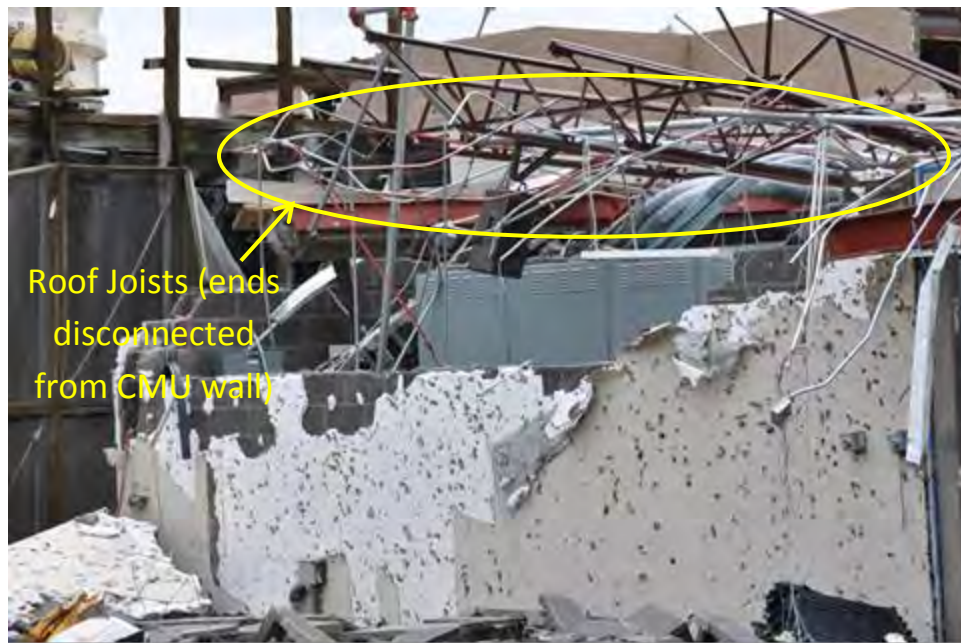
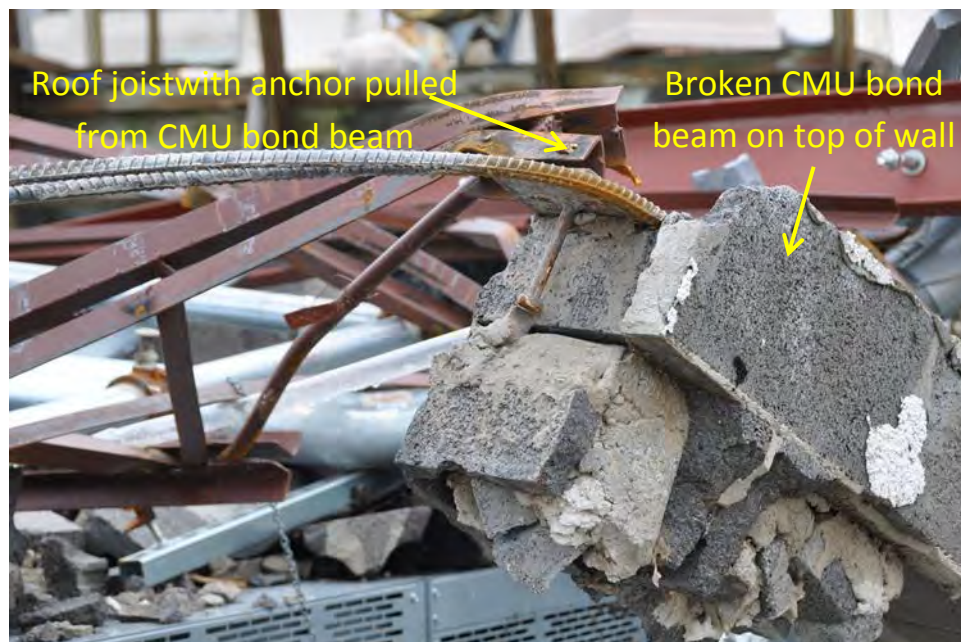
Figure 3–22. Failure details at Emergency Generator Building.

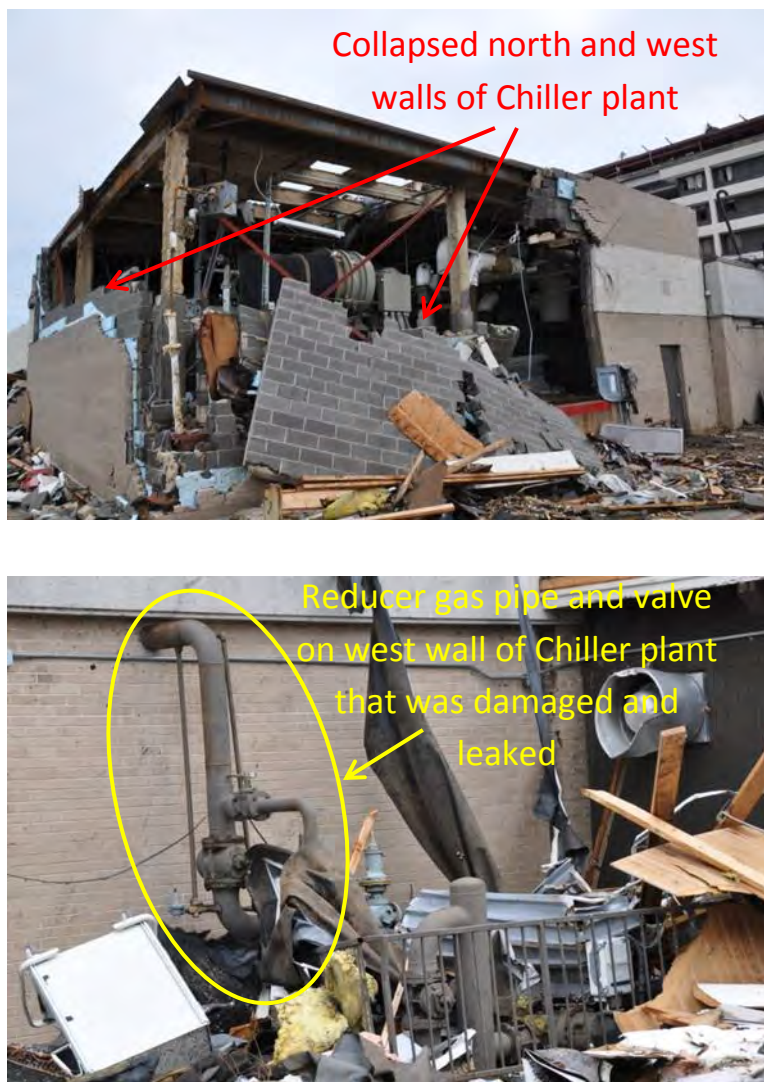
Figure 3–23. Views of damage sustained at the Chiller Plant.

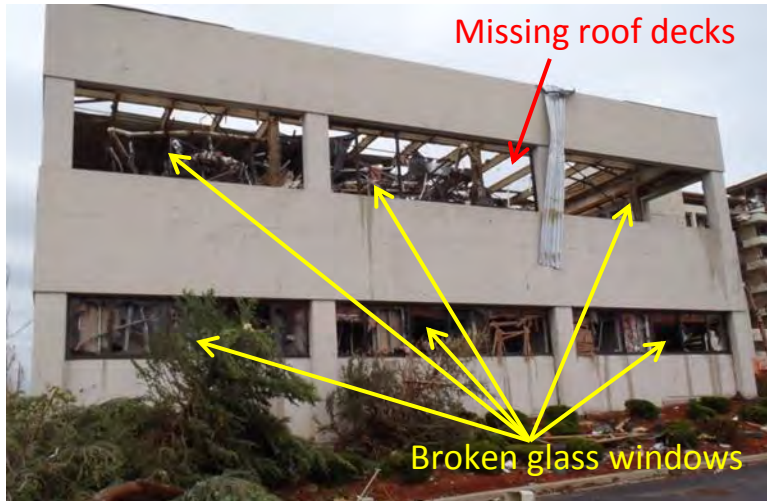
Source: FEMA Mitigation Assessment Team (MAT)

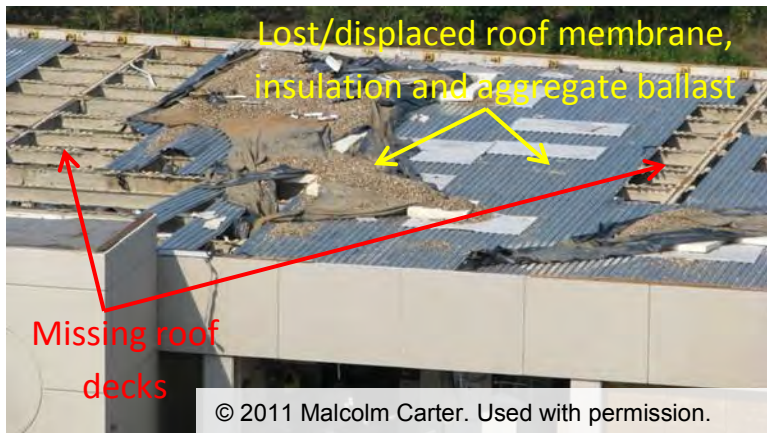
Figure 3–25. Roof of Oncology Clinic Building: missing steel deck panels, gypsum board, rigid insulation, membrane, and aggregate ballast.

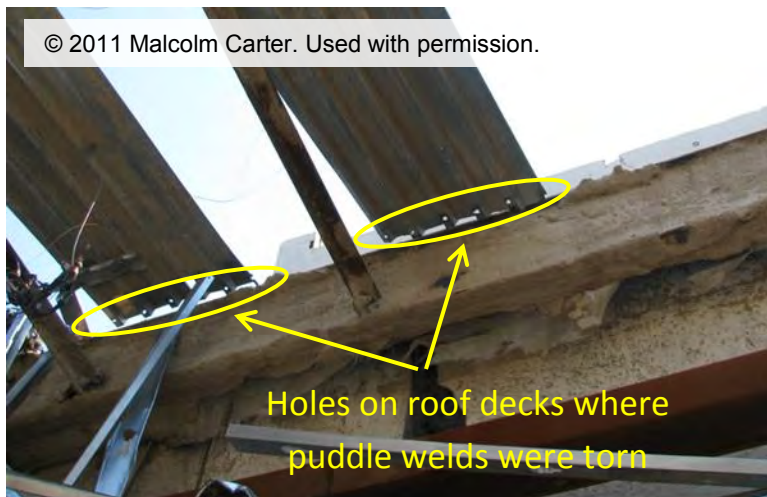
Figure 3–26. Roof of Oncology Clinic Building: failed puddle welds connecting roof deck with supporting roof beam.

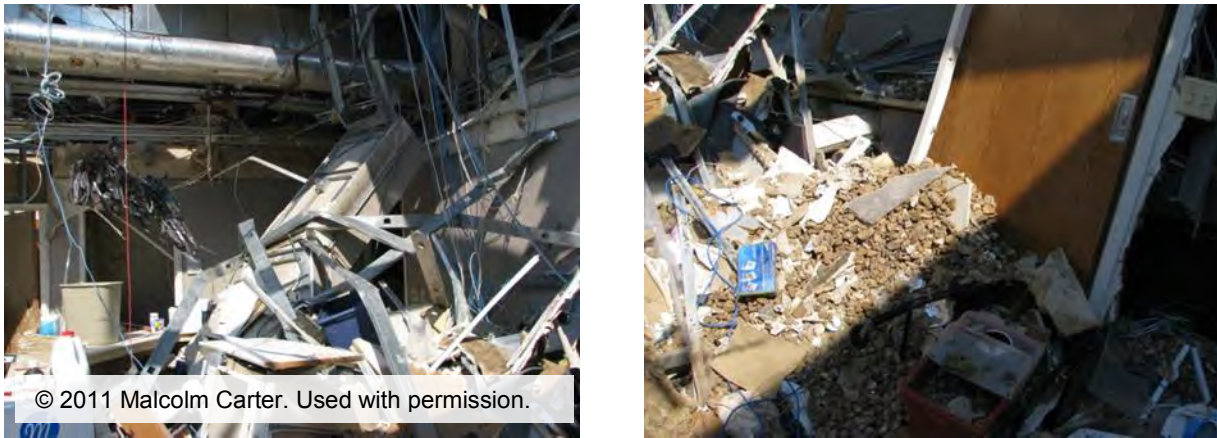
Figure 3–27. In Oncology Clinic Building, interior damage to ductwork, electrical wiring, suspended ceiling, interior partition/metal stud wall, furniture. Note the aggregate from roof in the interior.
