Draft Final Report • National Institute of Standards and Technology (NIST)

Technical Investigation

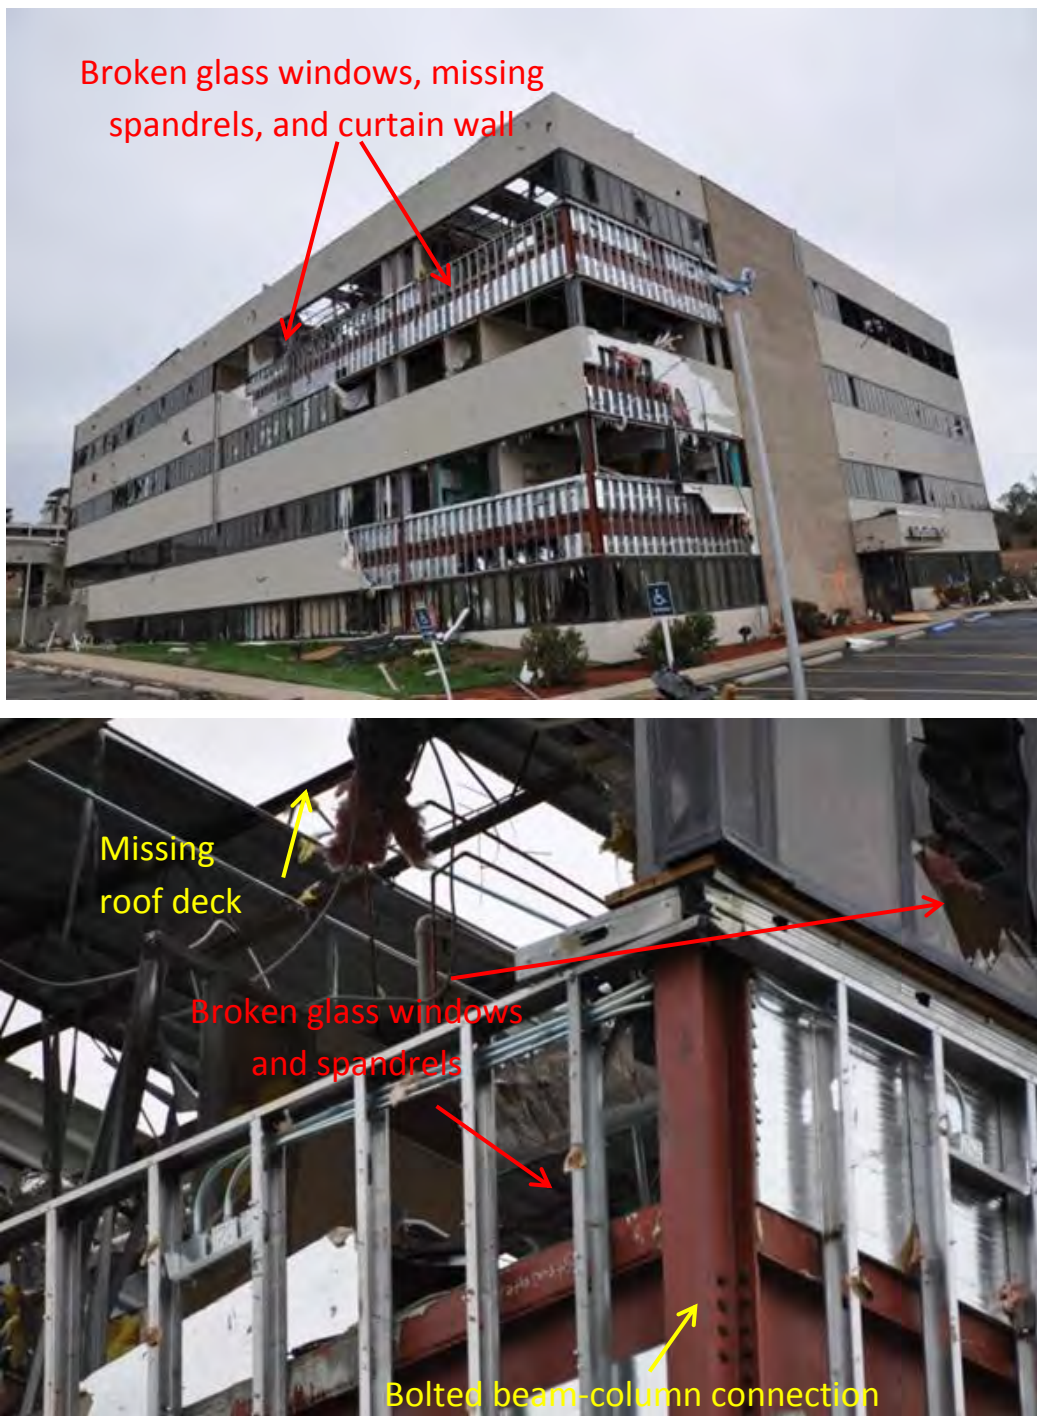
Figure 3–29. Views of (top) damage to envelope of Medical Office Building 2 and (bottom) portion of the steel frame system (bolted beam–column connection).

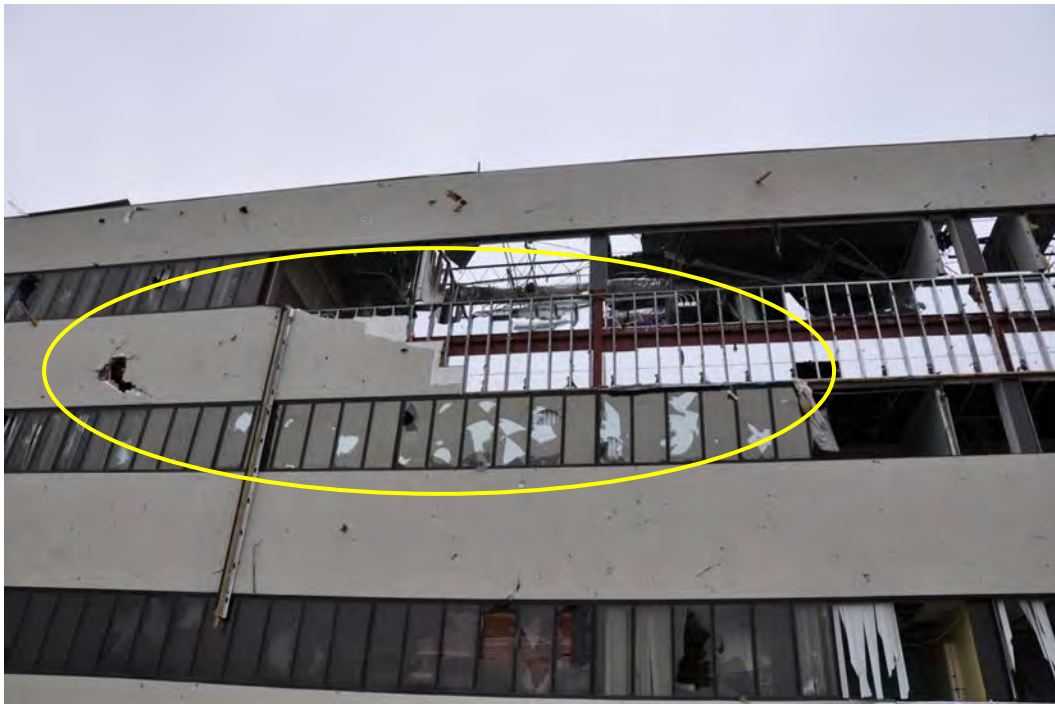
Figure 3–30. Evidence of debris impact causing breakage of windows at Medical Office Building 2.

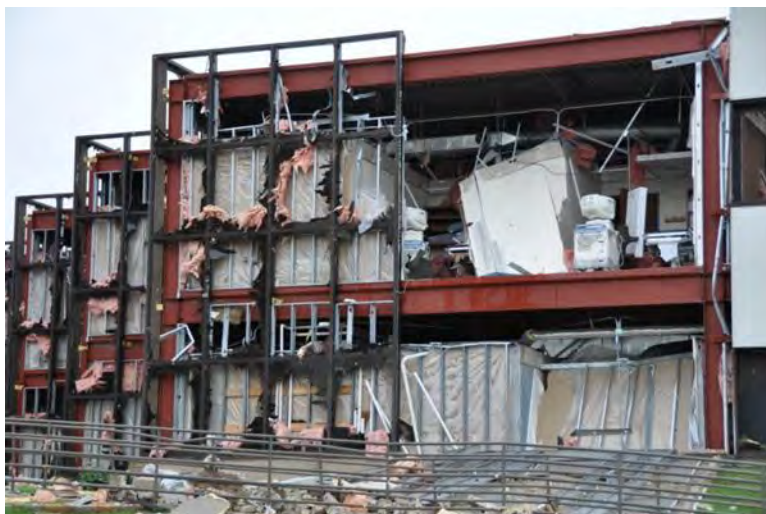
Figure 3–32. Collapse of an entire brick veneer curtain wall and the supporting aluminum stud frame on the south-facing wall of Physician’s Office Building.

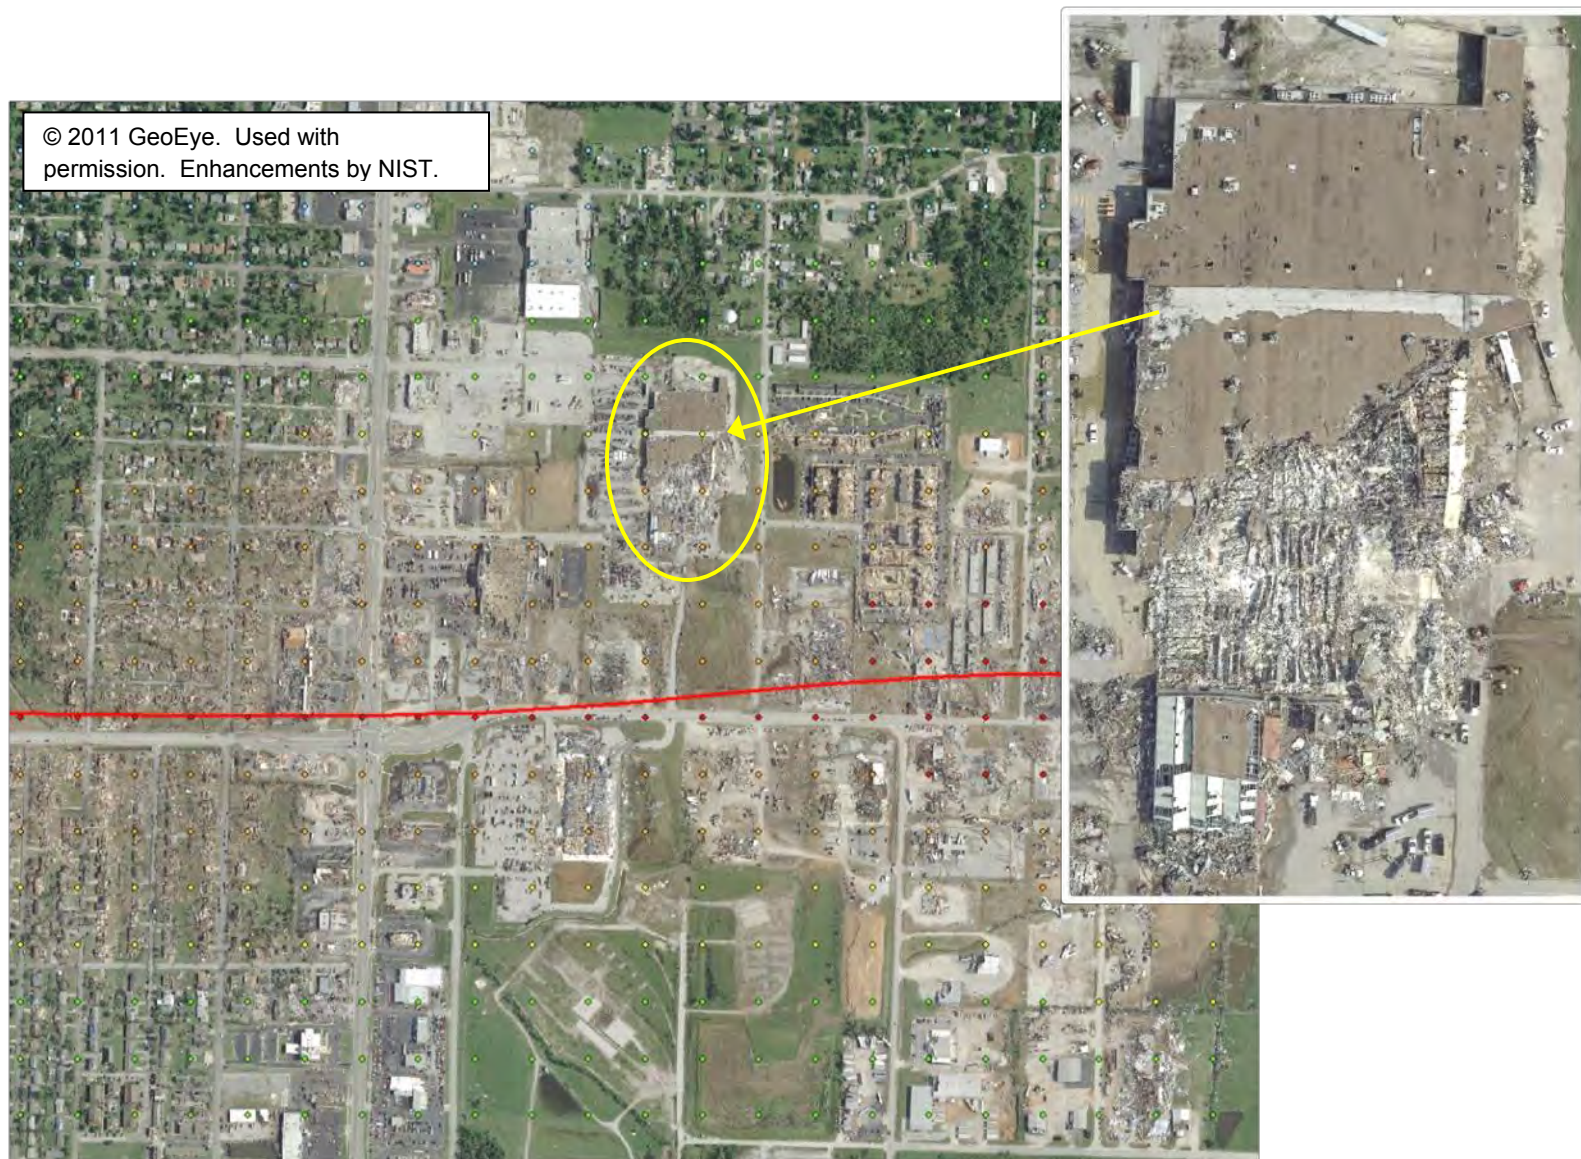
Figure 3–33. Aerial views of Walmart in relation to the tornado damage path (red line denotes center of damage path).

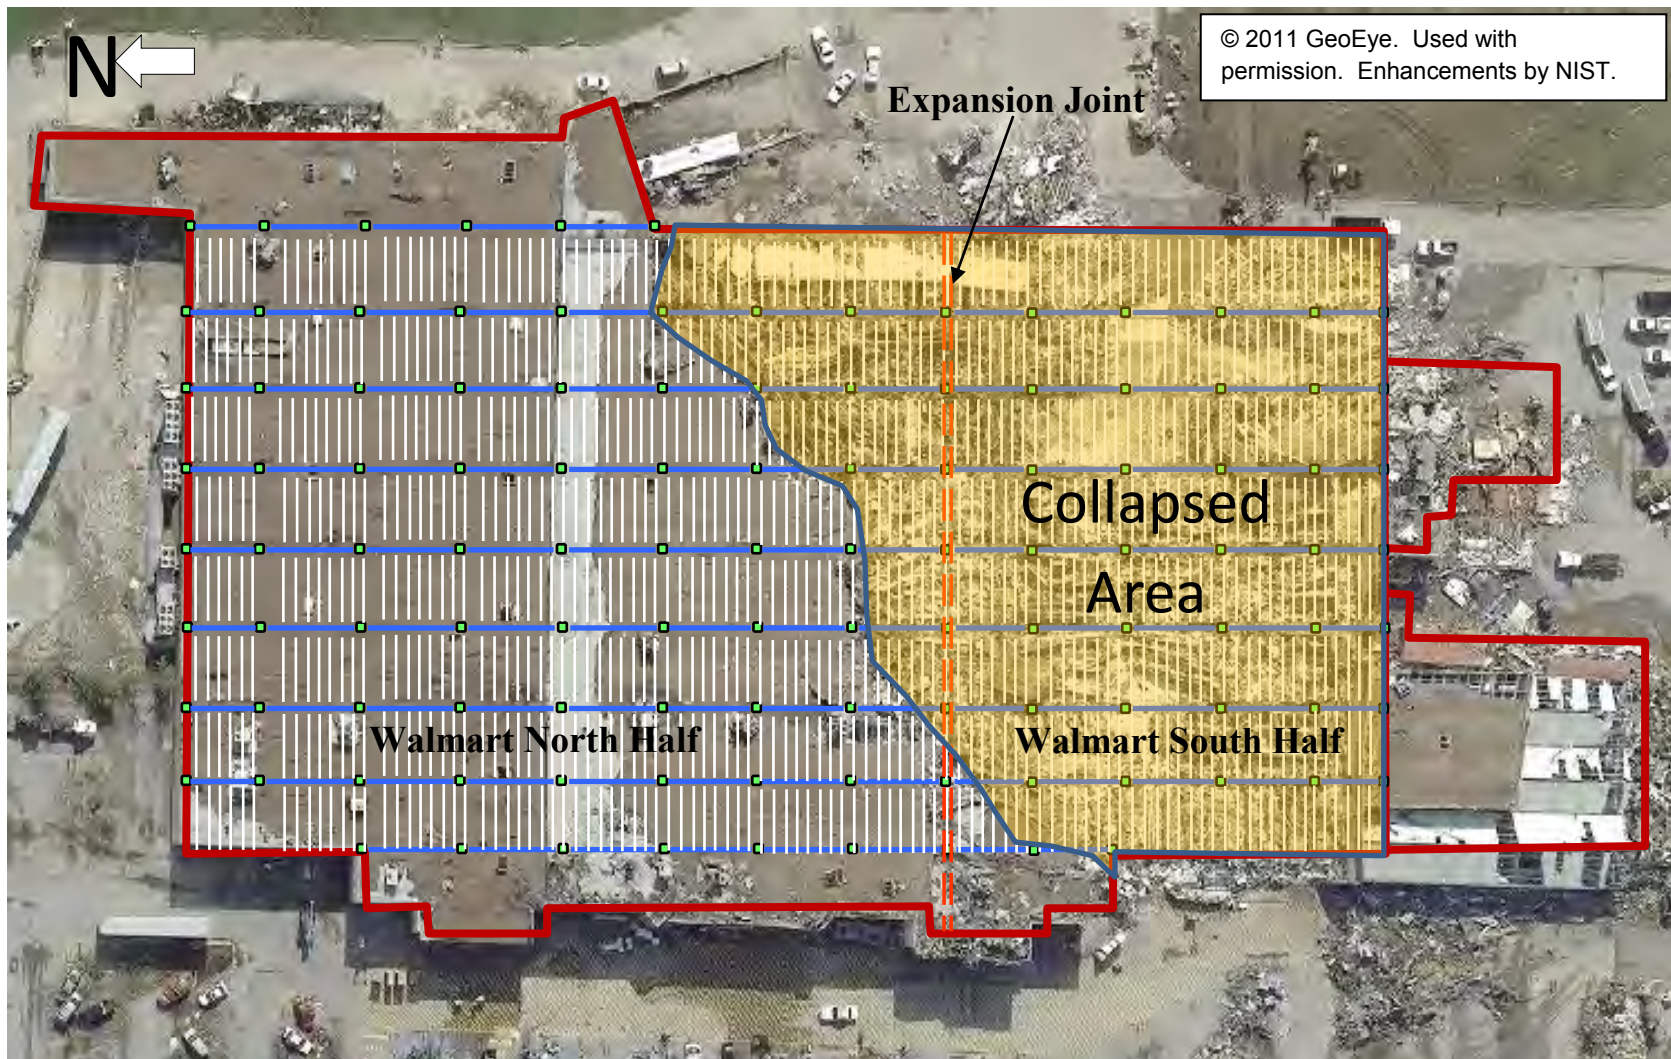
Figure 3–34. Aerial view of Walmart outlining southern half of building collapsed by the tornado.

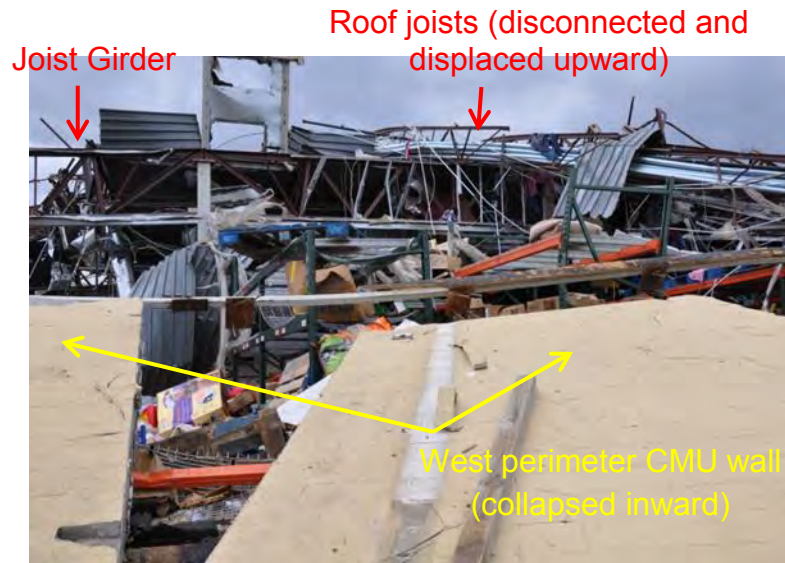
Figure 3–37. Roof system (decks and joists) missing. Some roof joists displaced upward (top chords used to be at same elevation as top chords of joist girders, but now sitting above joist girders), showing evidence of wind uplift action as primary cause of failure.

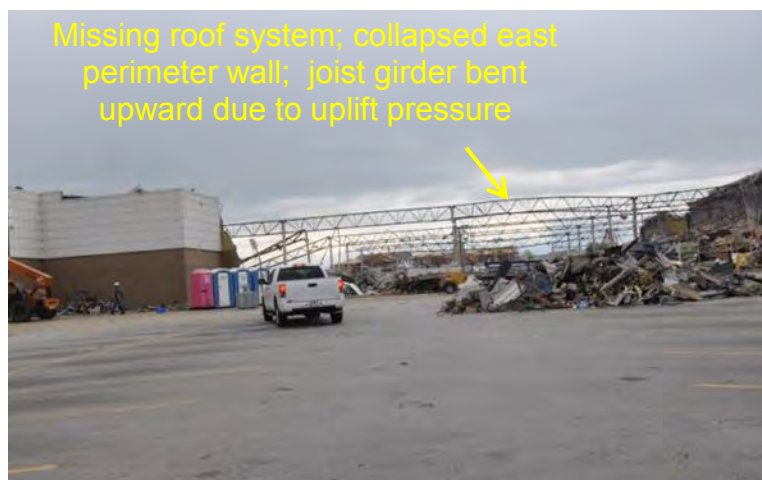
Figure 3–38. Large area of roof system shown missing. Joist girders bent upward due to uplift pressure.

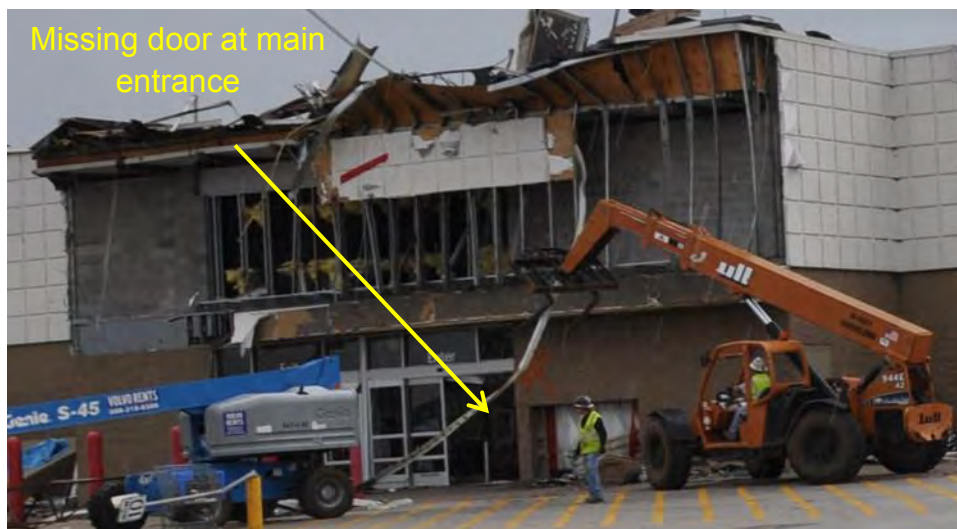
Figure 3–39. Missing door and glass panels and damage to signage at south entrance on west wall (envelope failure allowing air infiltration to the interior and causing increased wind uplift).

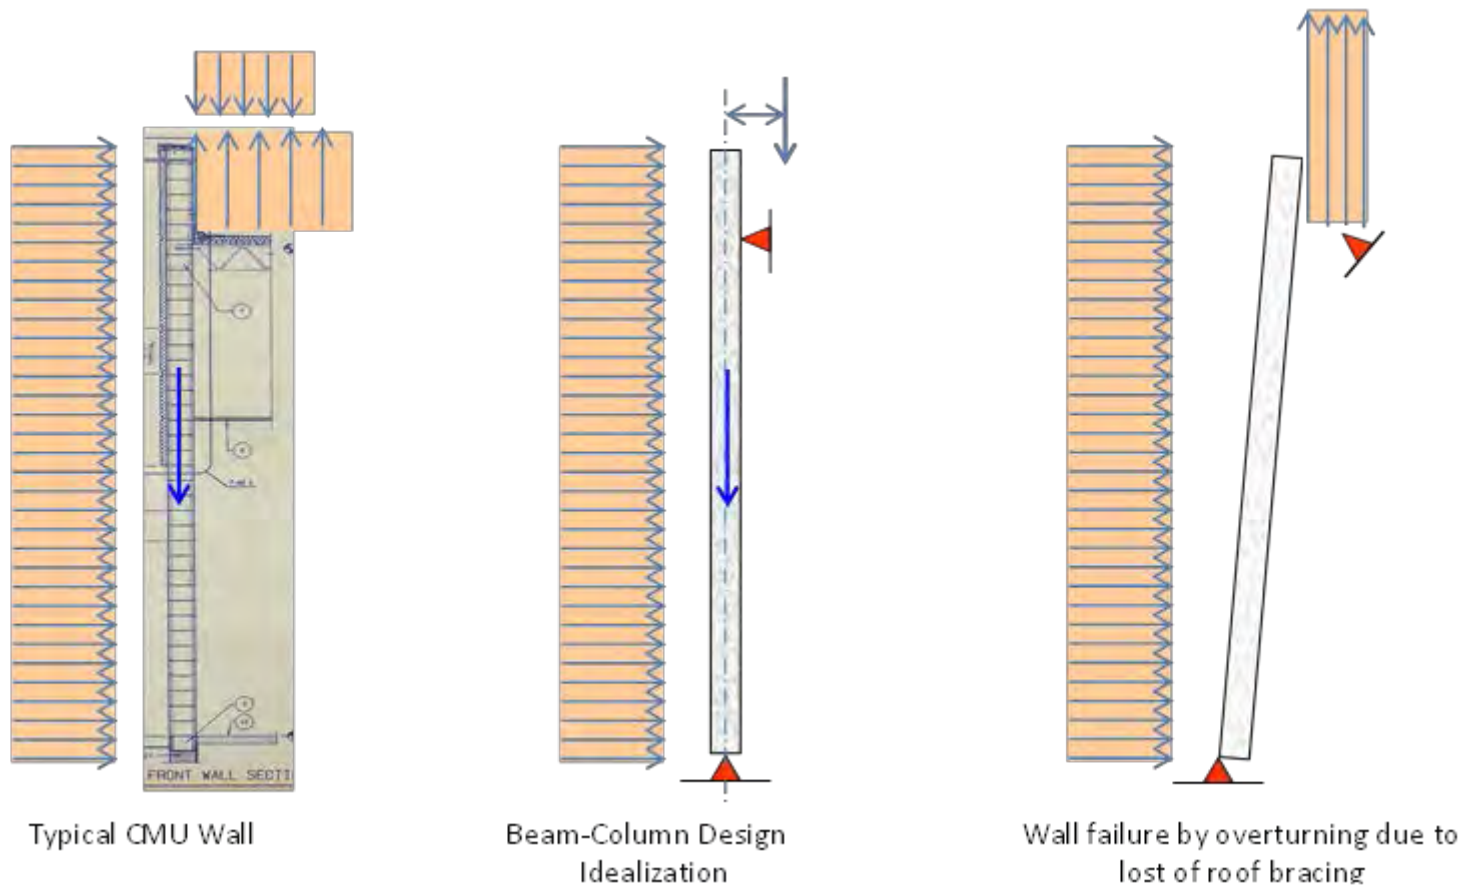
Figure 3–41. Typical loading and design conditions for BTS building and possible failure mode.

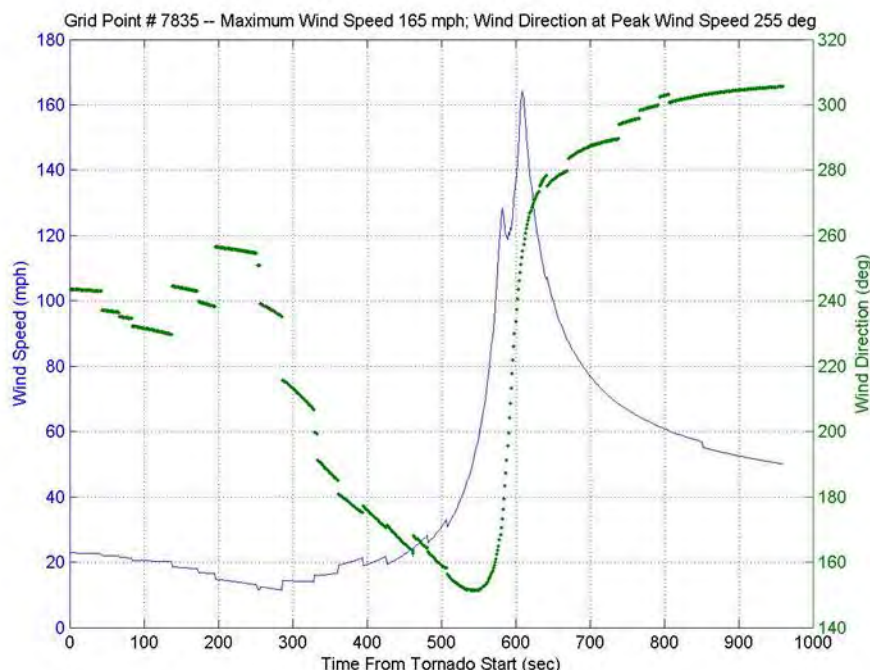
Figure 3-43. Time-history of wind speed and direction affecting Home Depot.

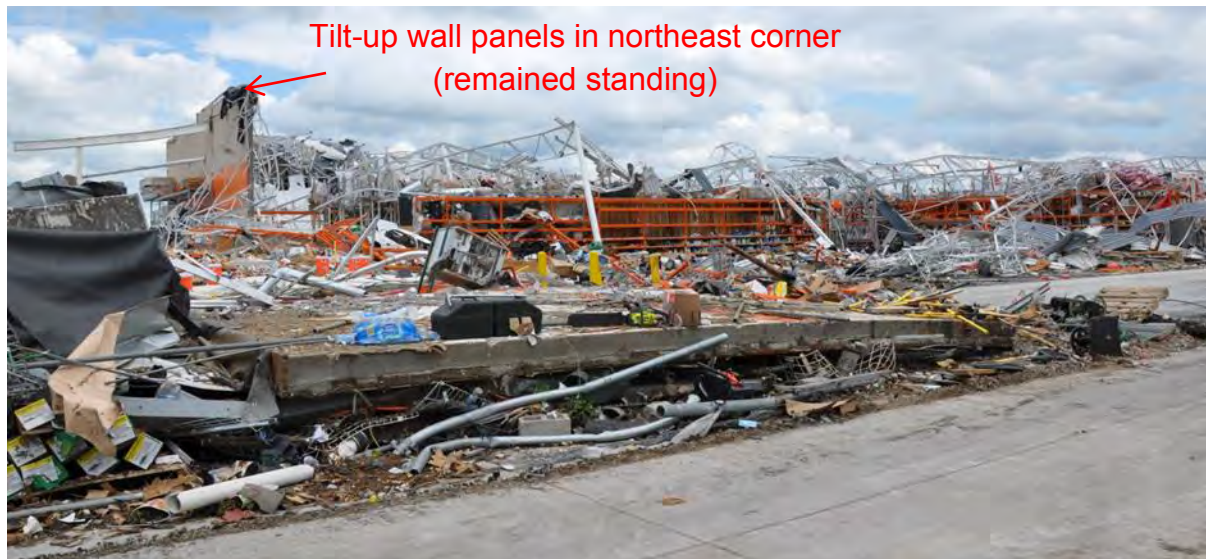
Figure 3–49. Collapsed Home Depot building (view from the northwest). Note the loss of all roof decks and upward displacement of joists and joist-girders

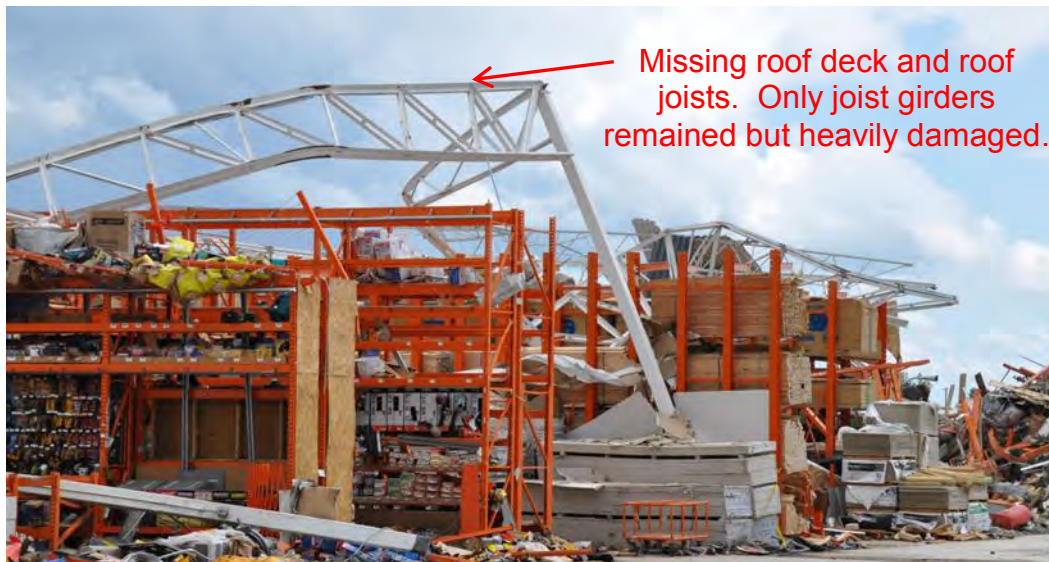
Figure 3–51. Damaged joist girders and interior columns. Note the complete loss of the roof system that was connected to the girders.

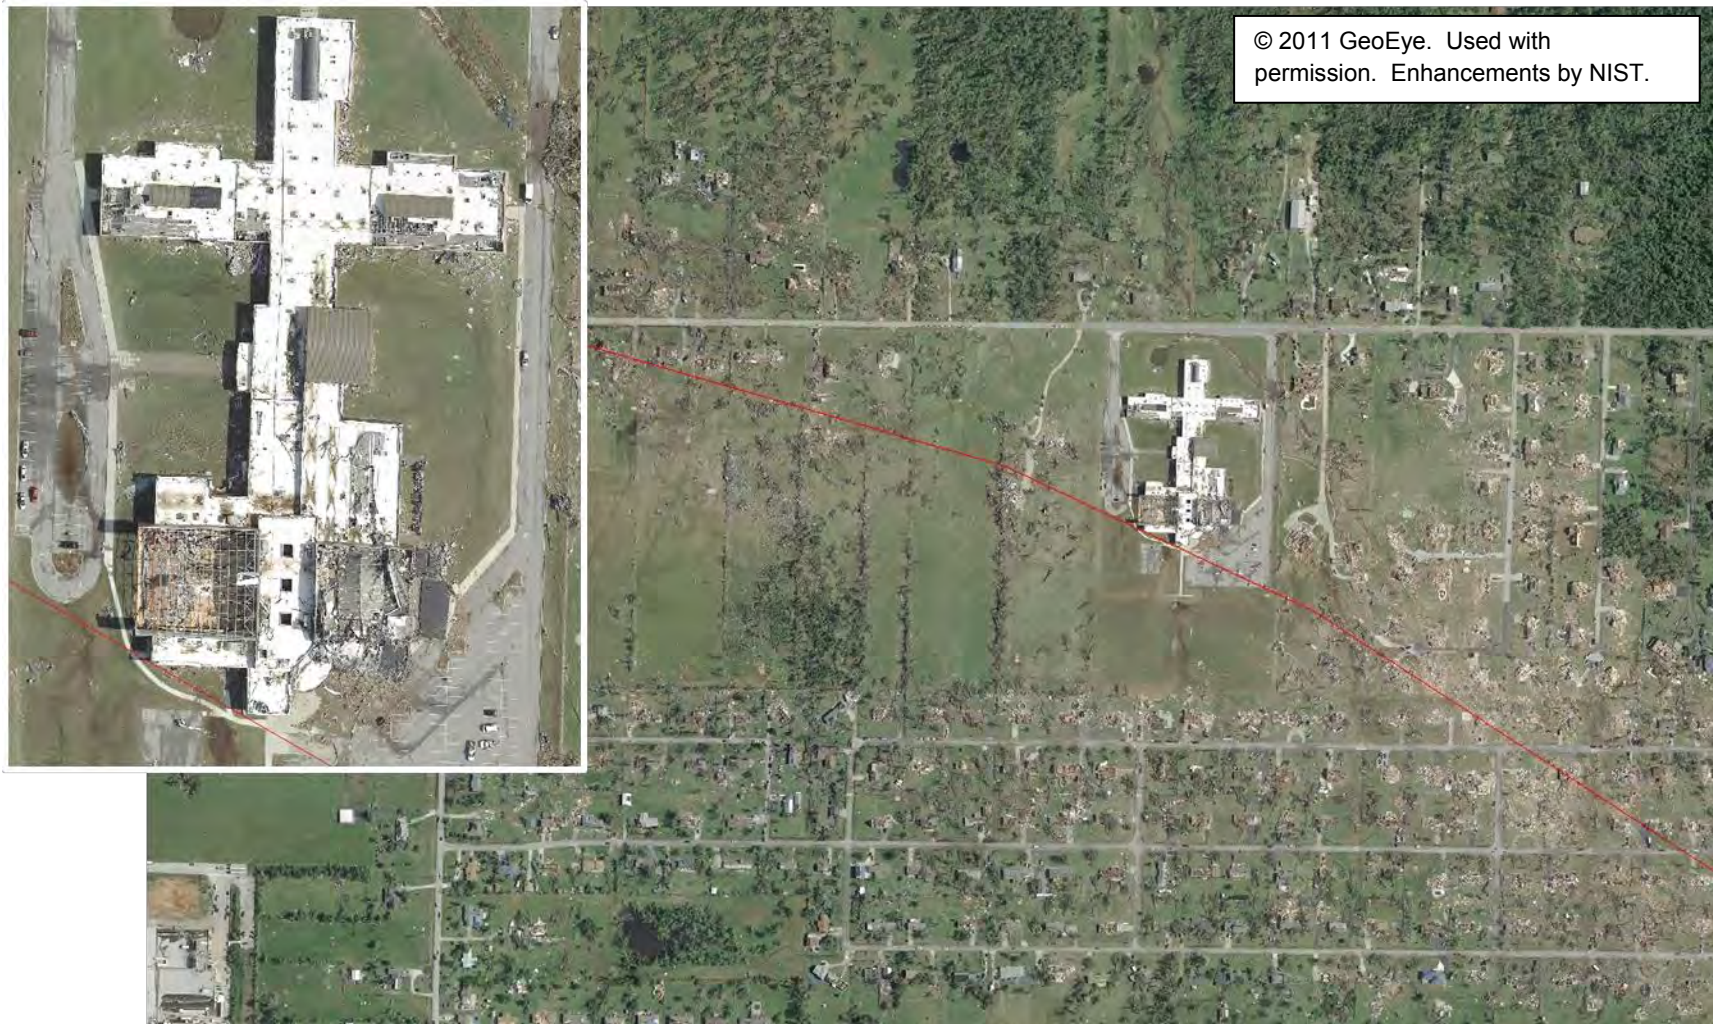
Figure 3–52. Aerial views of Joplin East Middle School in relation to the tornado damage path (red line denotes center of damage path).

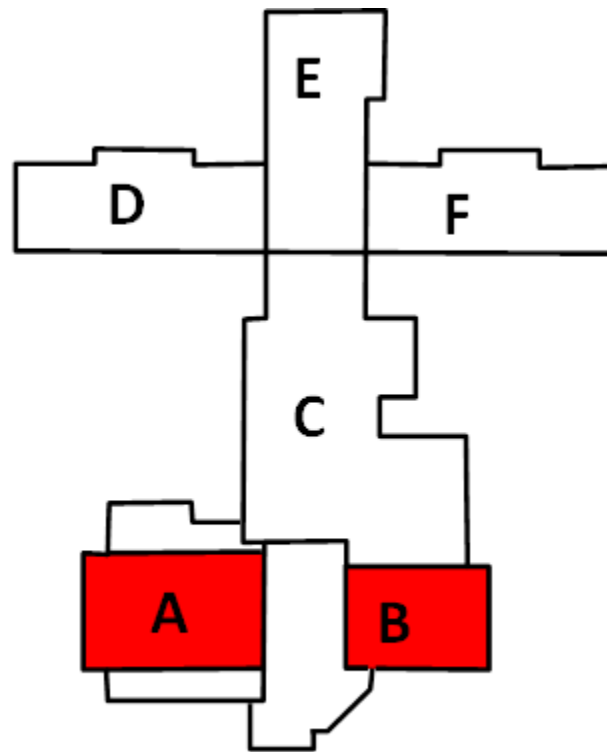
Figure 3–53. Layout of the Joplin East Middle School building complex. The Gymnasium (A) and Auditorium (B) sustained the greatest damage in the tornado.

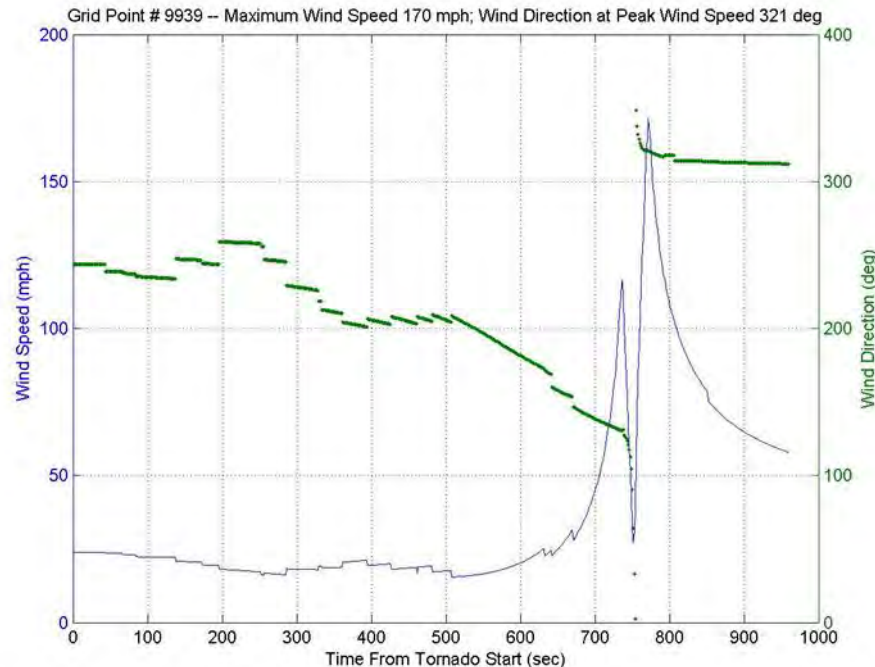
Figure 3–54. Time–history of wind speed and direction at the south end of Joplin East Middle School (over the Gymnasium).

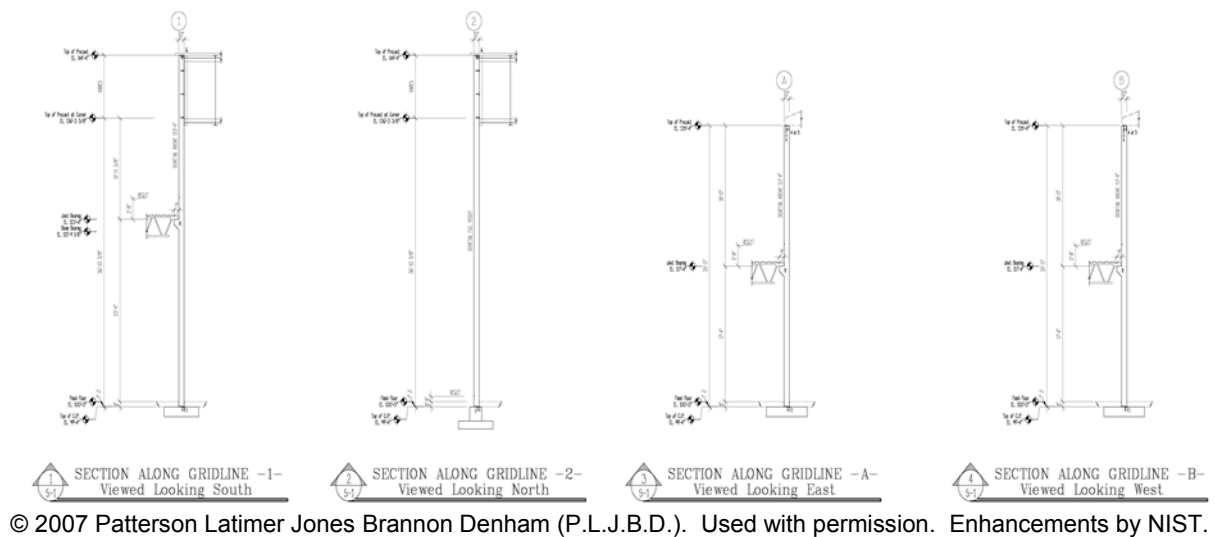
Figure 3–55. Lateral bracing for Gymnasium walls.

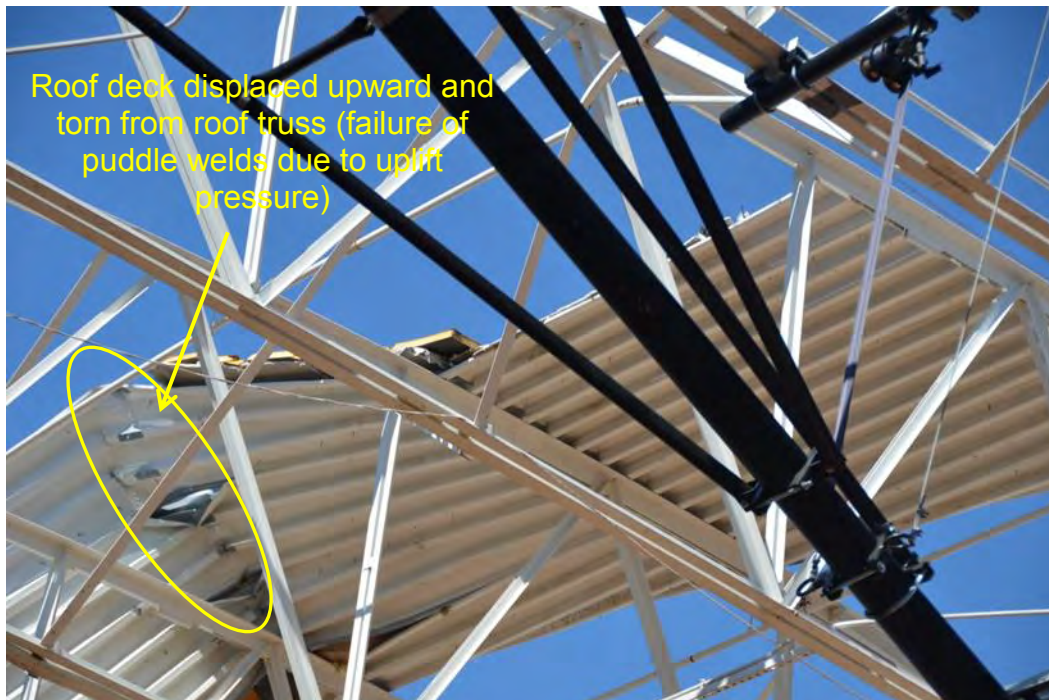
Figure 3–57. Disconnection of steel roof deck of Gymnasium due to failure of puddle welds due to uplift pressure.

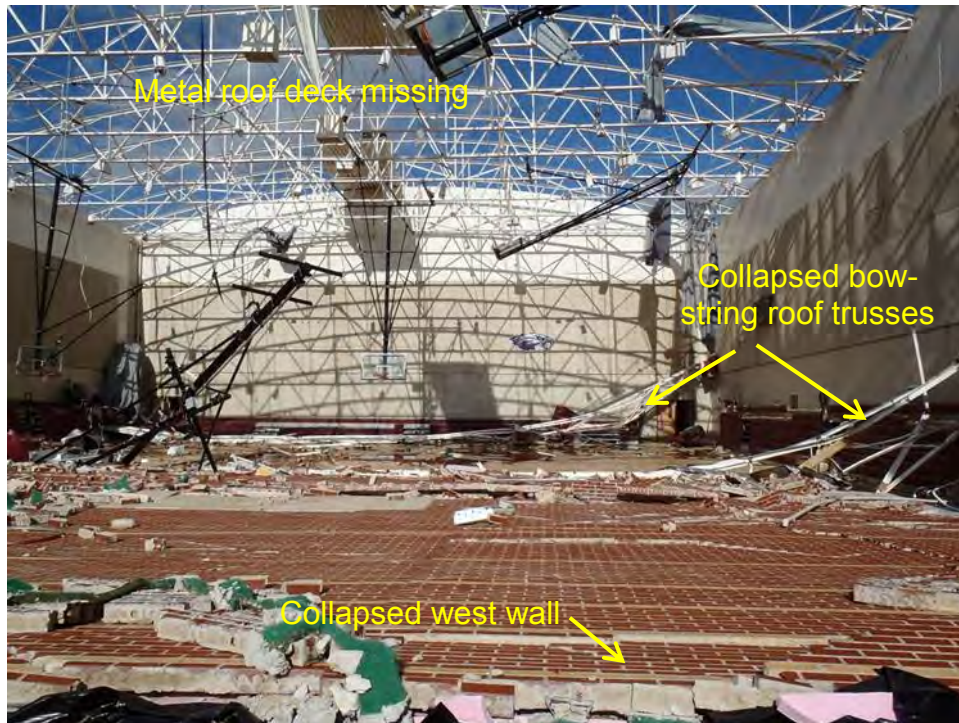
Figure 3–58. Collapsed bow–string roof trusses and collapsed west wall tilt–up panels in the interior of the Gymnasium.

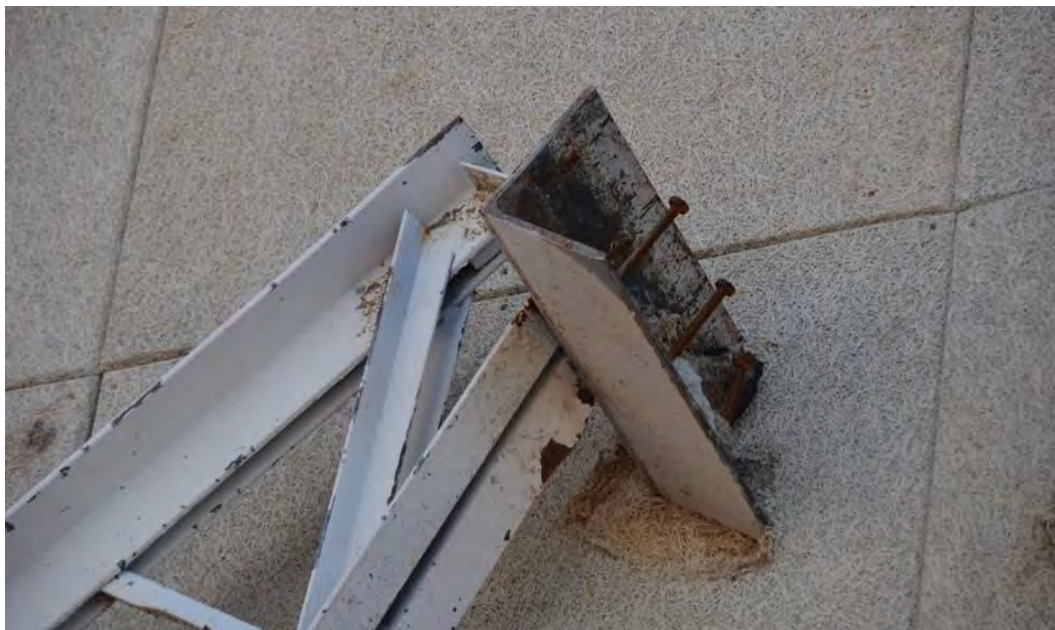
Figure 3–59. Seat angle welded to end of bow–string roof truss and embedded into top of tilt–up panel got disconnected. Note missing vertical headed studs (4, each 10 in. long), which appeared to have been sheared off from the angle. The three horizontal studs remained connected to the seat angle but pulled out from the concrete.

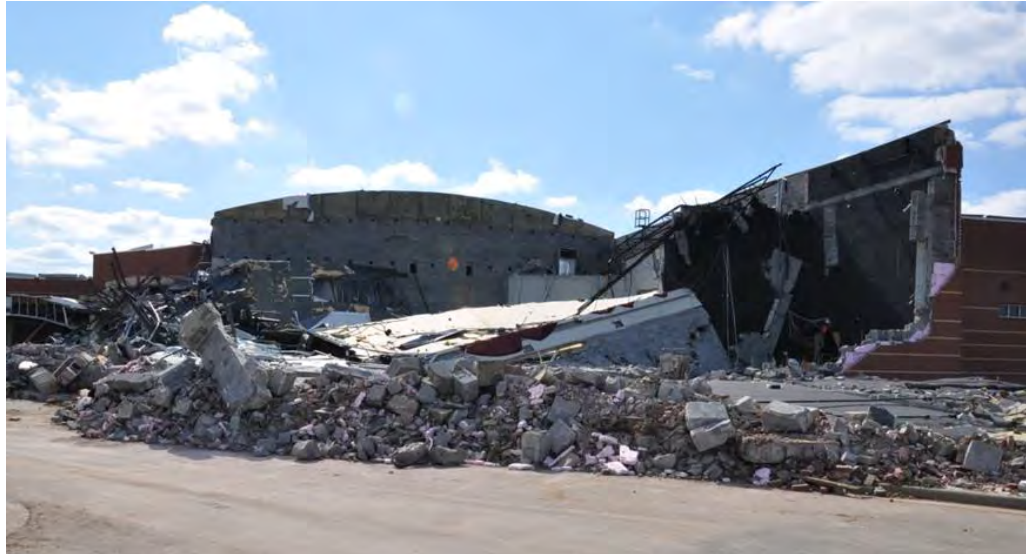
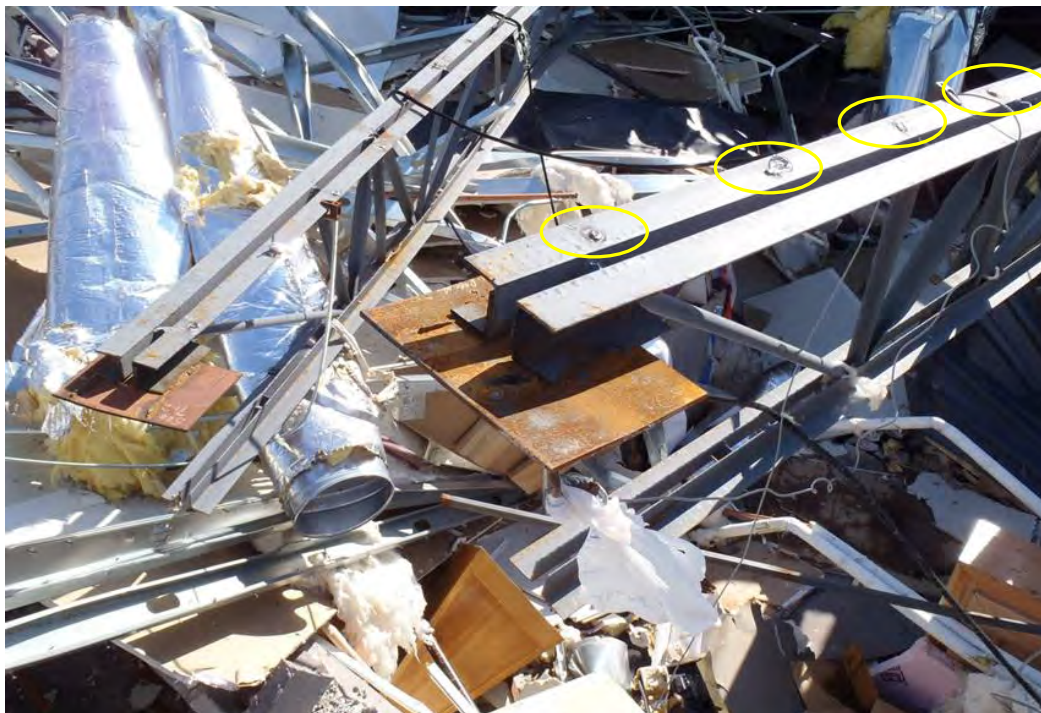
Figure 3–62. In wreckage of Auditorium, missing roof deck from top of joist—only puddle-weld marks remained.

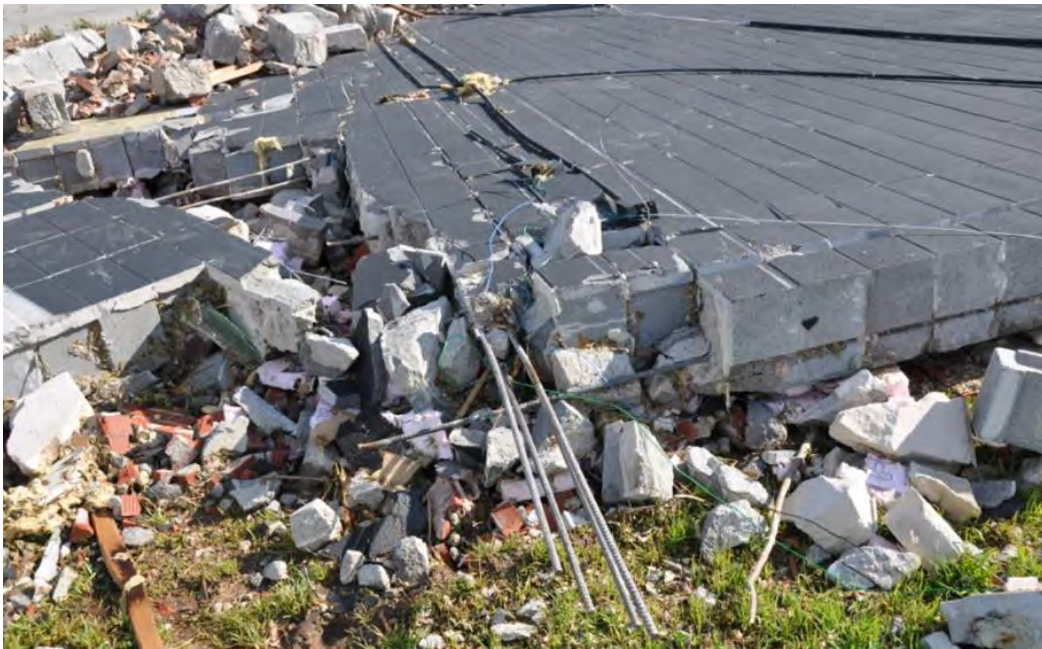
Figure 3–63. Collapse due to overturning (outward) of east perimeter Joplin East Middle School Auditorium wall after loss of roof diaphragm.

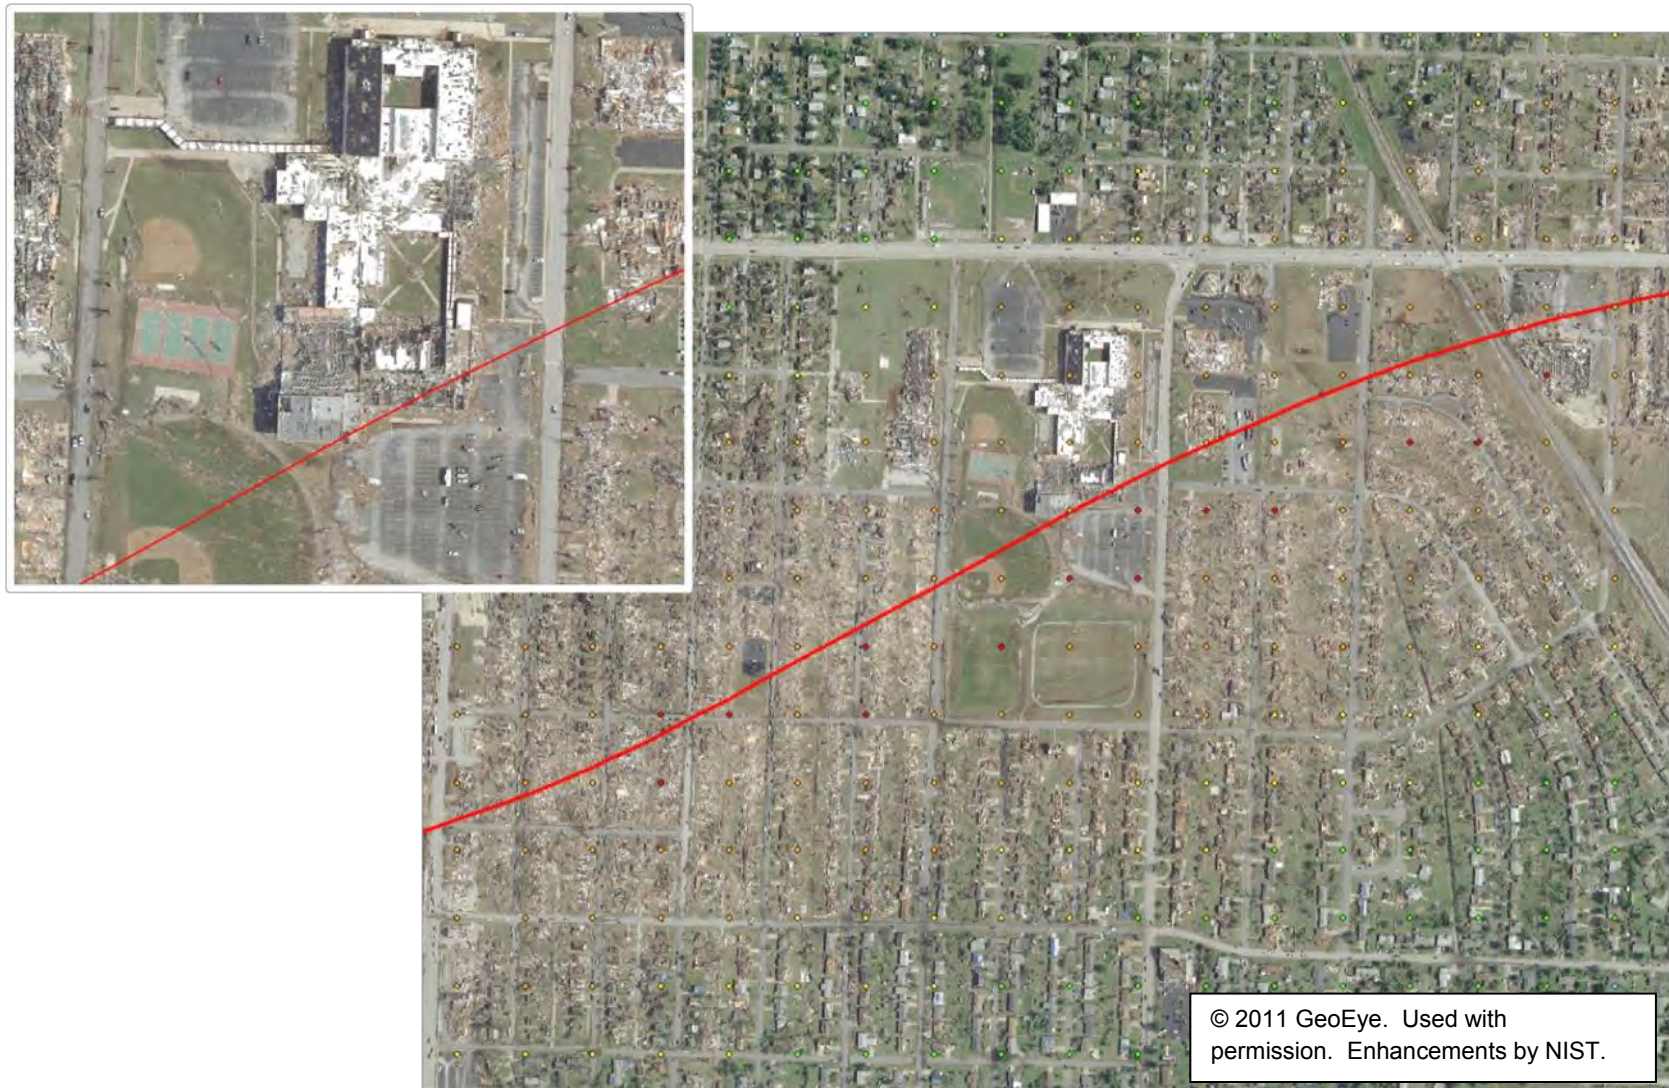
Figure 3–64. Overview of Joplin High School complex, with estimated center line of Joplin tornado damage path shown in red.

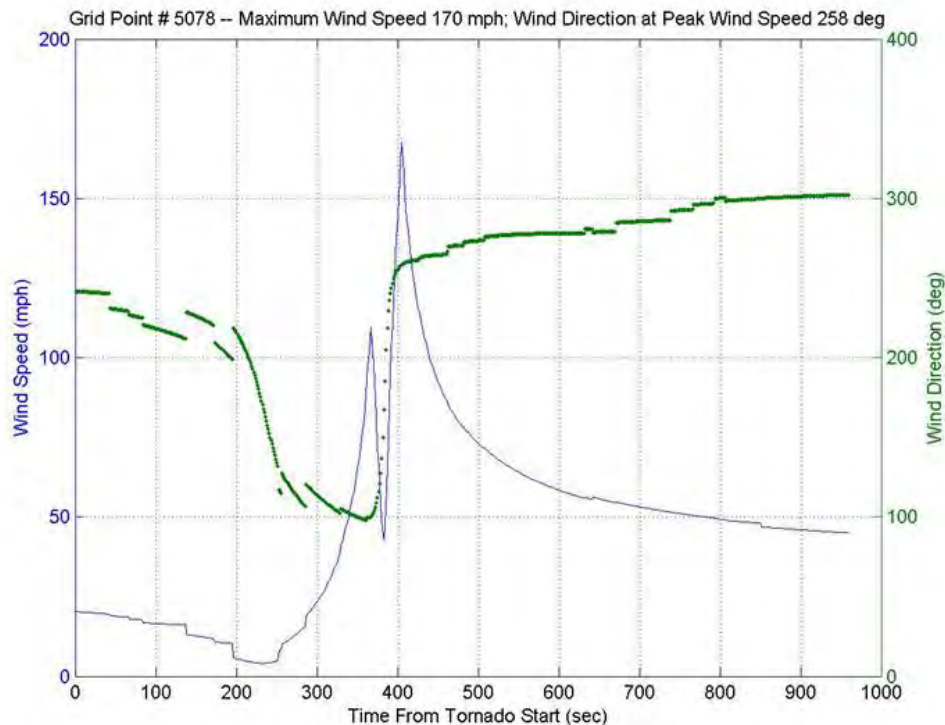
Figure 3–65. Estimated time–history of wind speed and direction at southeast corner (closest to center of tornado damage path) of Joplin High School.

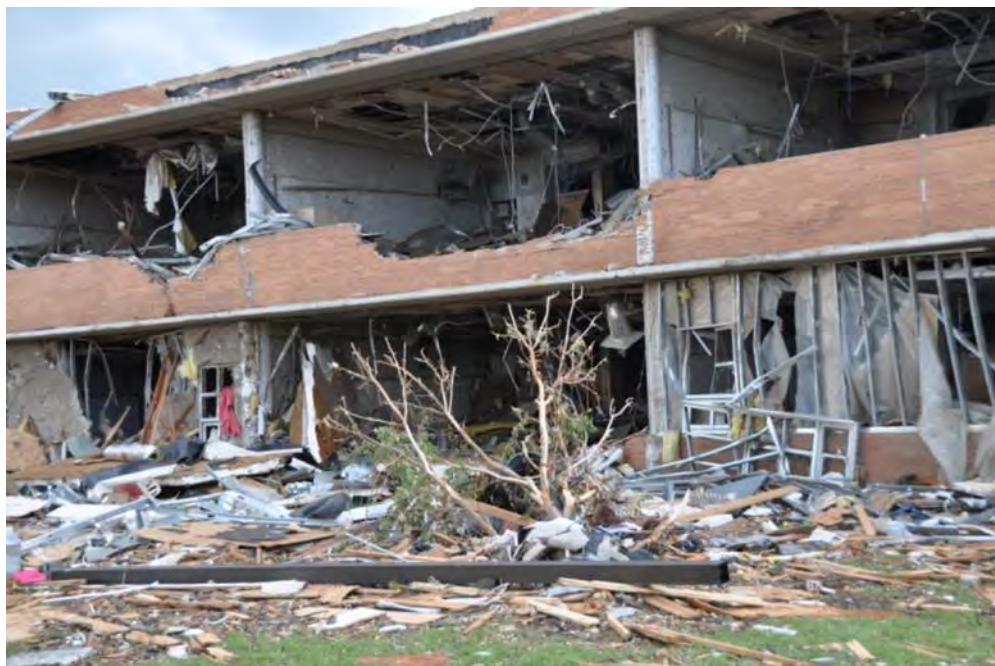
Figure 3–66. View from the exterior showing damage to the envelope of one of the RC frame buildings (east building) of Joplin High School.

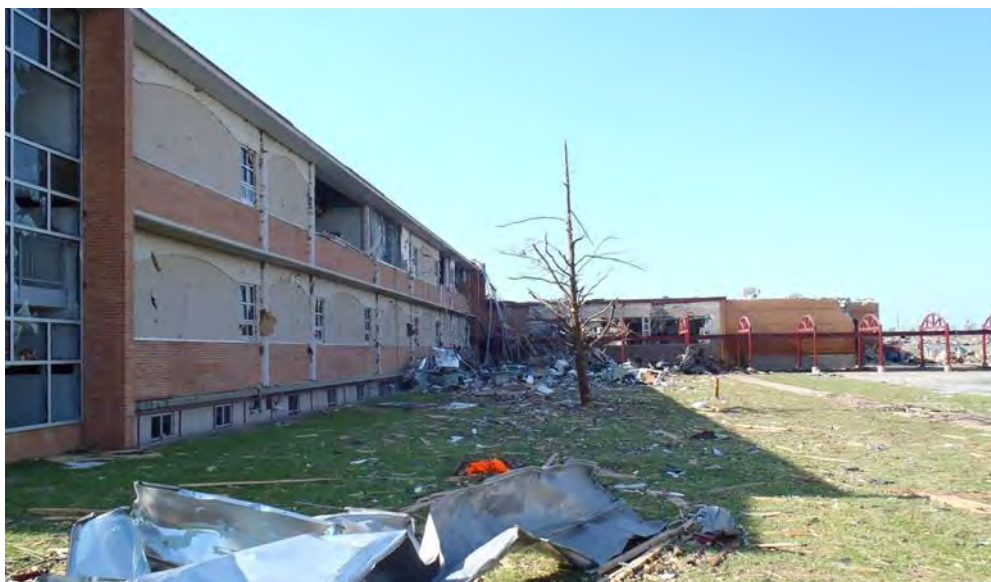
Figure 3–67. View from the exterior showing damage to the envelope of one of the RC frame buildings (west building) of Joplin High School.
