Draft Final Report • National Institute of Standards and Technology (NIST)

Technical Investigation

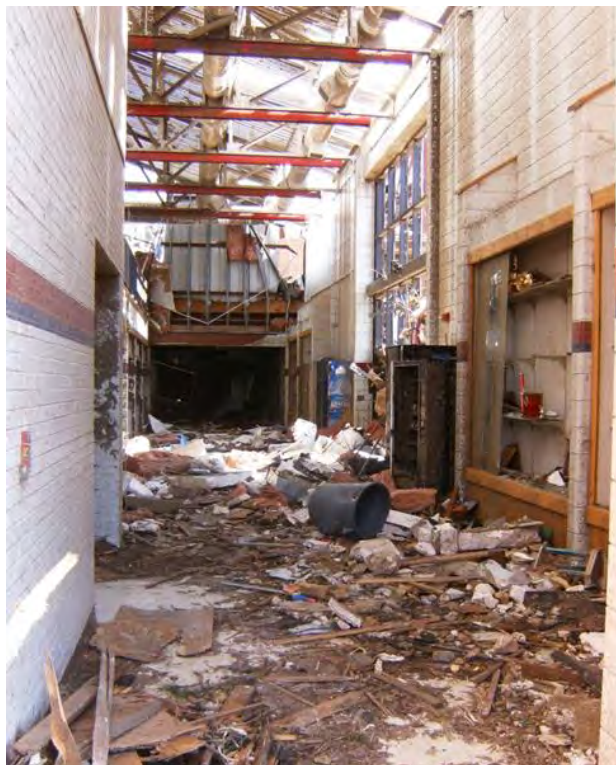
Figure 3–68. Damage and debris in an interior hallway of Joplin High School.

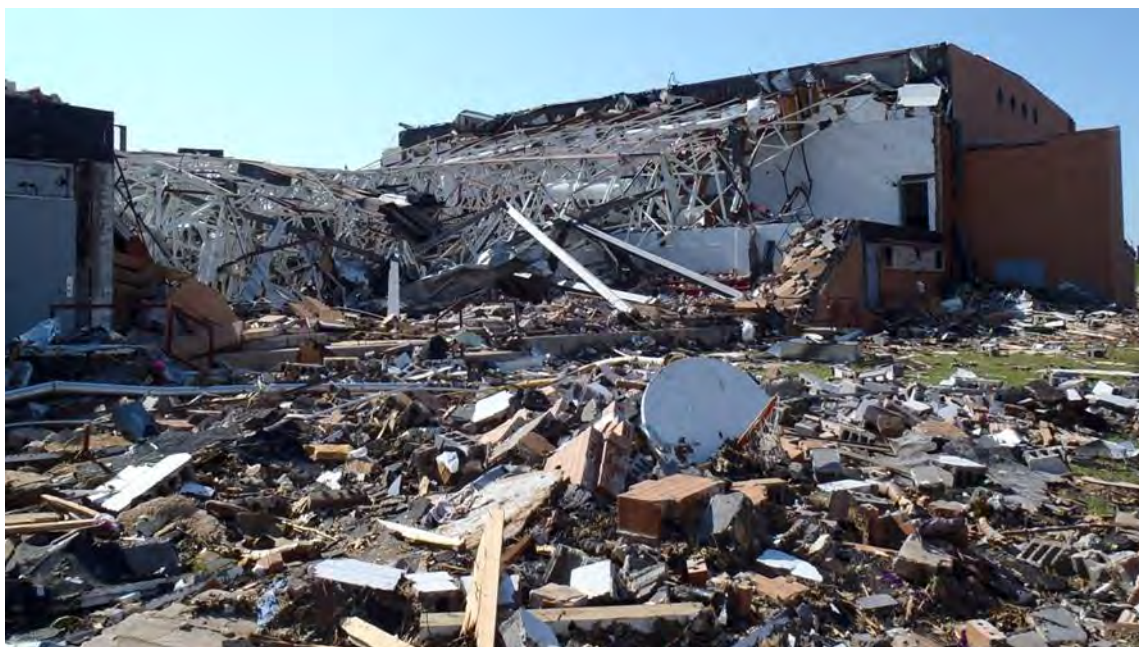
Figure 3–69. View from west of the Joplin High School Gymnasium building.

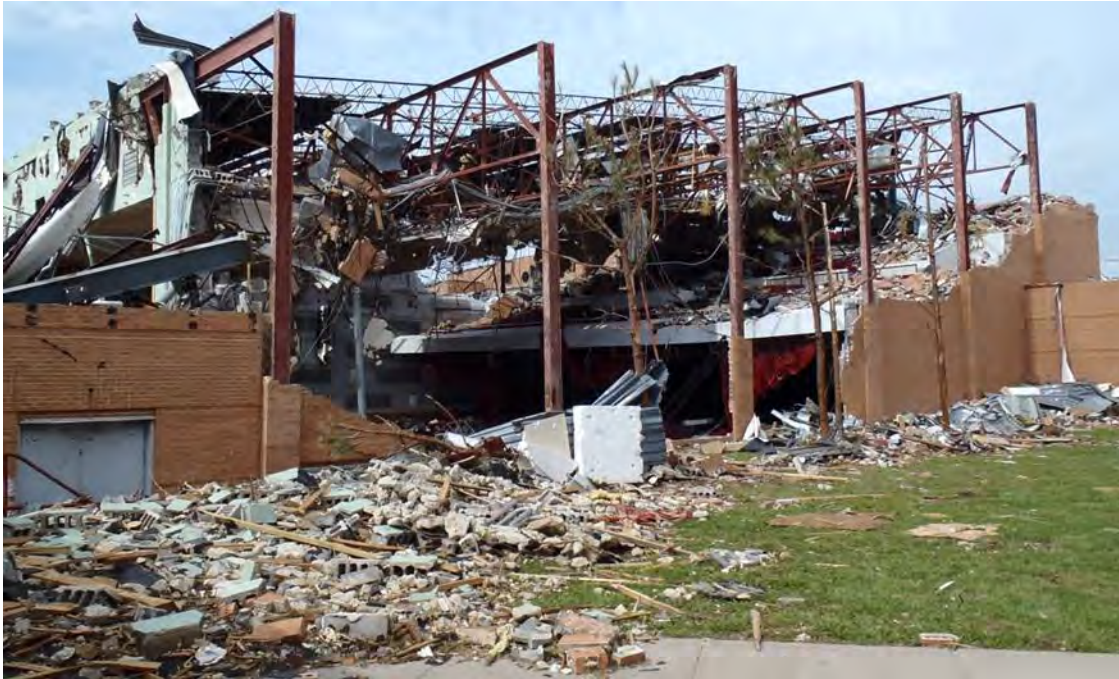
Figure 3–70. View from north of the Joplin High School Auditorium building.

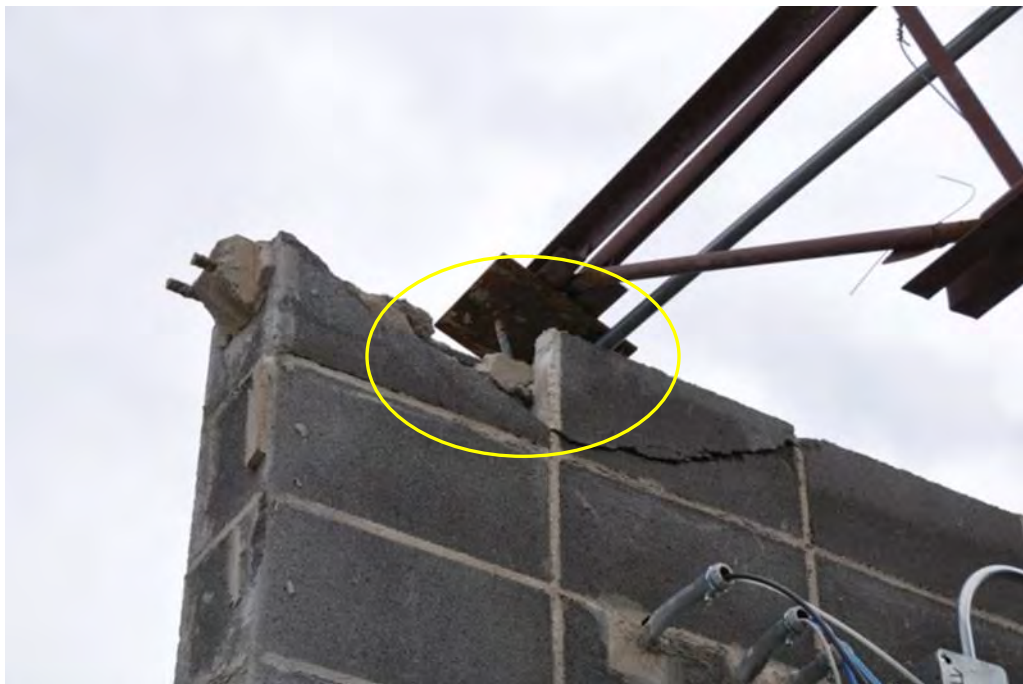
Figure 3–71. Failure of joist-to-CMU wall connection due to uplift.

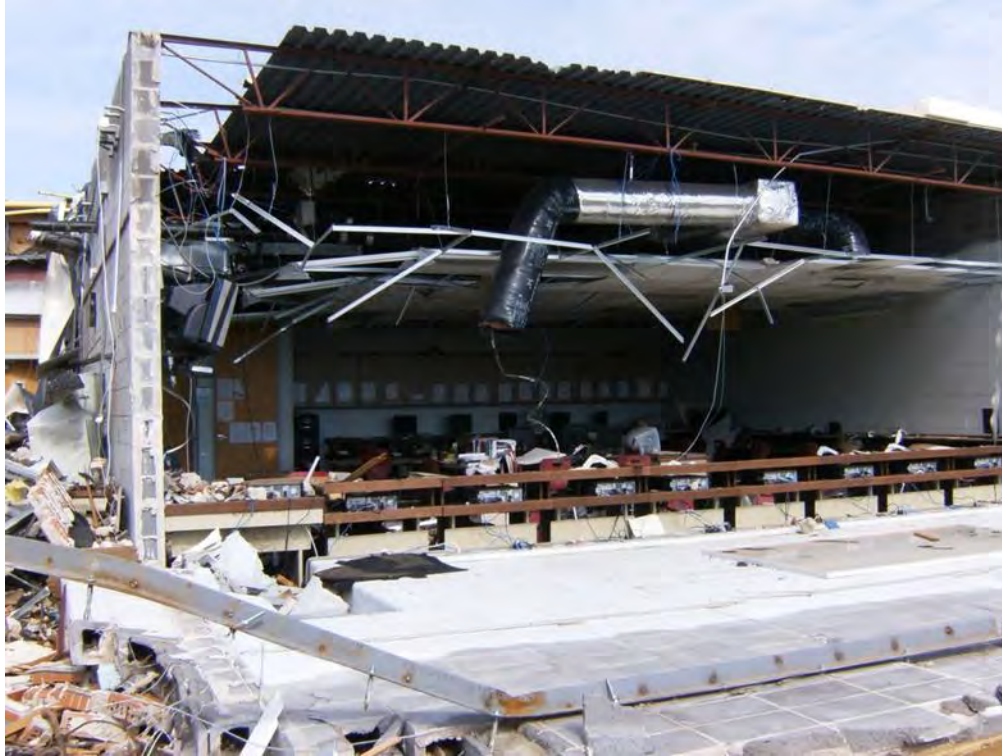
Figure 3–72. Collapse of CMU wall due to loss of lateral roof bracing.

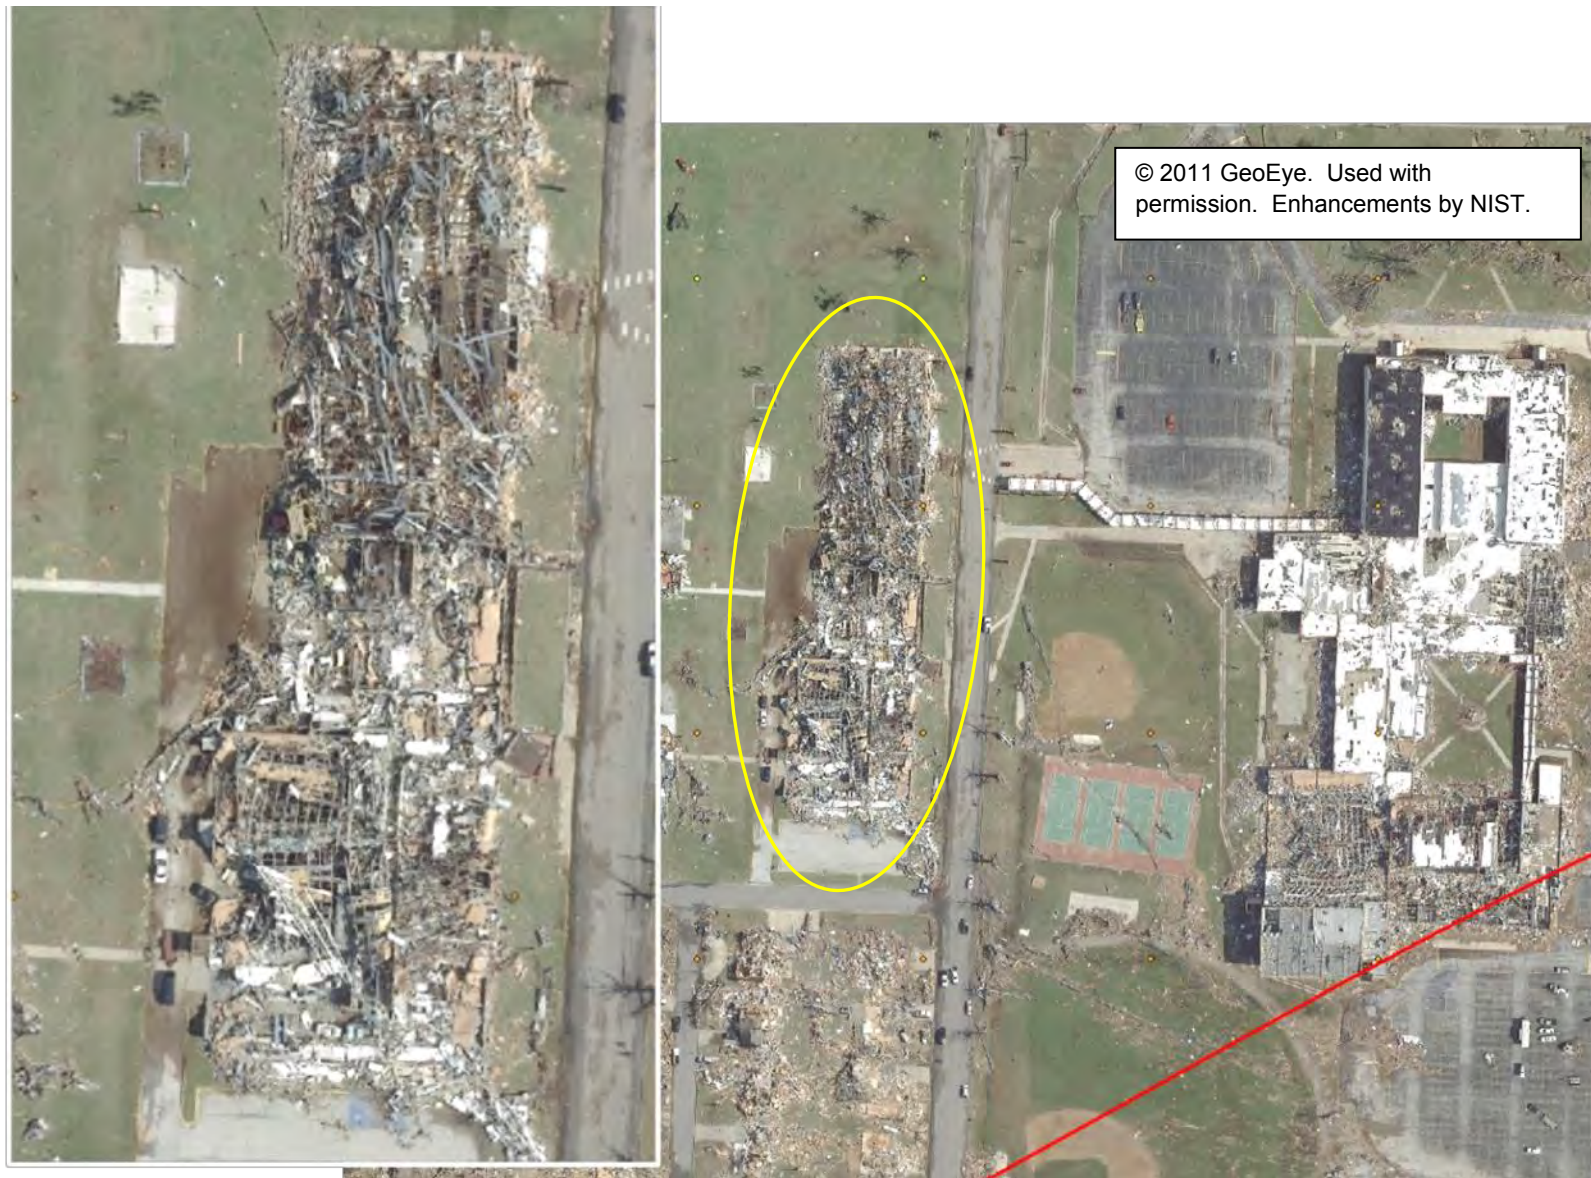
Figure 3–74. Overview of damage at Franklin Technology Center, with center line of tornado damage path (in red).

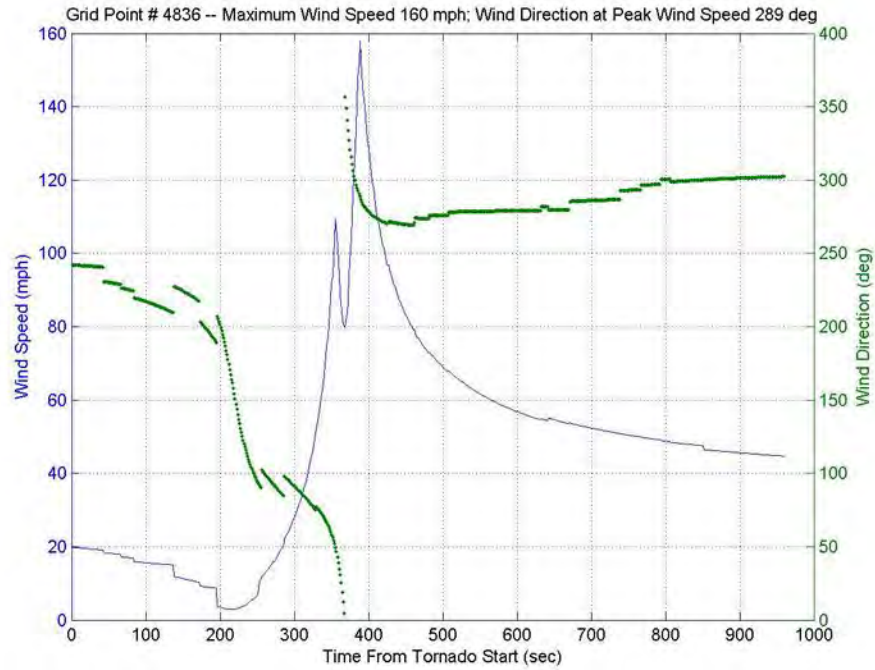
Figure 3–75. Estimated time–history of wind speed at southeast corner of Franklin Technology Center.

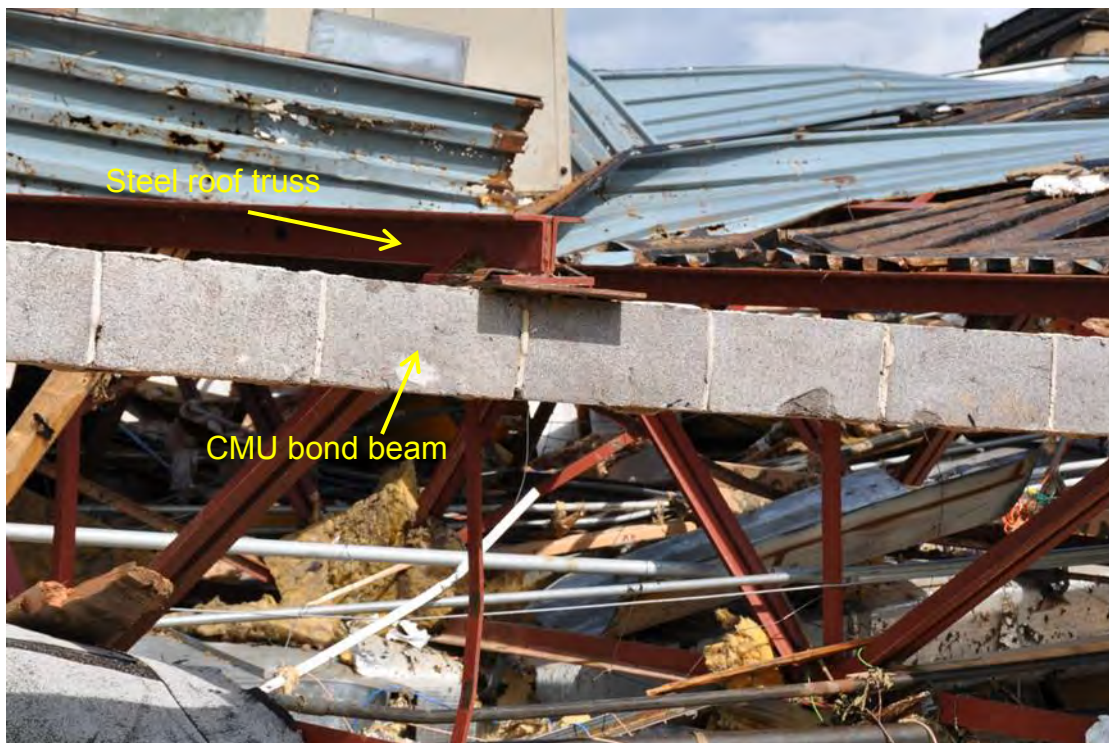
Figure 3–76. Steel roof deck and roof joist connection to CMU wall bond beam.

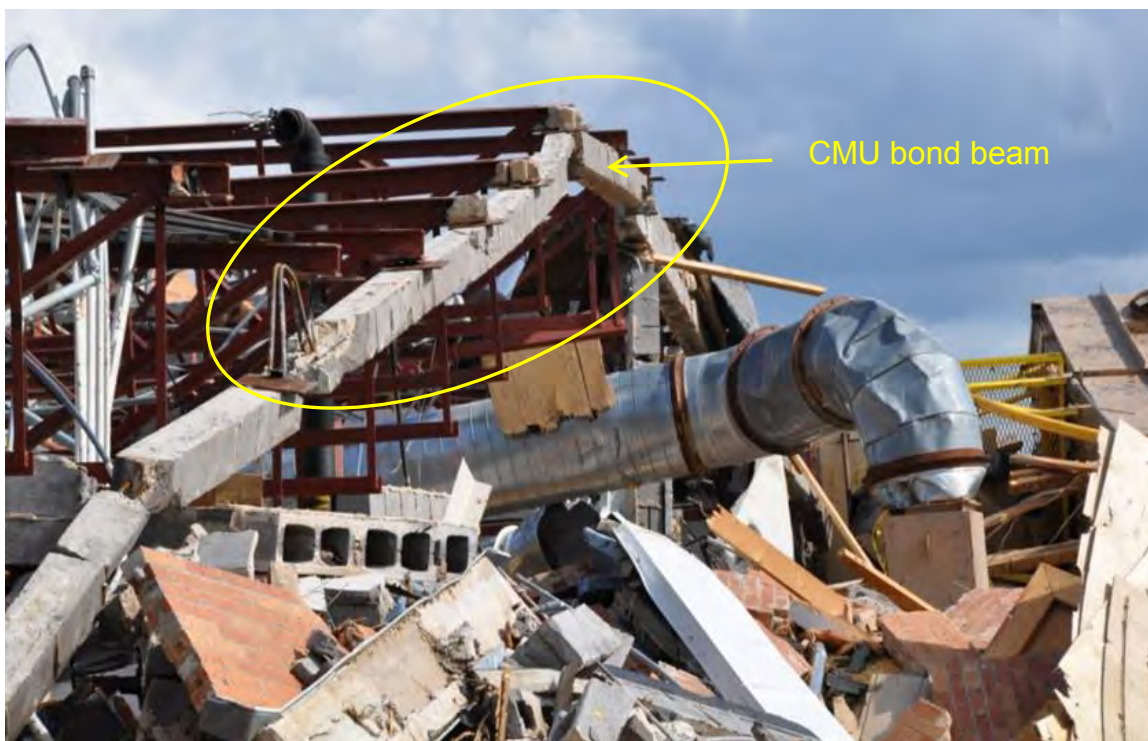
Figure 3–77. Steel roof joists, with missing roof decks, remained connected to CMU bond beam. Bond beam remained continuous, but was disconnected from the CMU walls along the bond line between the two CMU courses at the top of the wall.

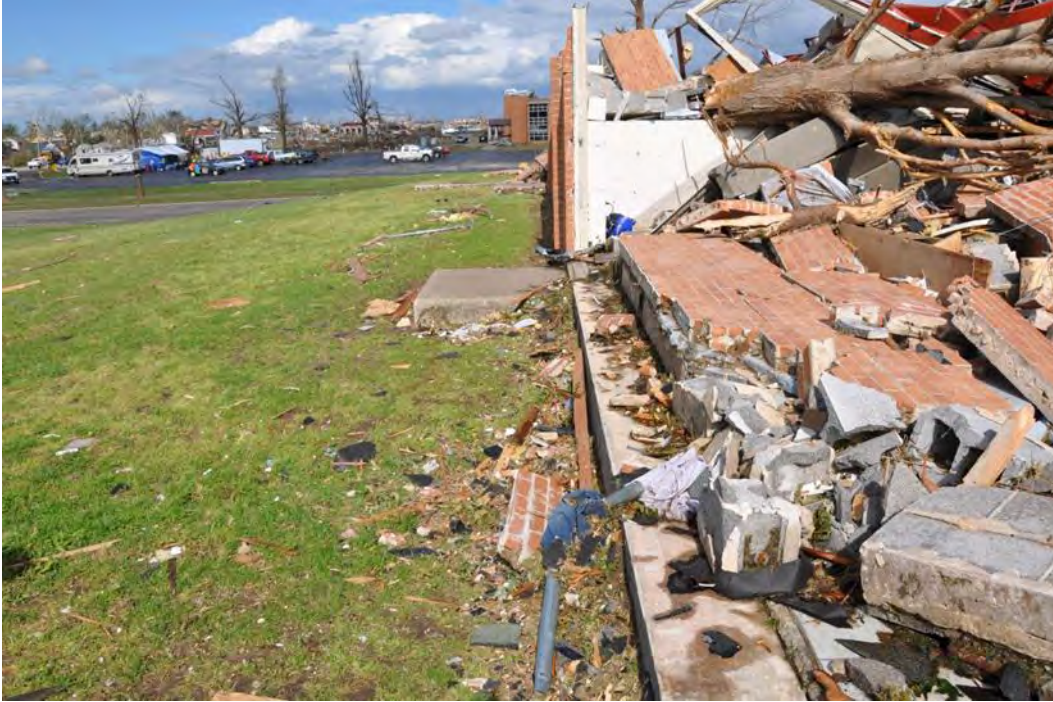
Figure 3–78. Perimeter CMU wall that collapsed after loss of roof lateral bracing (note lack of reinforcing dowels connecting wall to concrete footing).

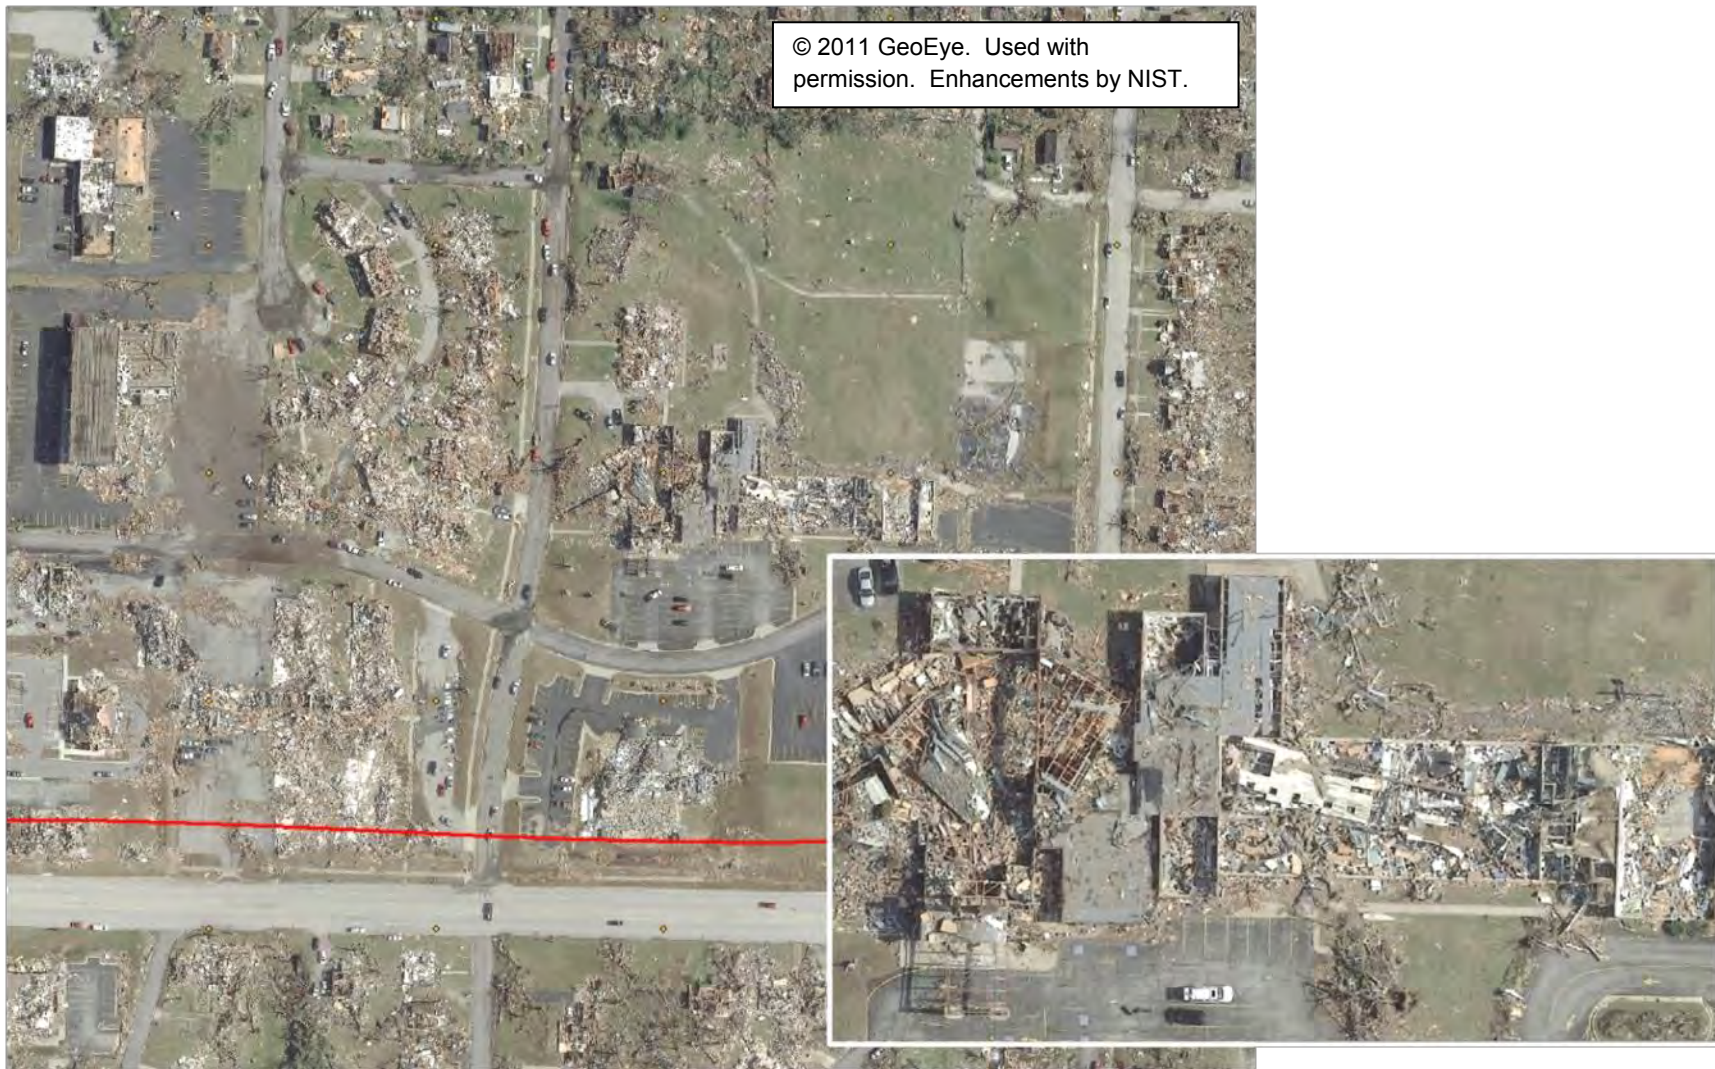
Figure 3–80. Overview of damage at St. Mary’s Catholic Elementary School, with estimated center line of tornado damage path shown in red.

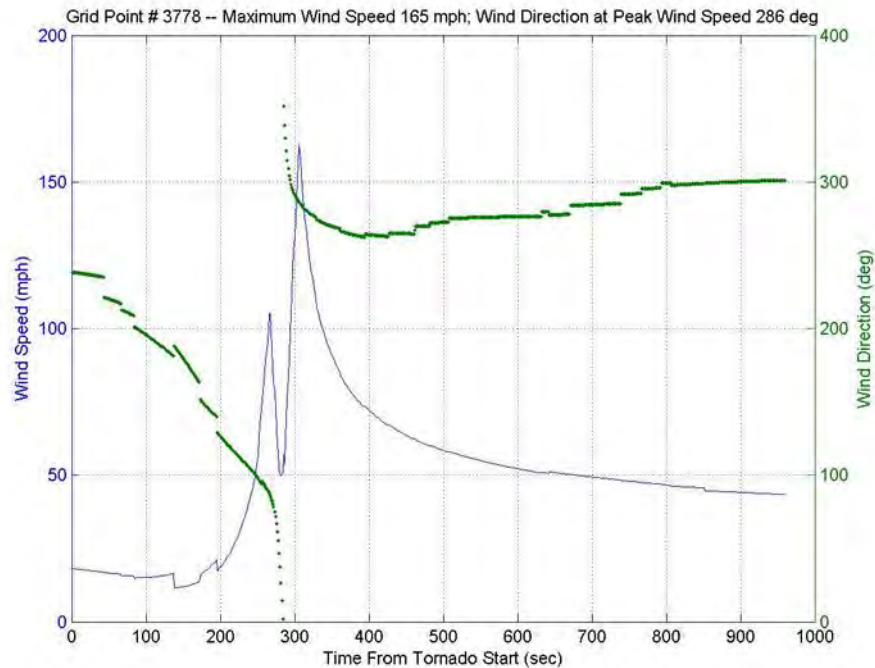
Figure 3–81. Estimated time–history of wind speed affecting the buildings at St. Mary’s Catholic Elementary School.

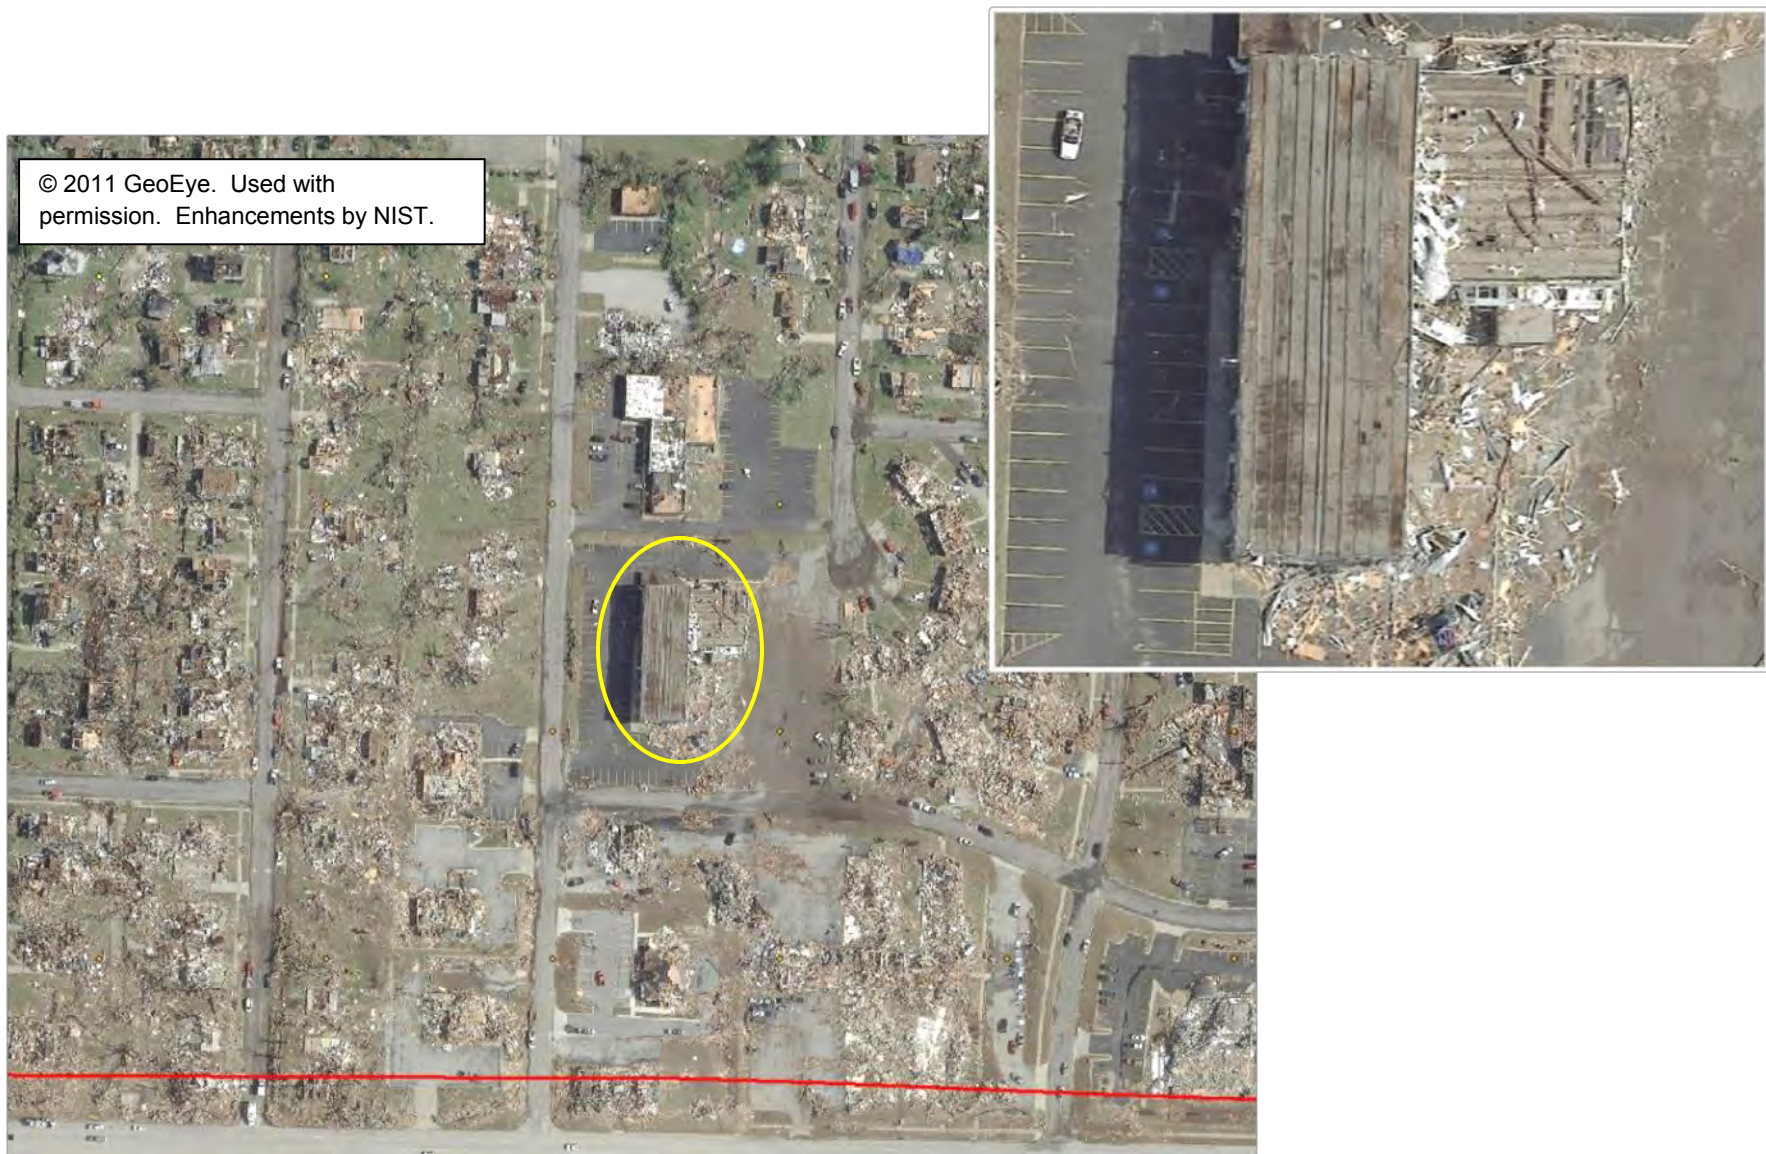
Figure 3–84. Overview of damage to the Ozark Center for Autism and surrounding buildings, with estimated center line of tornado damage path shown in red.

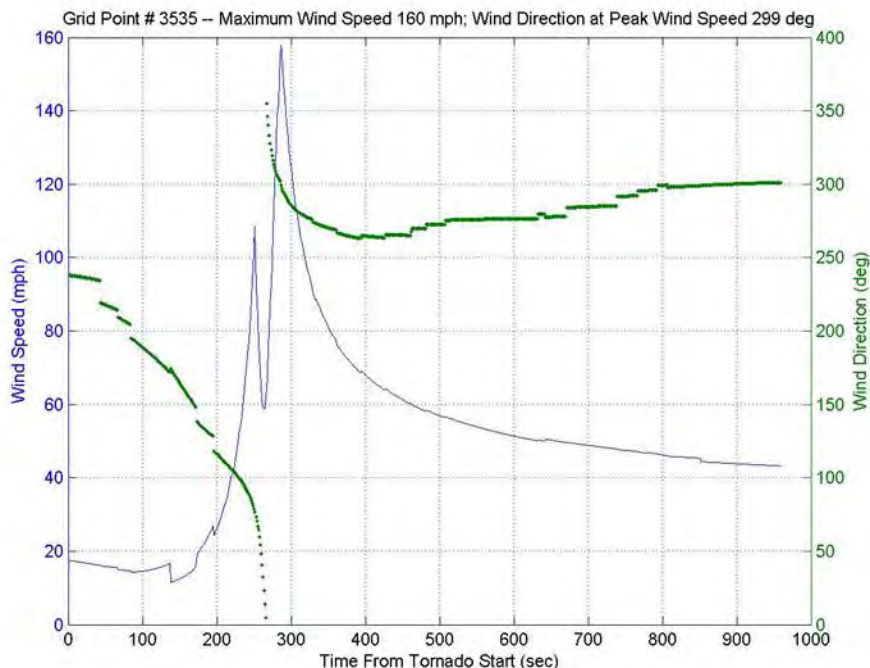
Figure 3–85. Estimated time–history of wind speed and direction at the Ozark Center.

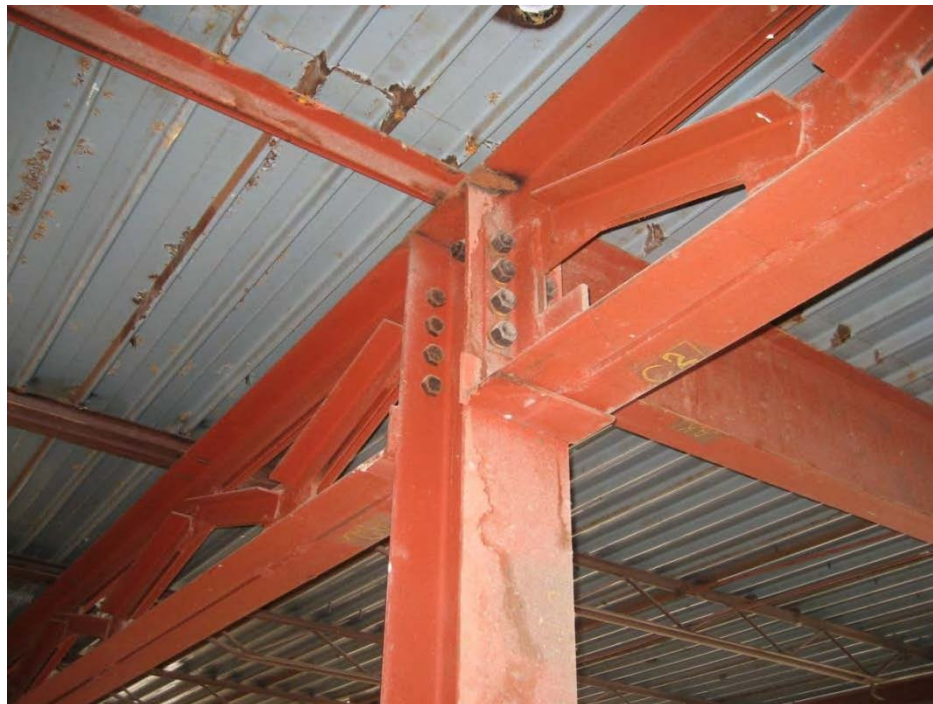
Figure 3–87. Interior view of the physical education section of the Ozark Center showing structural system with roof truss–column moment connection and open–web roof joist and wide–rib steel roof deck.

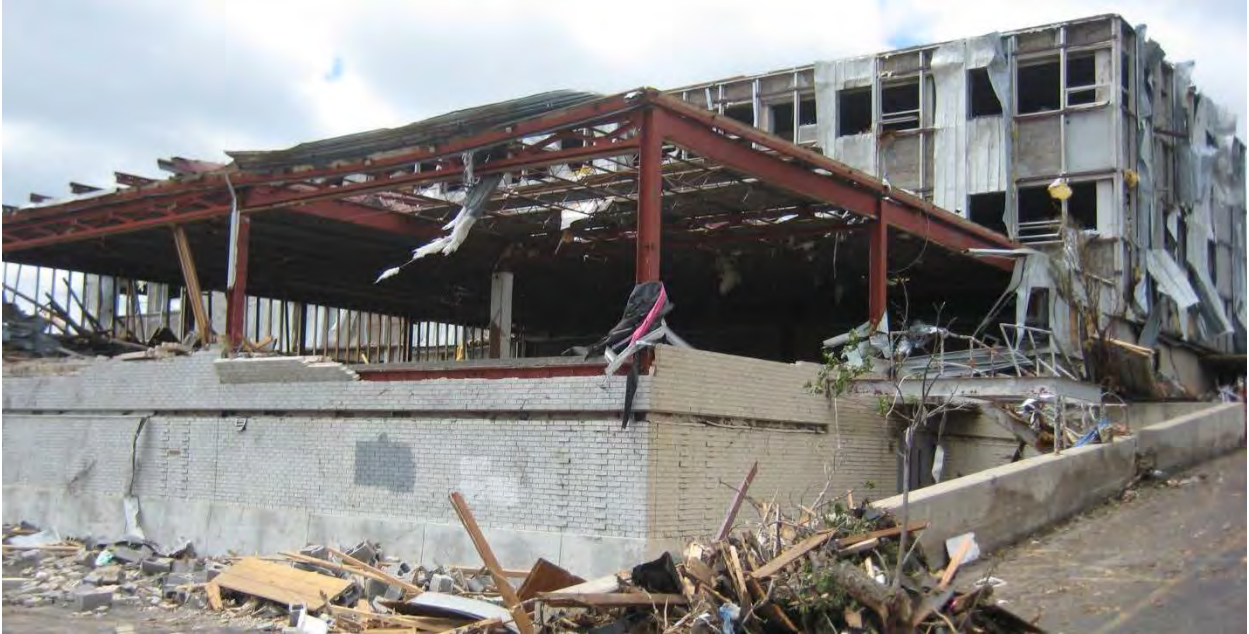
Figure 3–88. Significant damage to the envelope and minor damage to the MWFRS of the physical education section of the Ozark Center building, including (1) loss of part of steel roof decks, (2) loss of all insulating windows and steel frames on all wind-exposed sides, and (3) deformation of steel beam (likely due to debris impact).

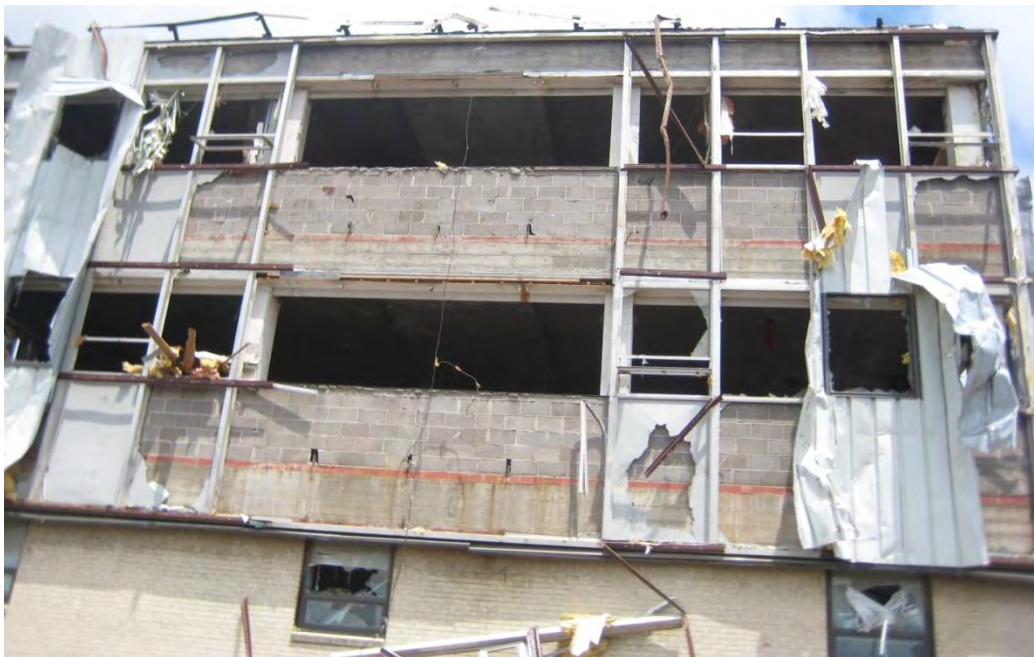
Figure 3–89. Typical damage to the Ozark Center building envelope (broken window glazing, missing window frames, and torn exterior steel panels).

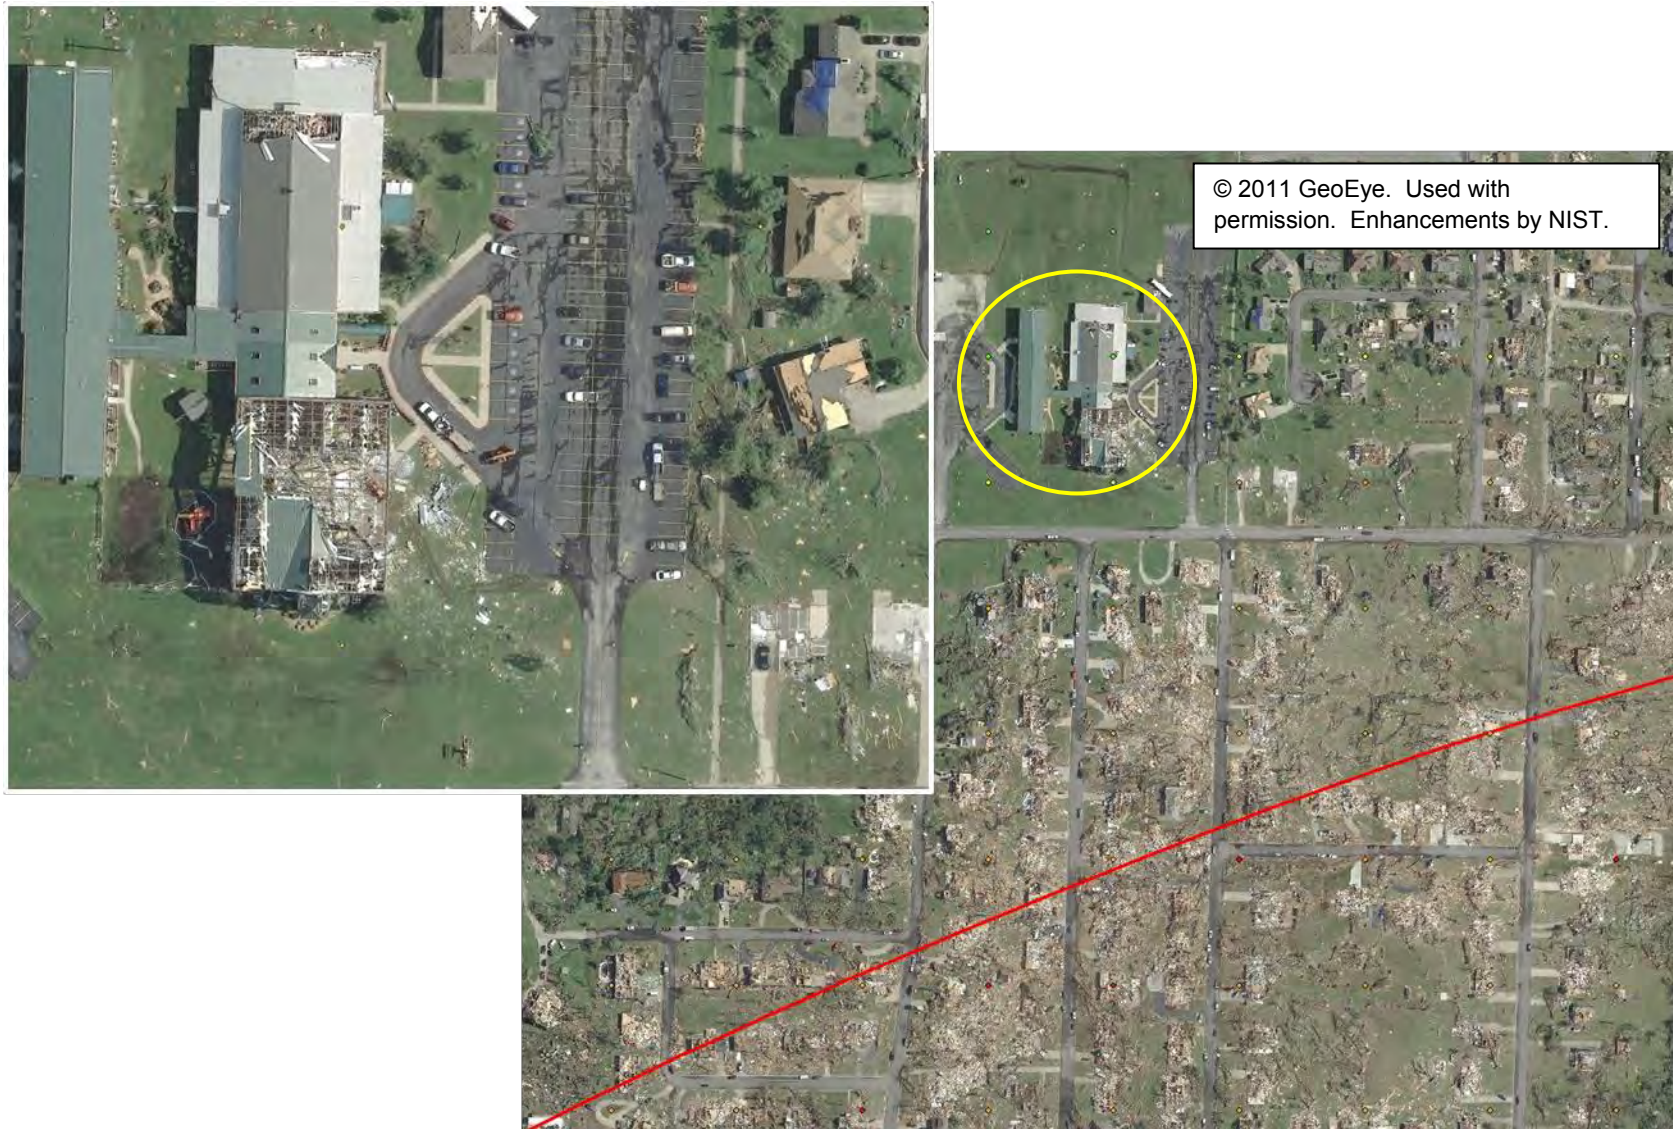
Figure 3–90. Overview of damage at St. Paul’s United Methodist Church and surrounding areas, with the estimated center line of the tornado damage path shown in red.

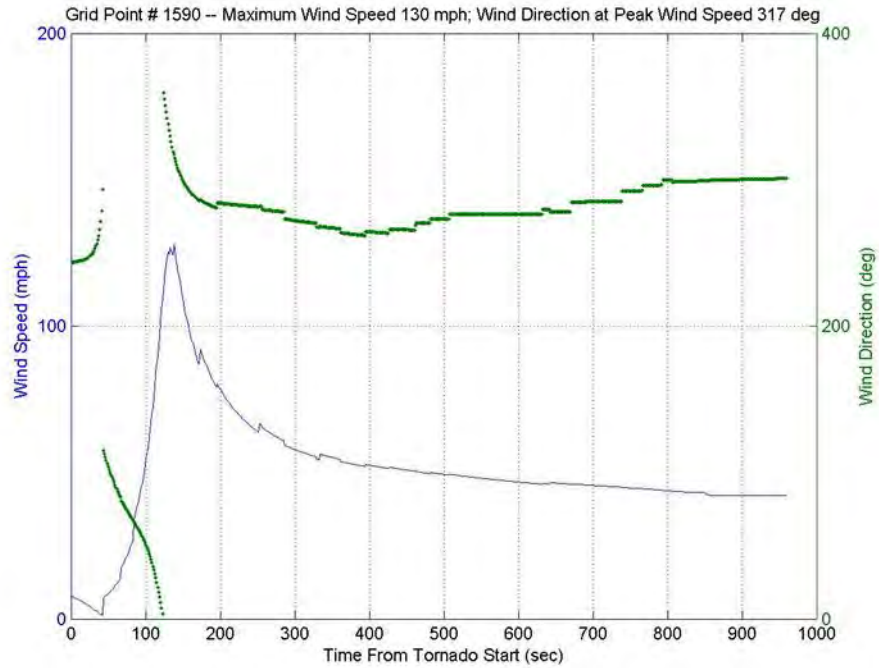
Figure 3–91. Estimated time–history of wind speed affecting the Mass Hall of St. Paul’s United Methodist Church.

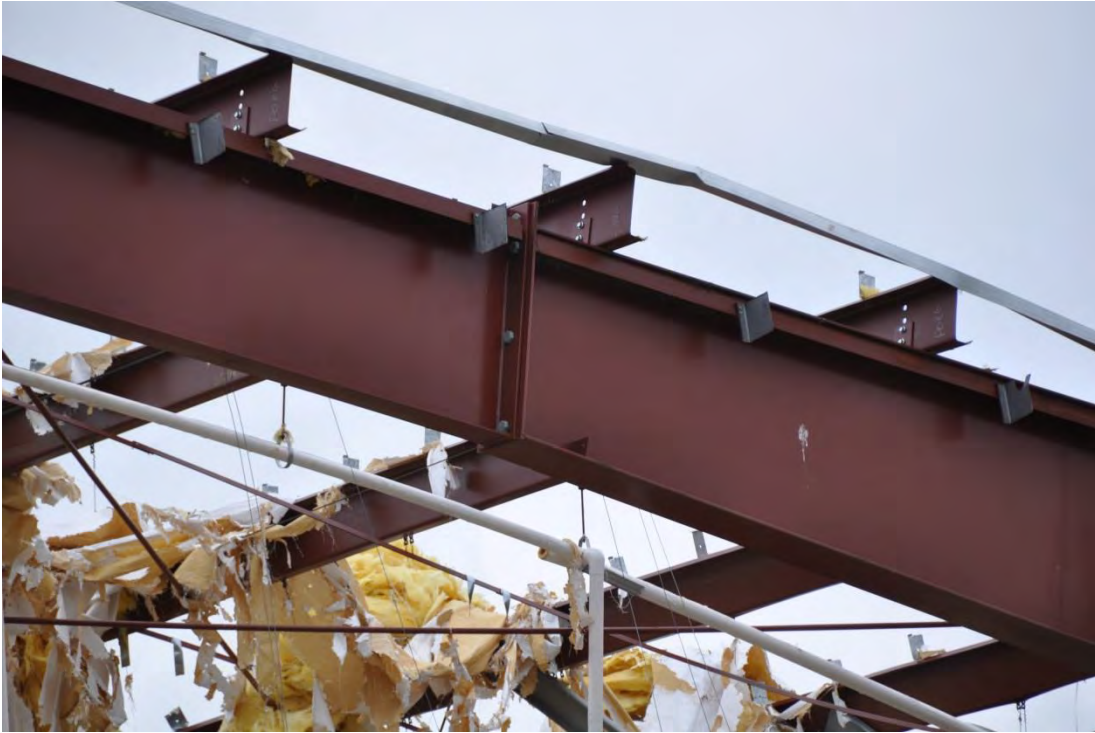
Figure 3–93. Tapered rafter sections with bolted connection and roof purlins of St. Paul's United Methodist Church.

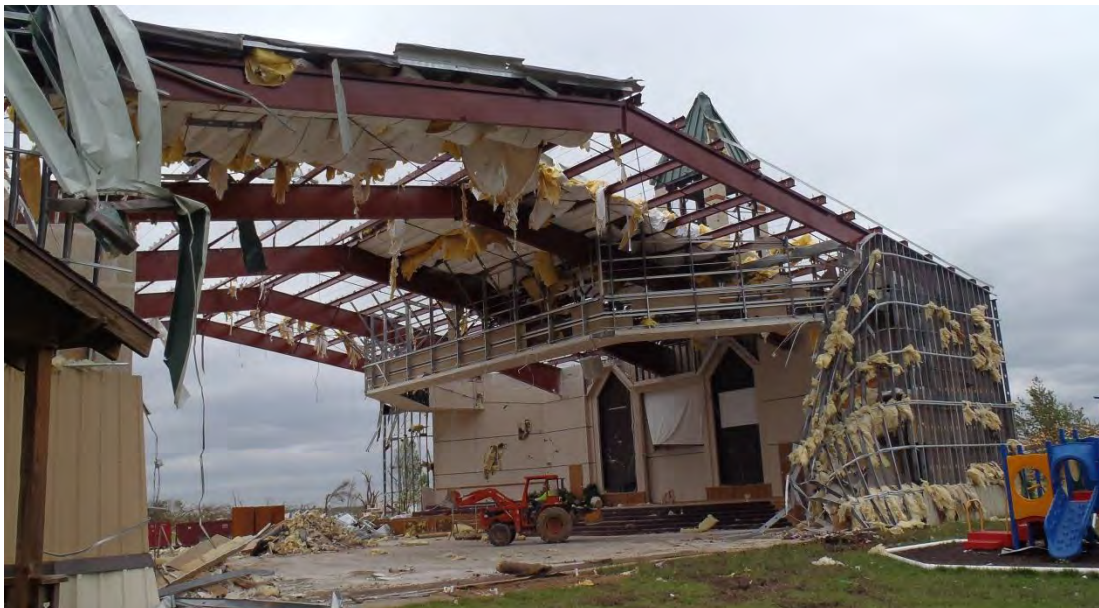
Figure 3–94. Damage to envelope of St. Paul's United Methodist Church.

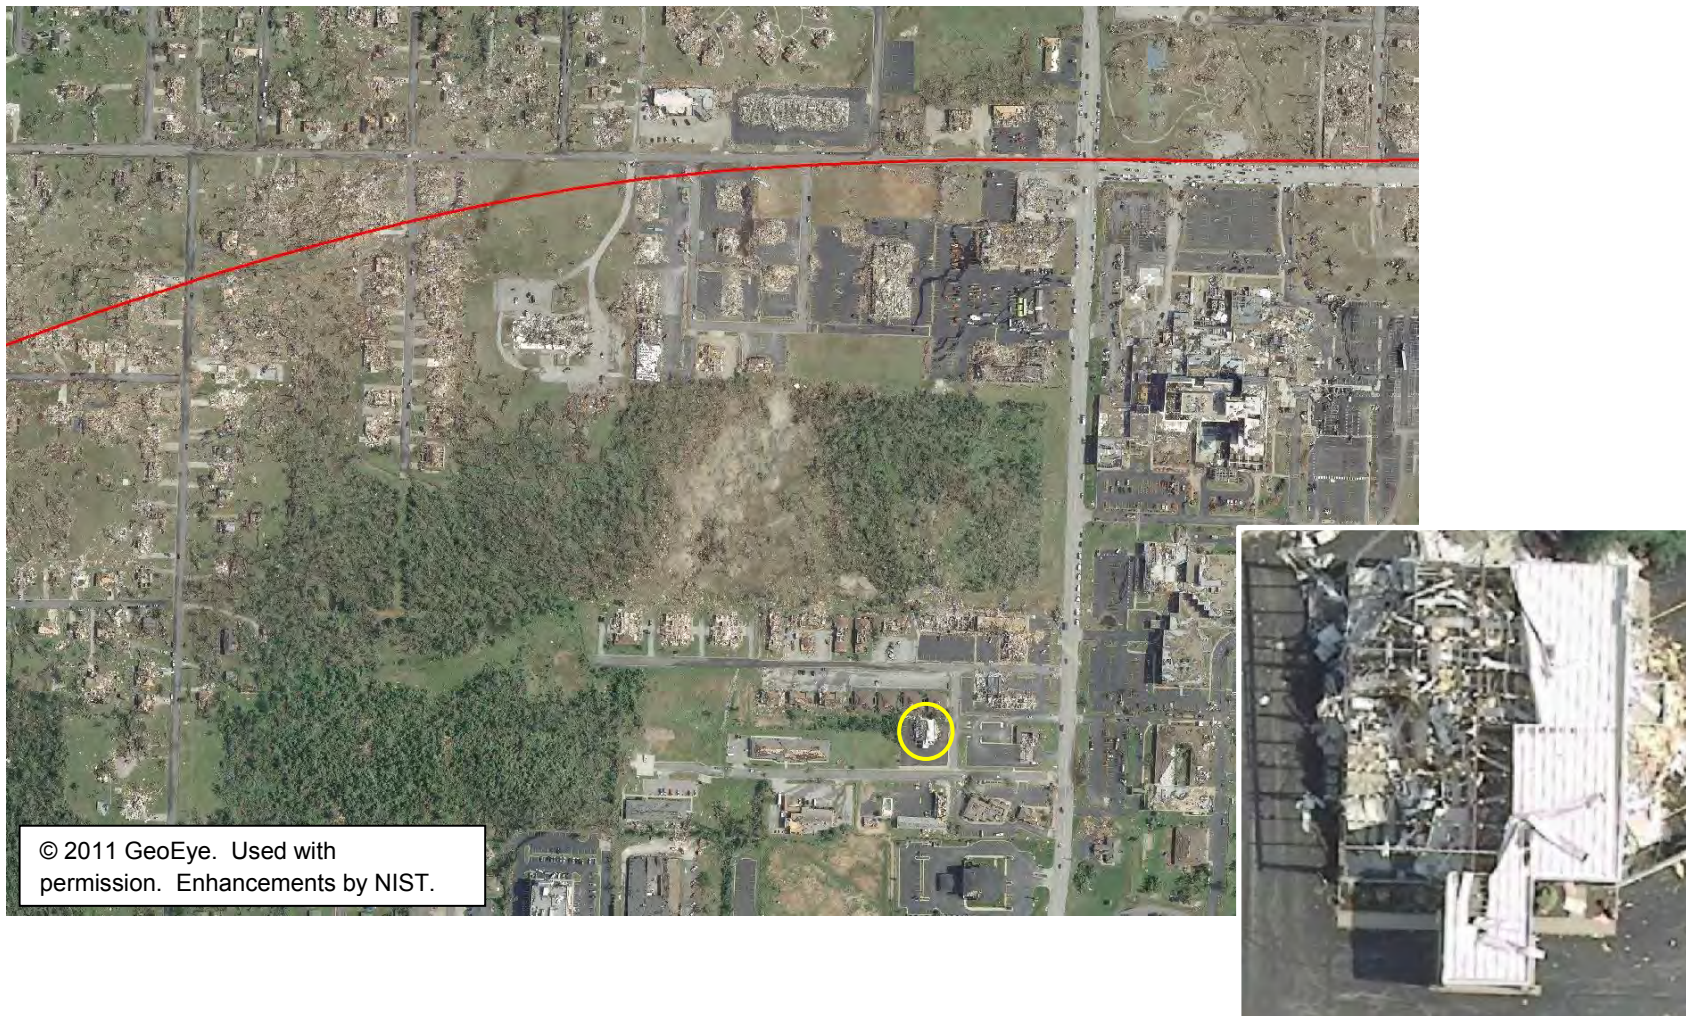
Figure 3–95. Overview of damage at the Ramesh Shah Ophthalmology Center, with the estimated center line of the tornado damage path shown in red.

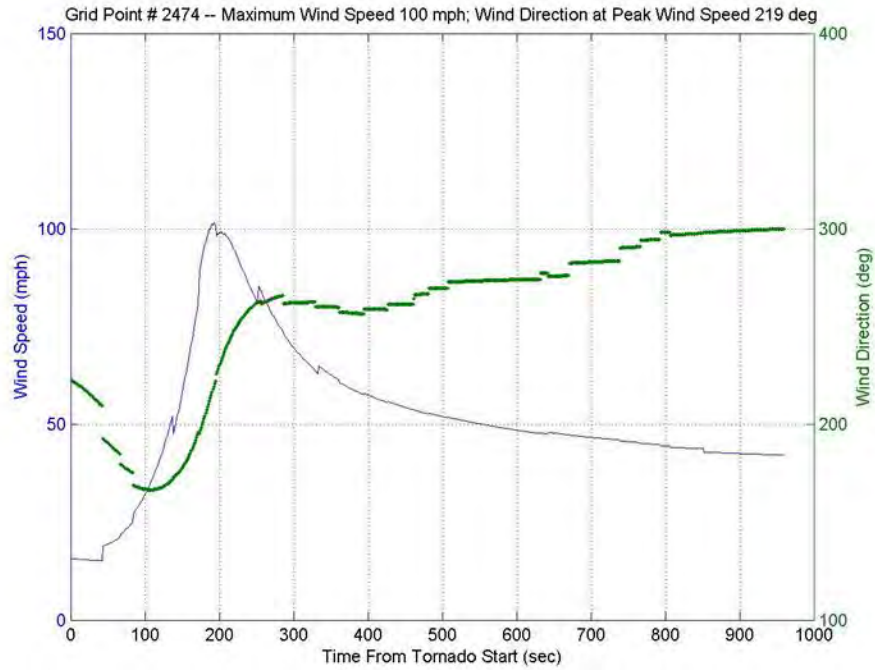
Figure 3–96. Estimated time–history of wind speed and direction at the Ramesh Shah Ophthalmology Center.
