Draft Final Report • National Institute of Standards and Technology (NIST)

Technical Investigation

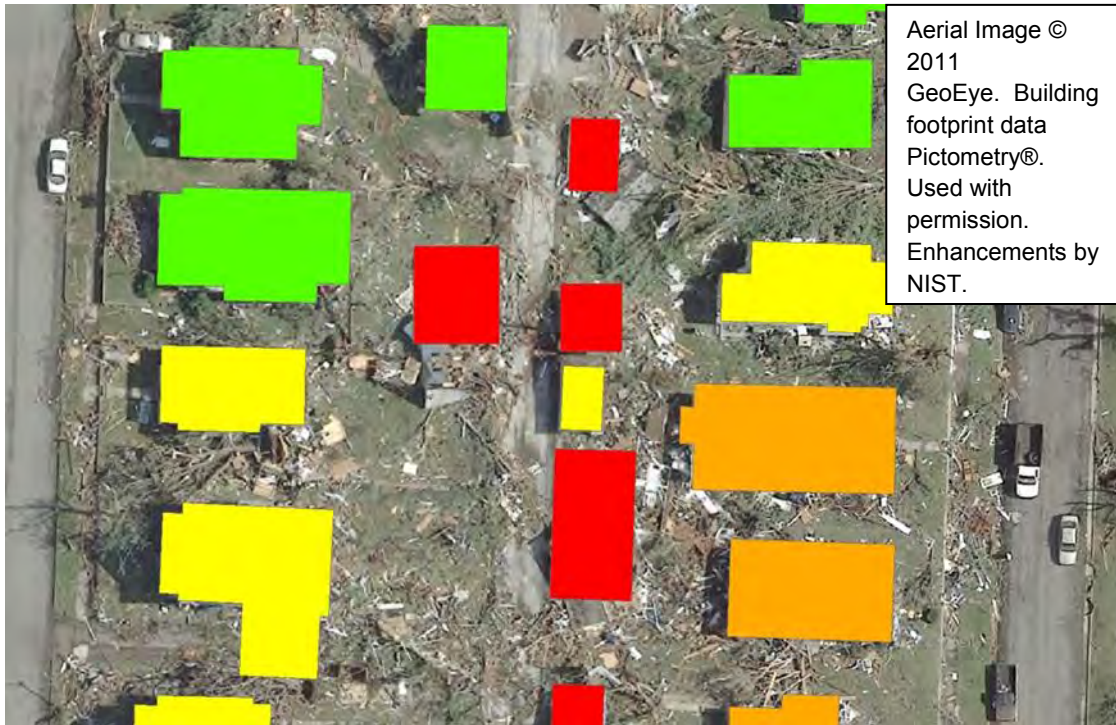
Figure 3–101. References for Pictometry® database damage classifications and coding: light (green), medium (yellow), heavy/total (orange), and demolished (red).

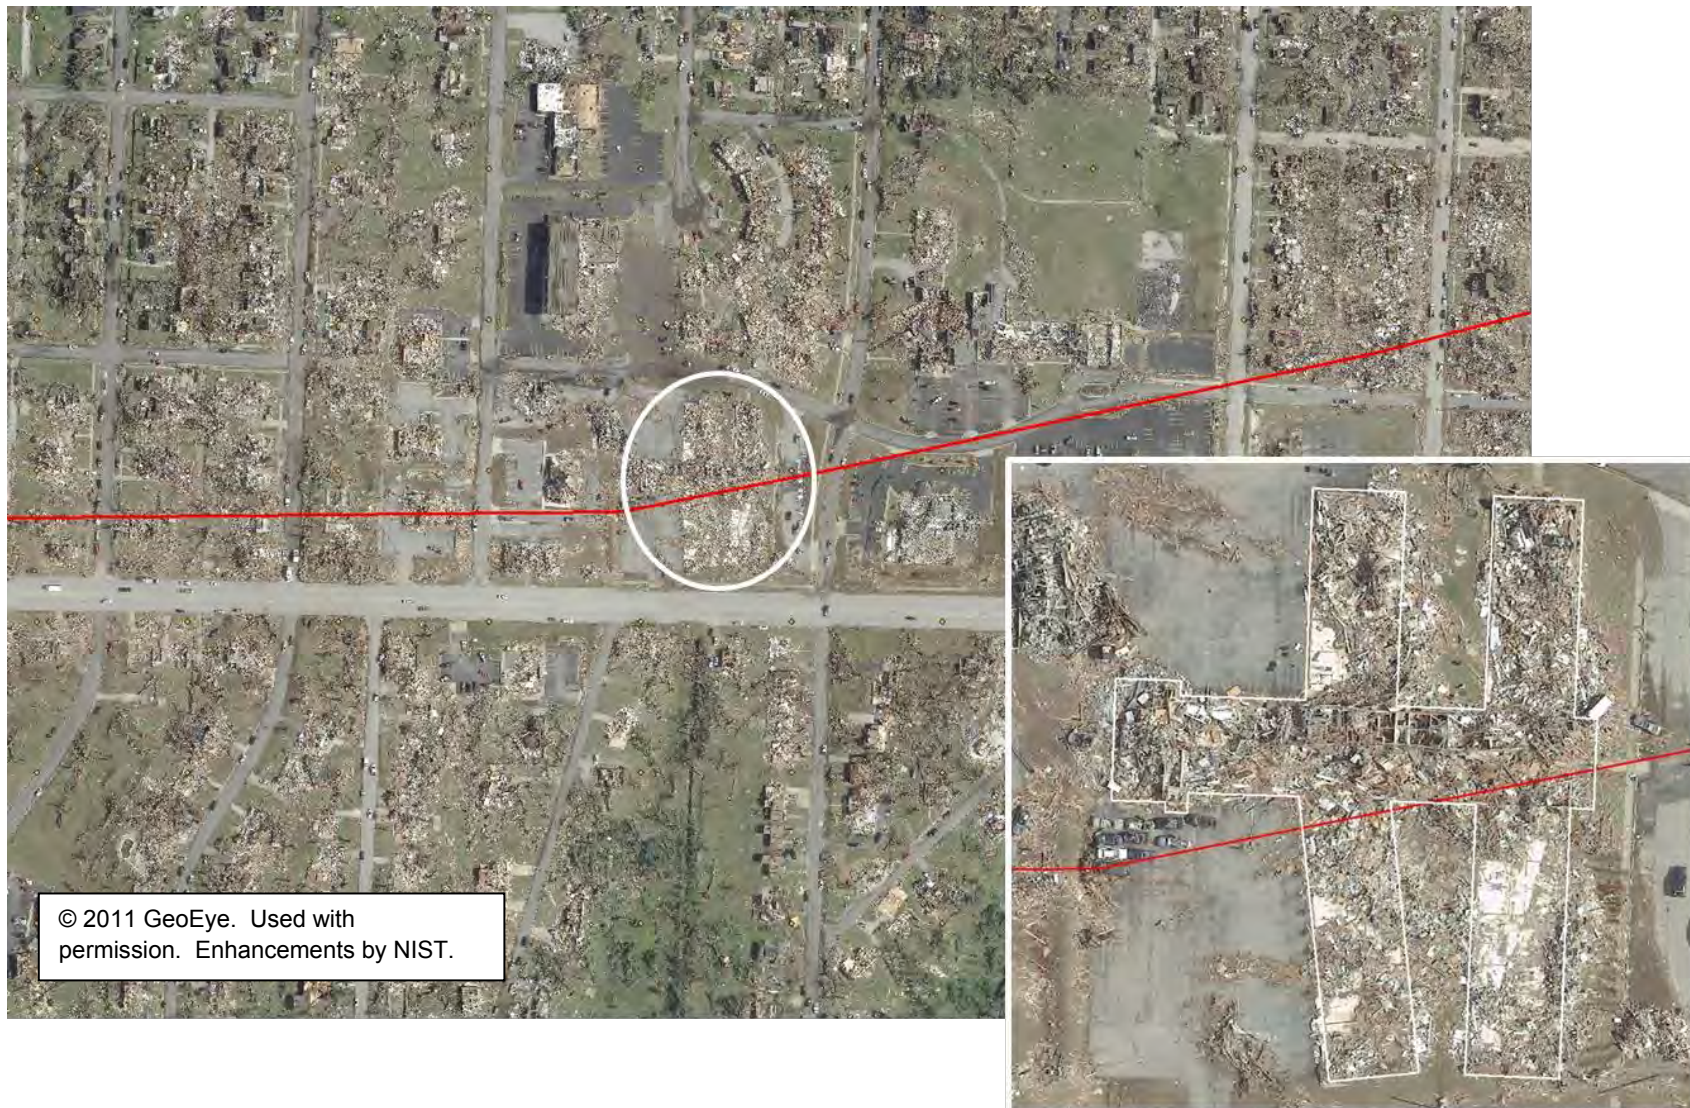
Figure 3–102. Overview of the Greenbriar Nursing Home, shown in relation to the estimated center line of the tornado damage path (red line).

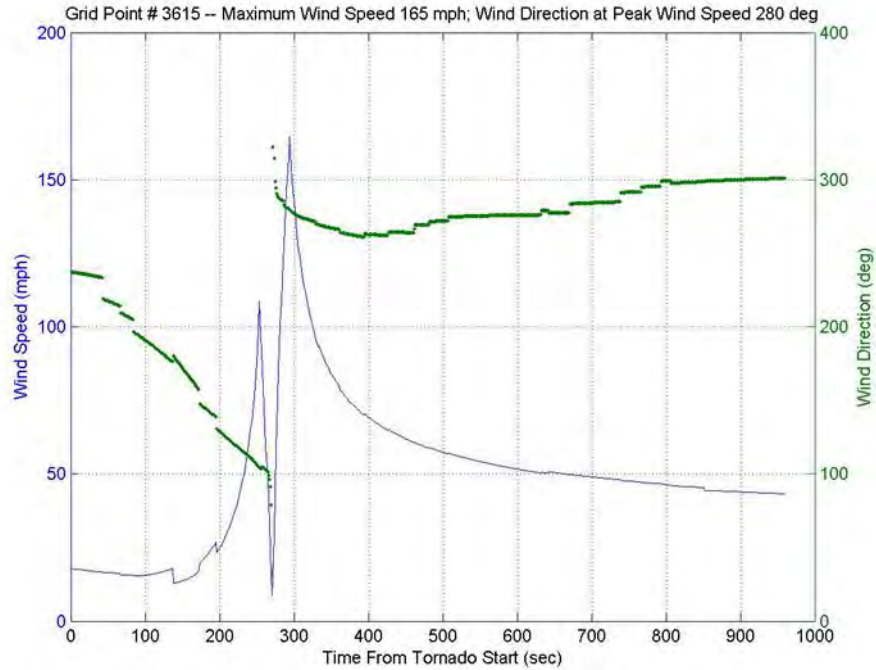
Figure 3–103. Estimated time–history of wind speed affecting the Greenbriar Nursing Home.

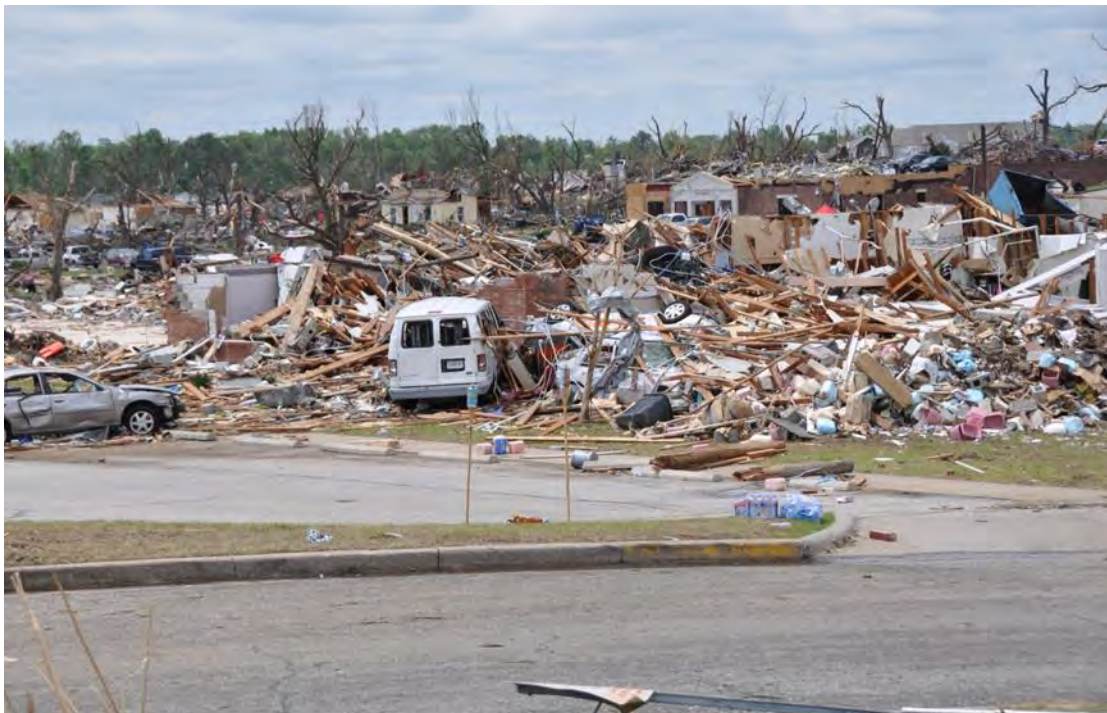
Figure 3–104. Collapsed Greenbriar Nursing Home (viewed from the east) with missing roof system and collapsed exterior CMU walls. Note debris from building materials as well as other sources (automobiles) in all interior areas of the facility.

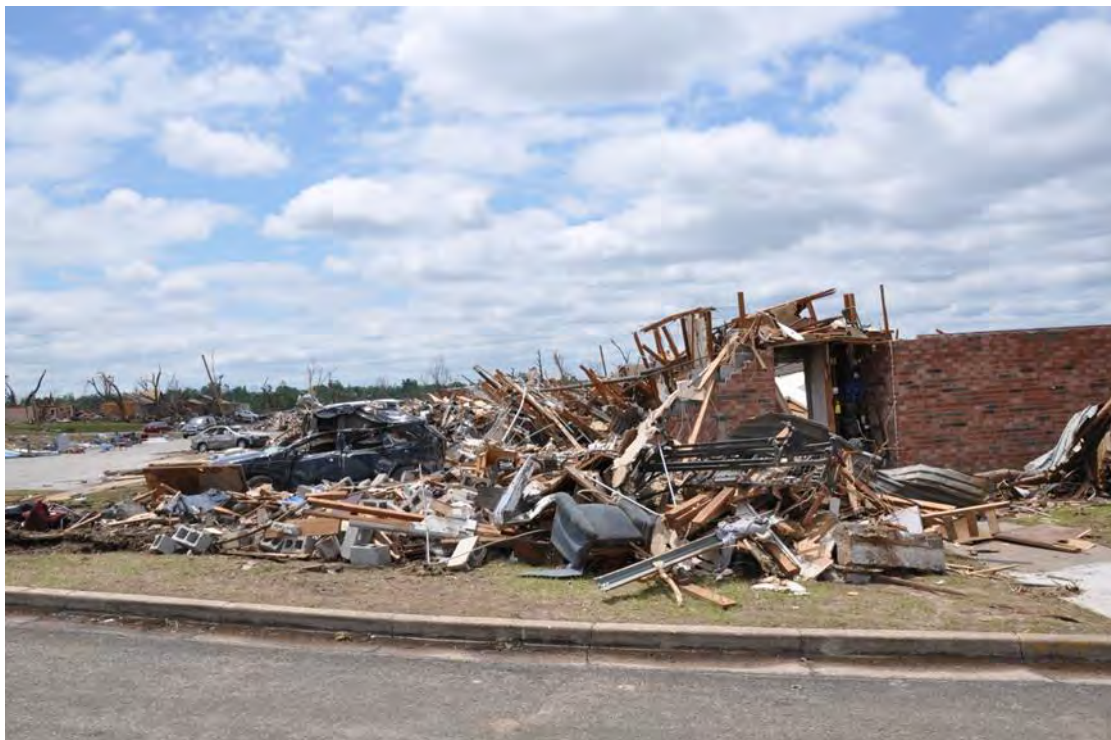
Figure 3–106. Collapsed Greenbriar Nursing Home (viewed from the north) showing the portion of the north wing’s exterior wall that did not collapse.

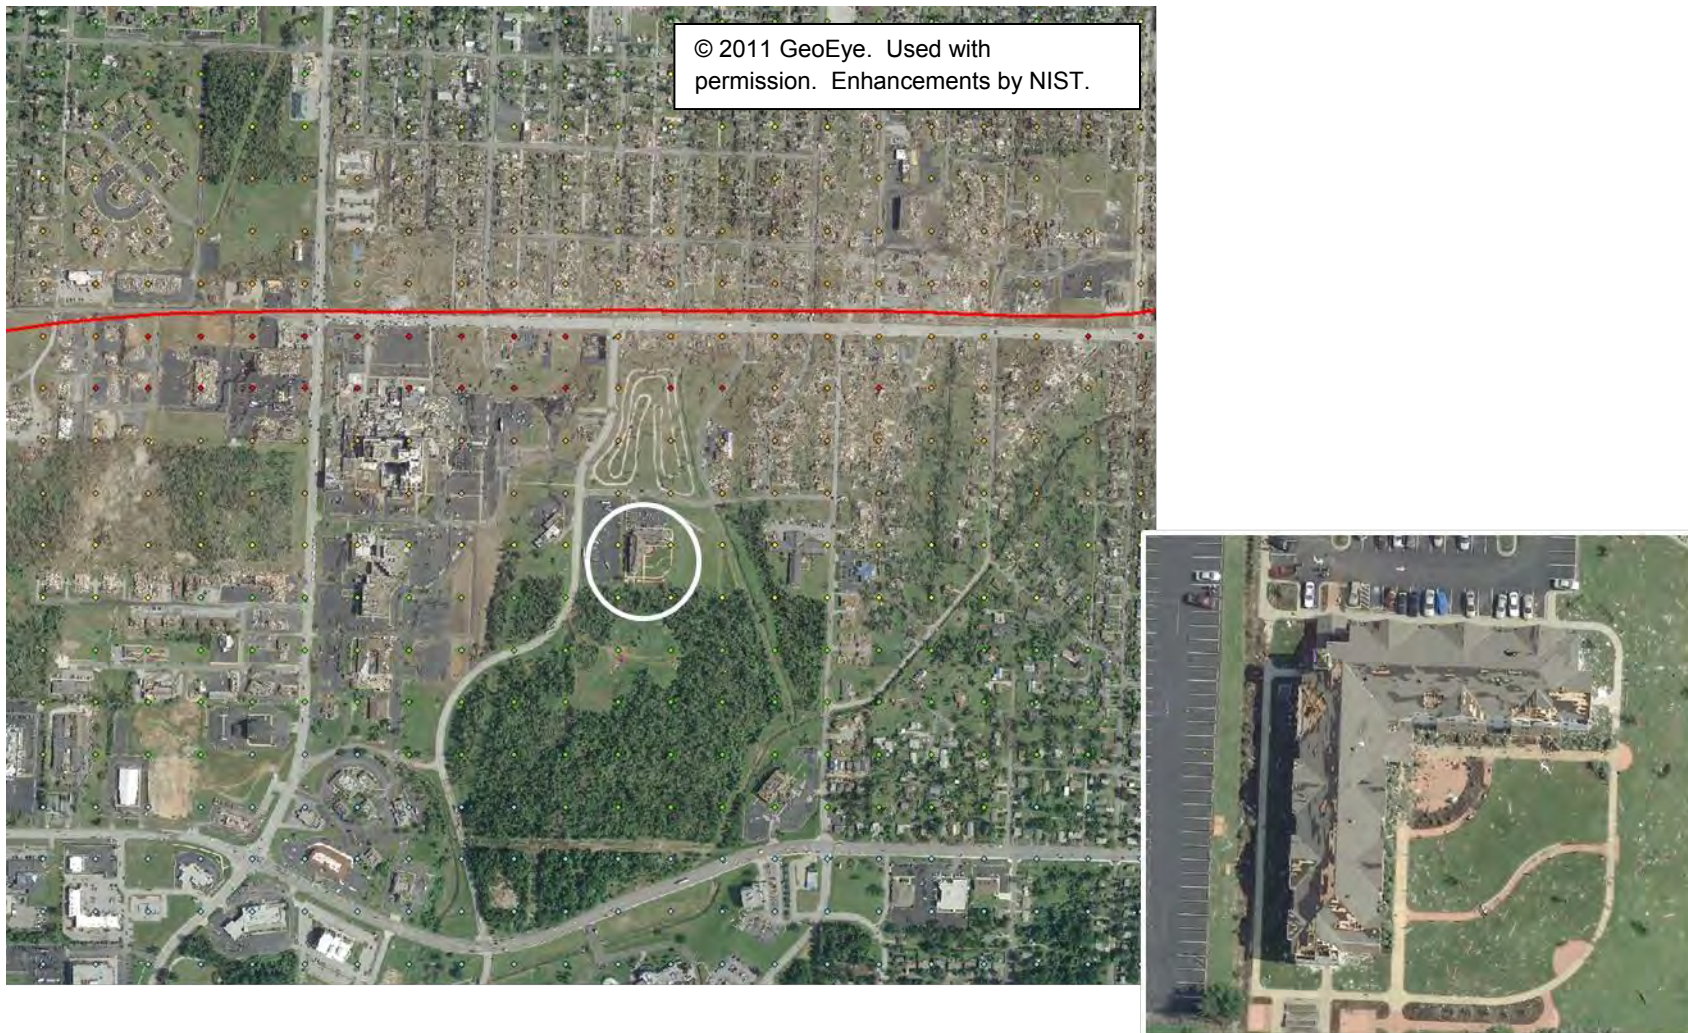
Figure 3–107. Overview of the Mercy Village Apartments, shown in relation to the estimated center line of the tornado damage path (red line). SJRMC is located to the west (left) of the apartments.

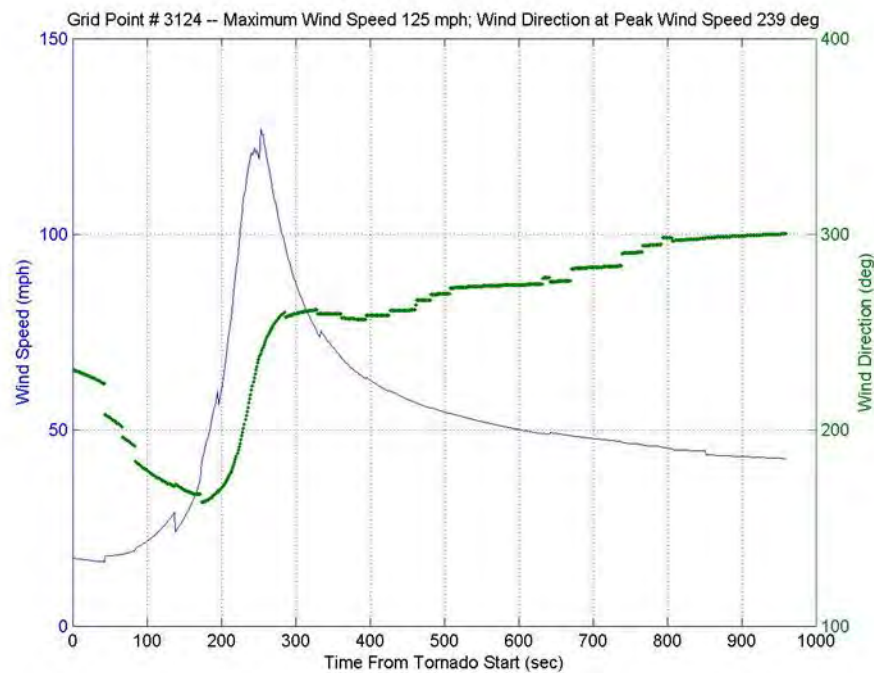
Figure 3-108. Estimated time-history of wind speed affecting the Mercy Village Apartments.

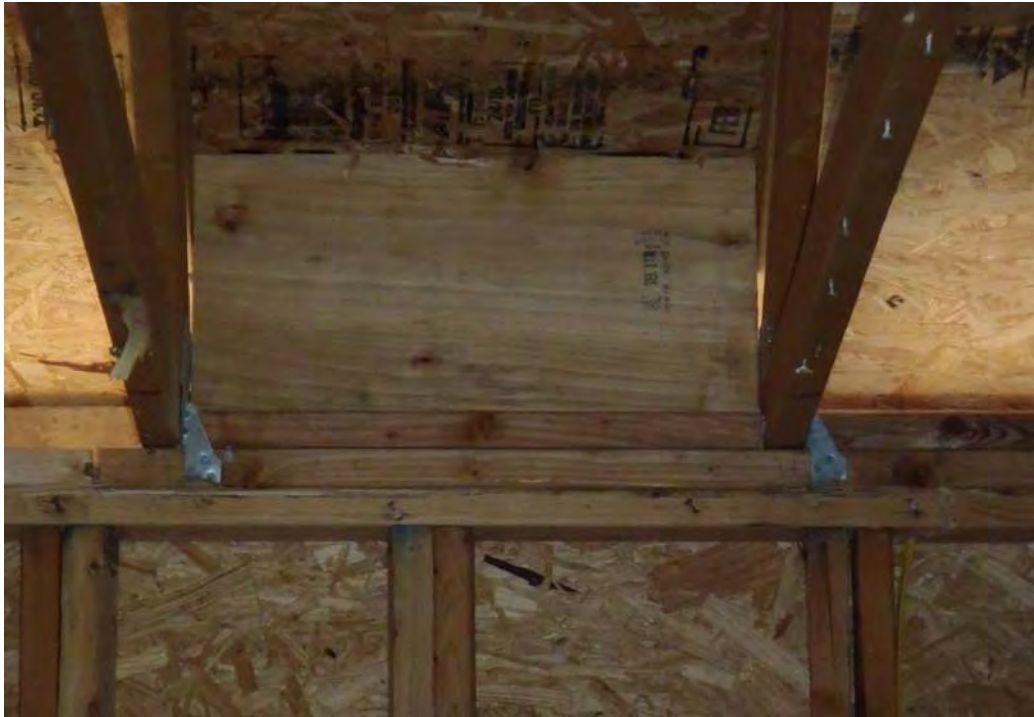
Figure 3–109. Hurricane tie–downs connecting wood roof trusses to load–bearing wood–frame wall.

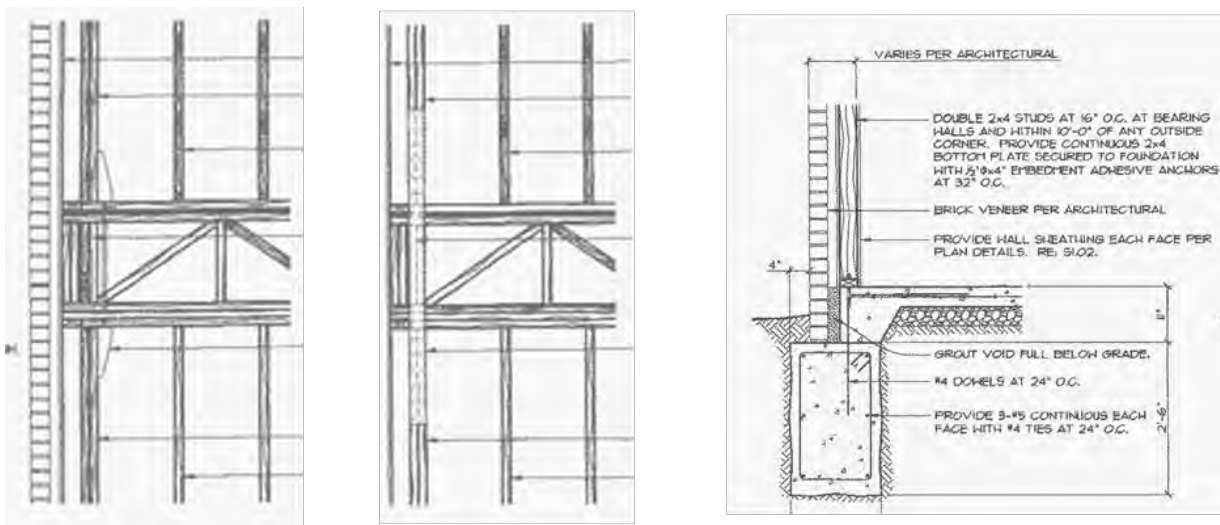
© 2013 Ron Reid. Used with permission.

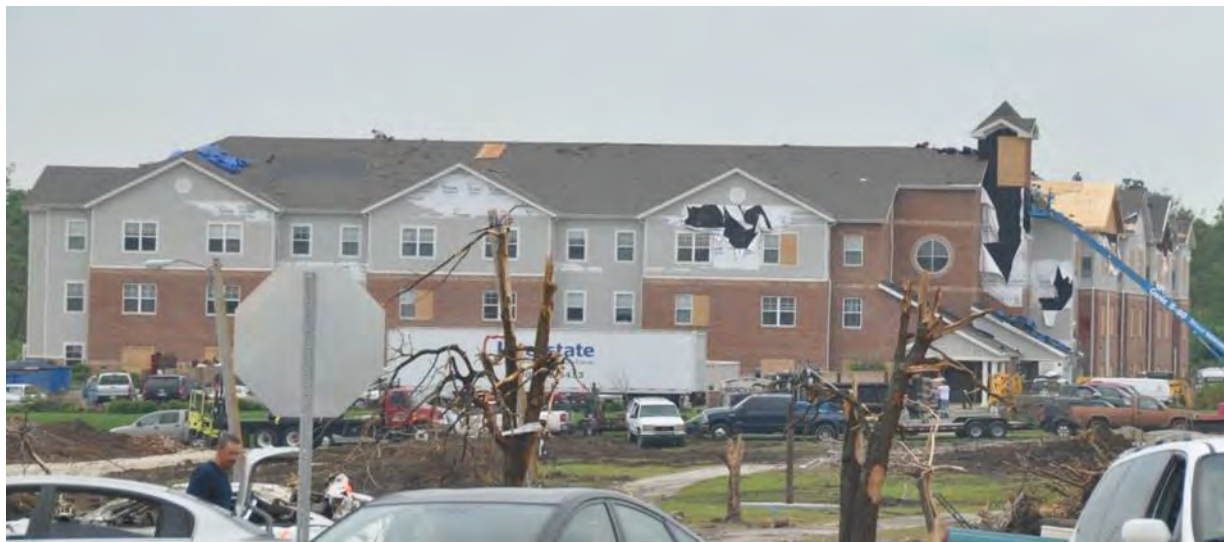
Figure 3–111. Mercy Village Apartments, viewed from the north, with envelope damage (sidings, window glazing, roof covering).

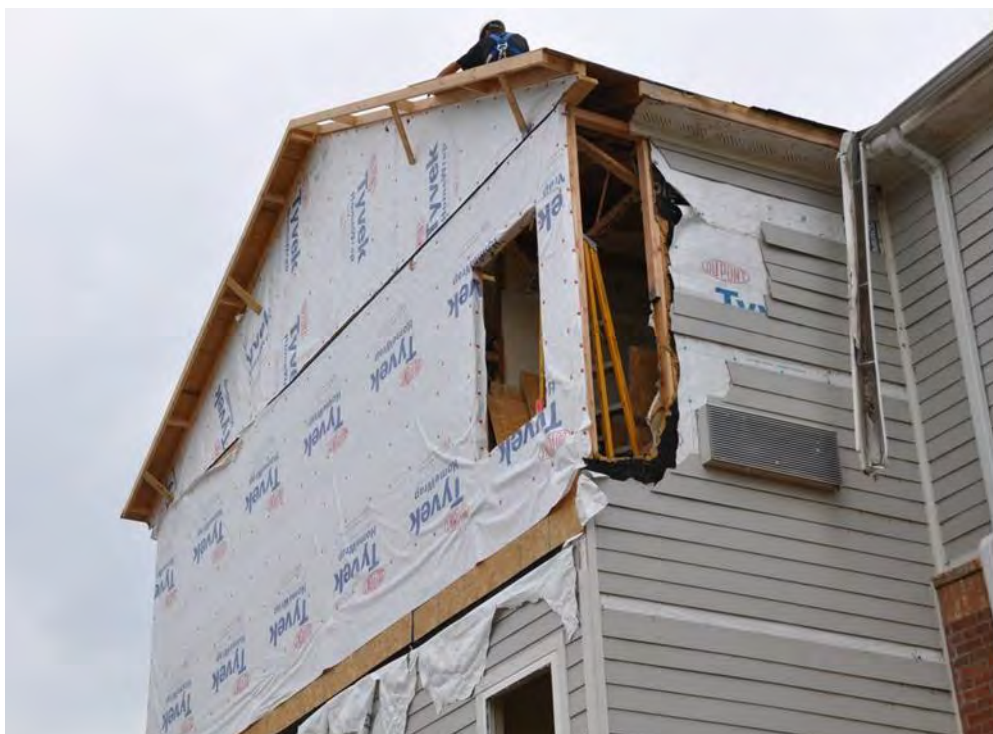
Figure 3–112. Damage to the building envelope of the Mercy Village Apartments.

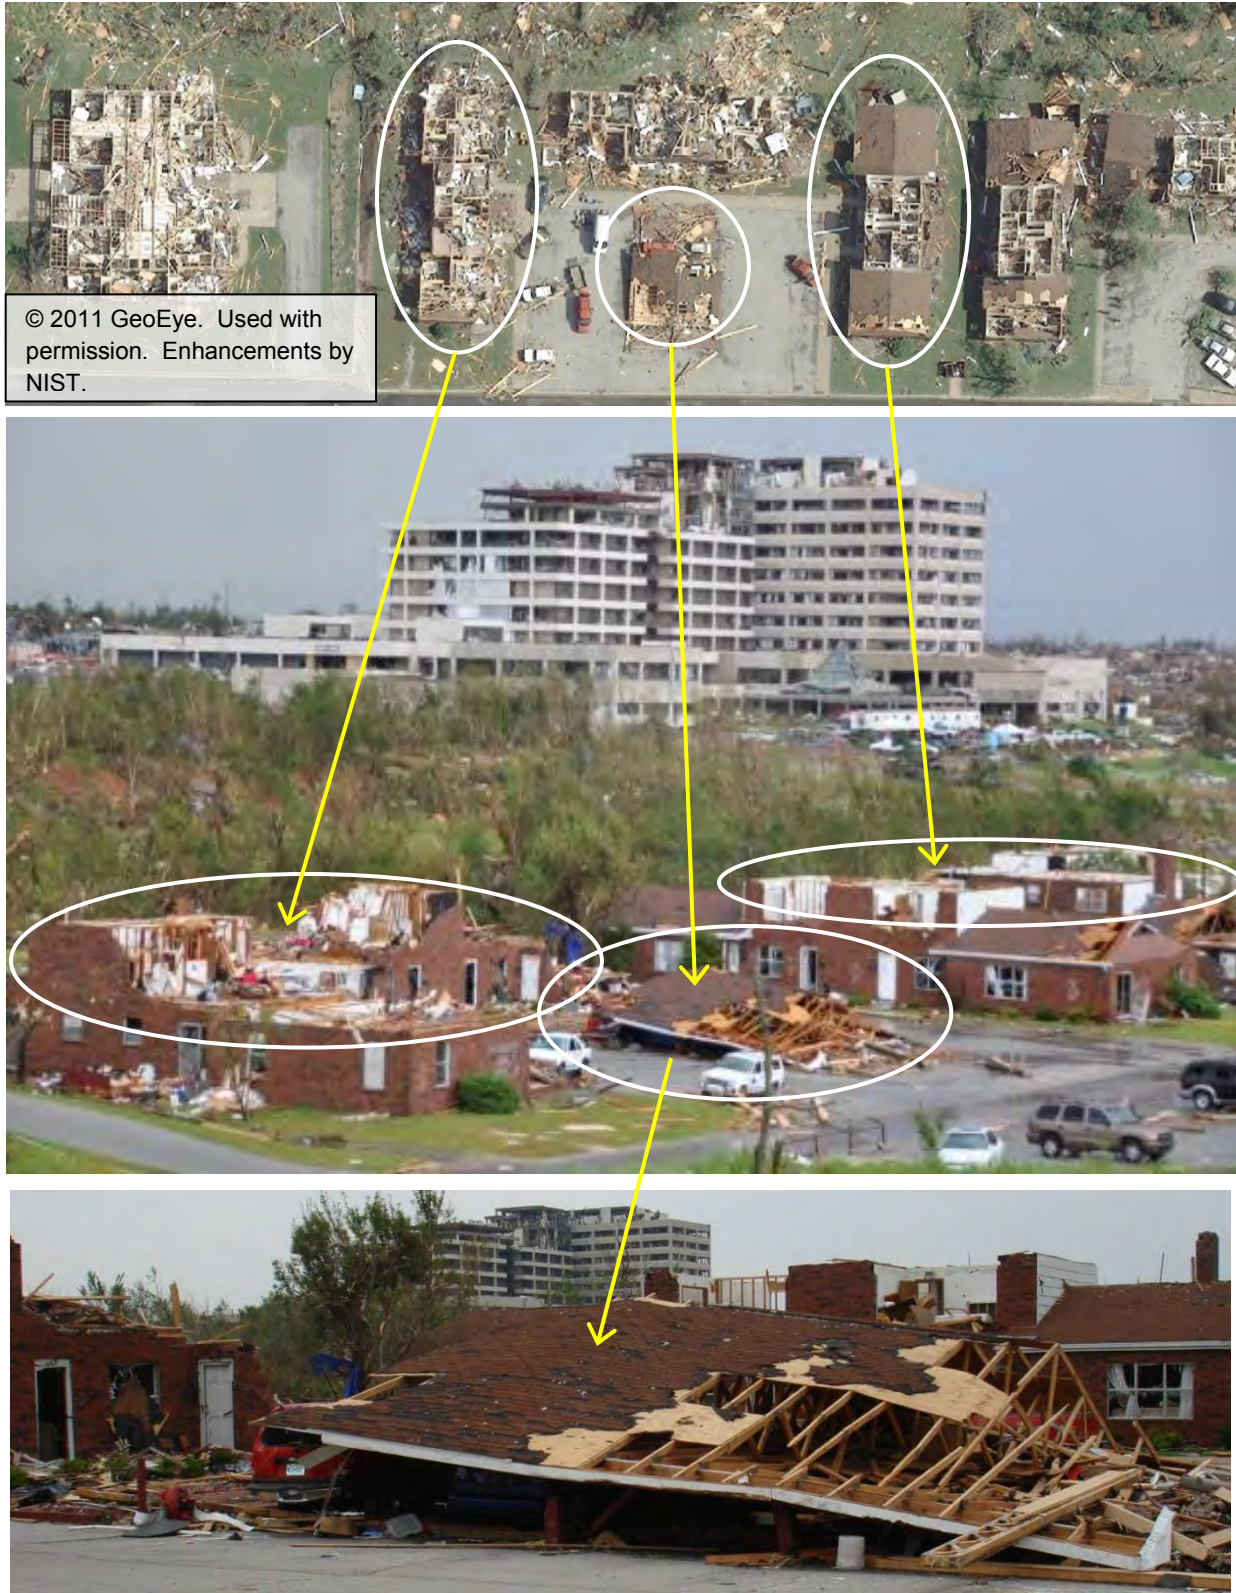
Figure 3–113. Residential failure due to disconnection of entire roof system (roof-to-wall connection failure due to wind uplift).

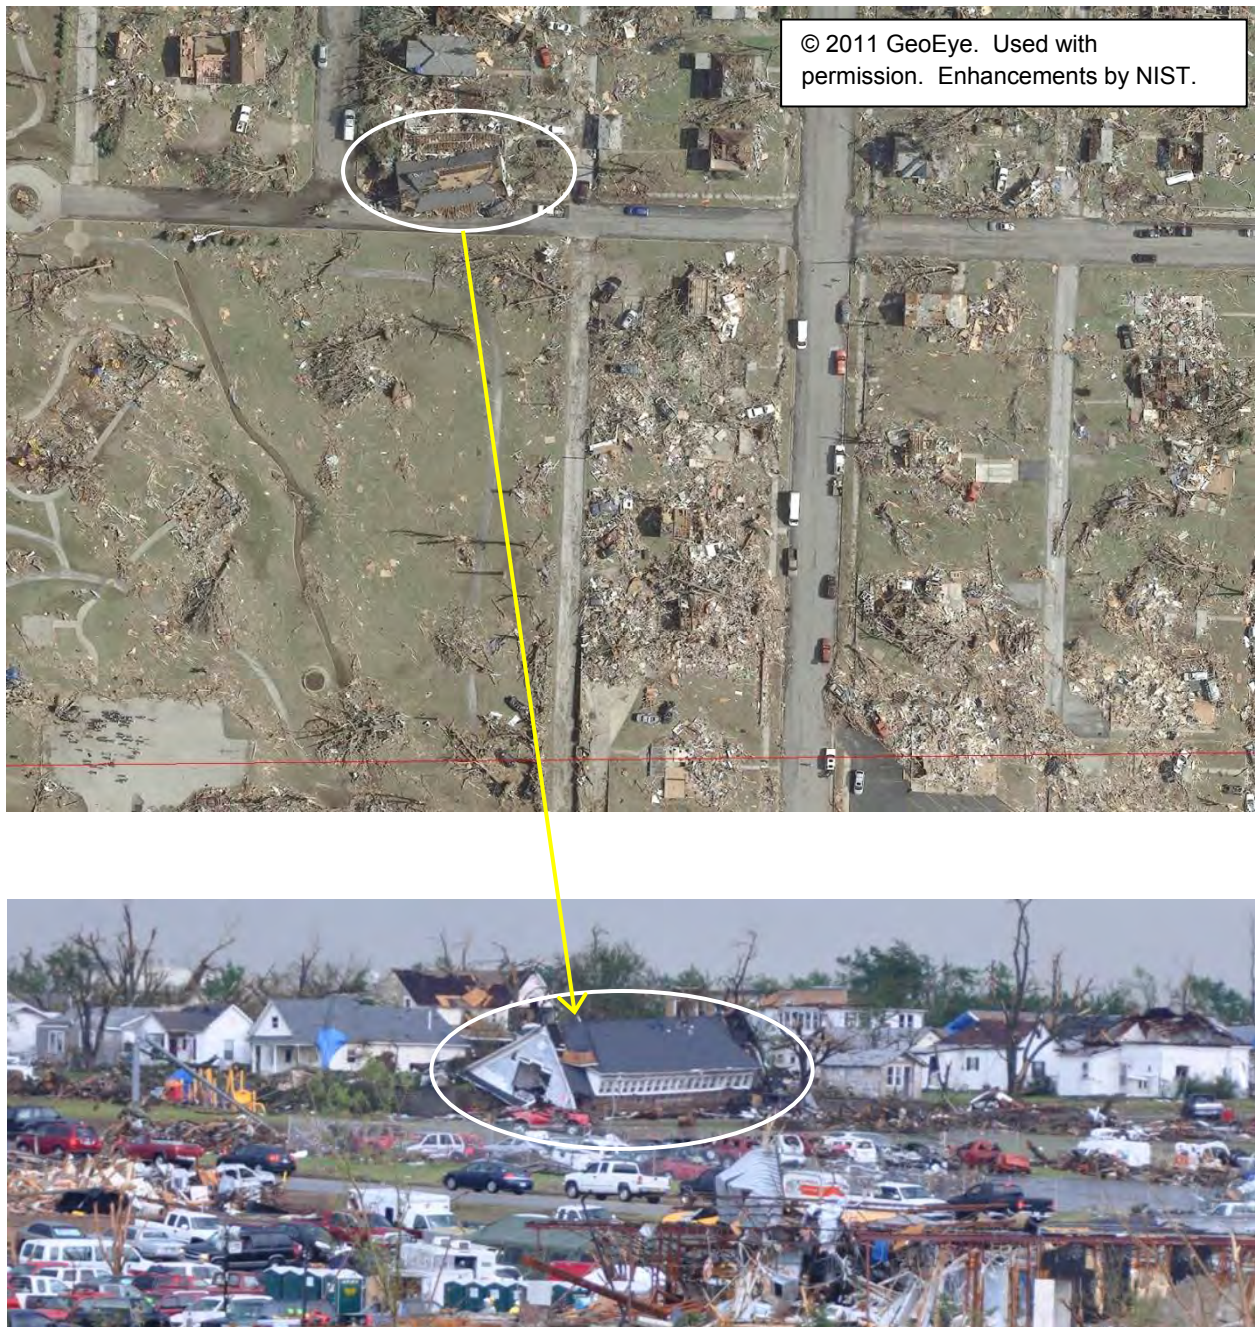
Figure 3–114. Failure of first-story-to-foundation wall connection. Entire roof and first floor shifted off of lower story (directly north of SJRMC).

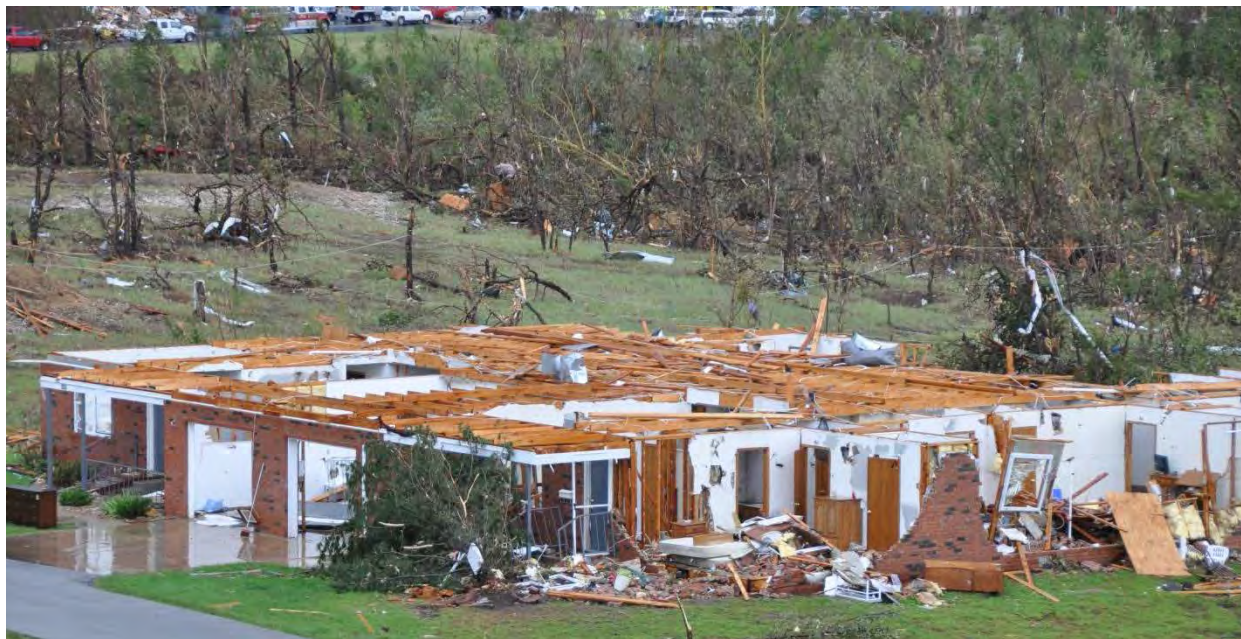
Figure 3–115. Disconnection and loss of entire roof system.

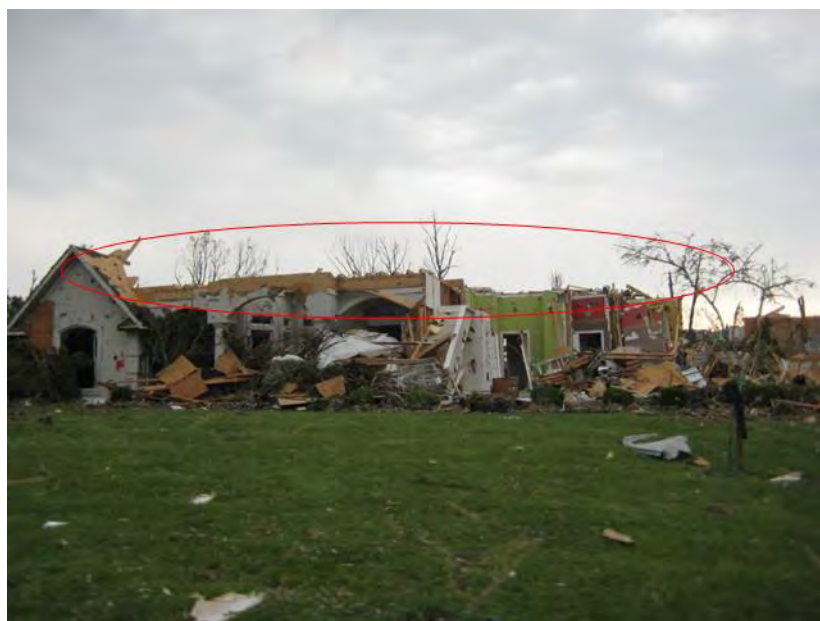
Figure 3–116. Typical roof-to-wall connection damage.

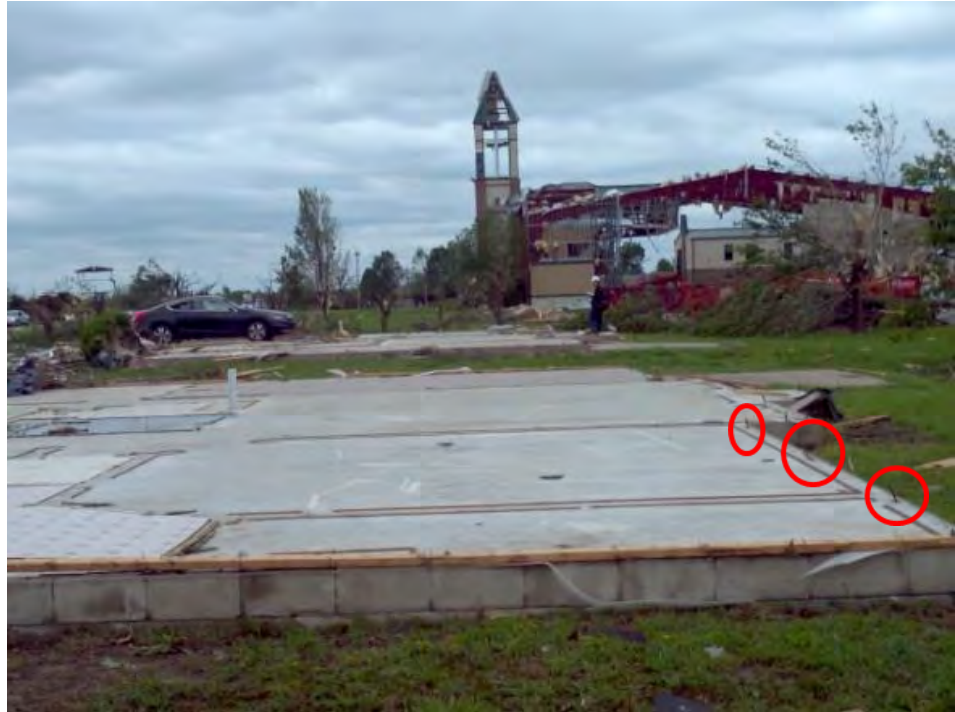
Figure 3-117. Typical wall-to-foundation connections.

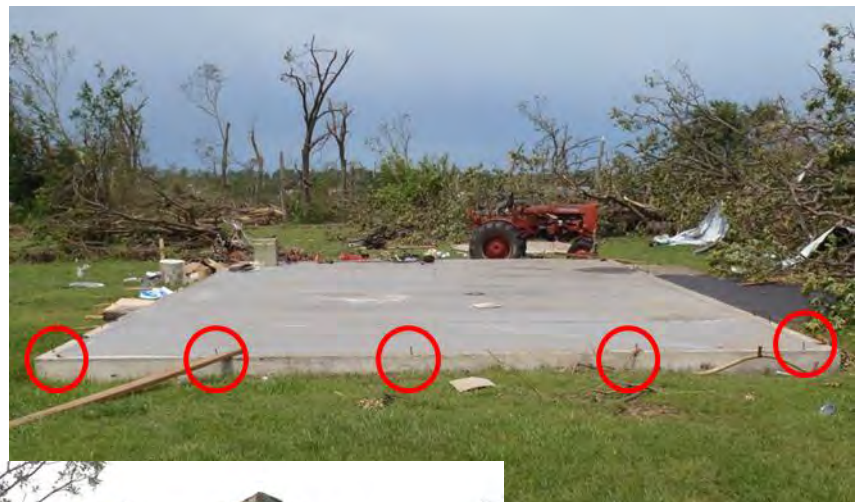
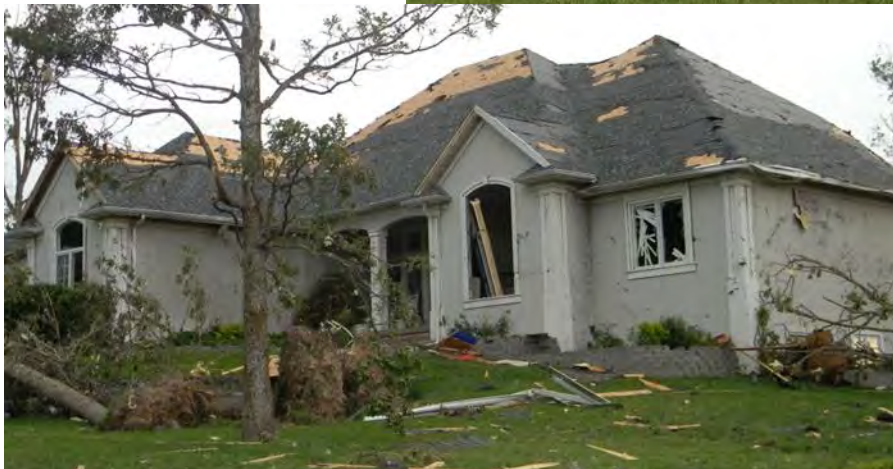
Figure 3-118. Typical damage to residential dwelling envelope.

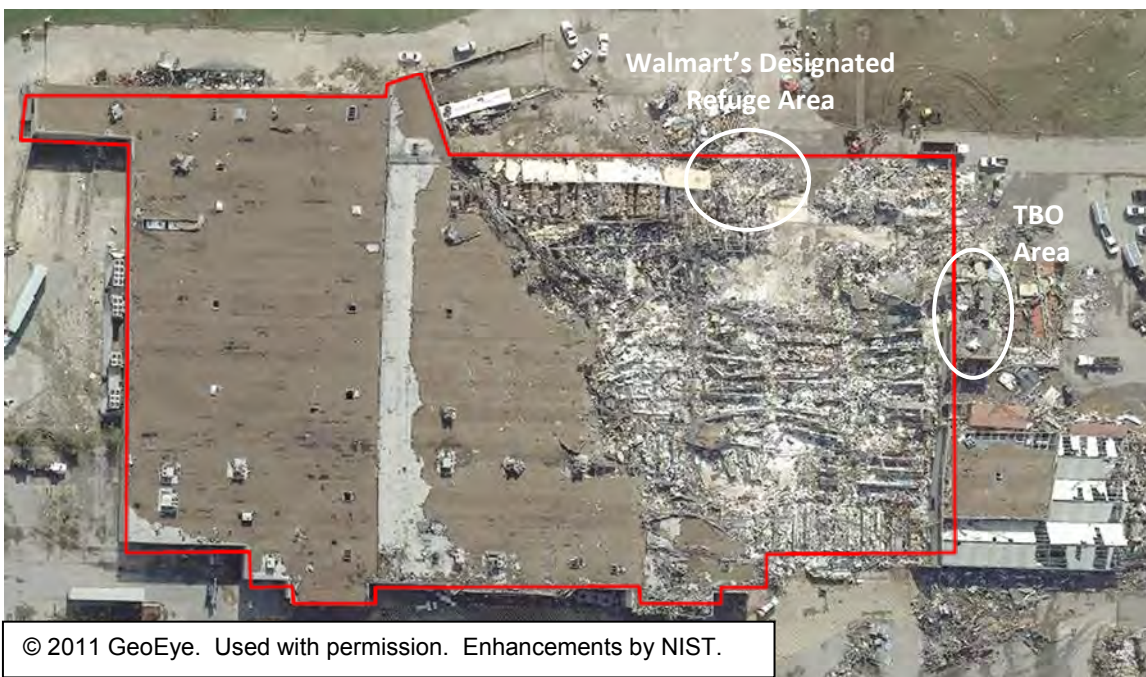
Figure 3–119. Aerial photo showing the locations of the designated refuge area and TBO area in the Walmart store a drawing containing the refuge area. .

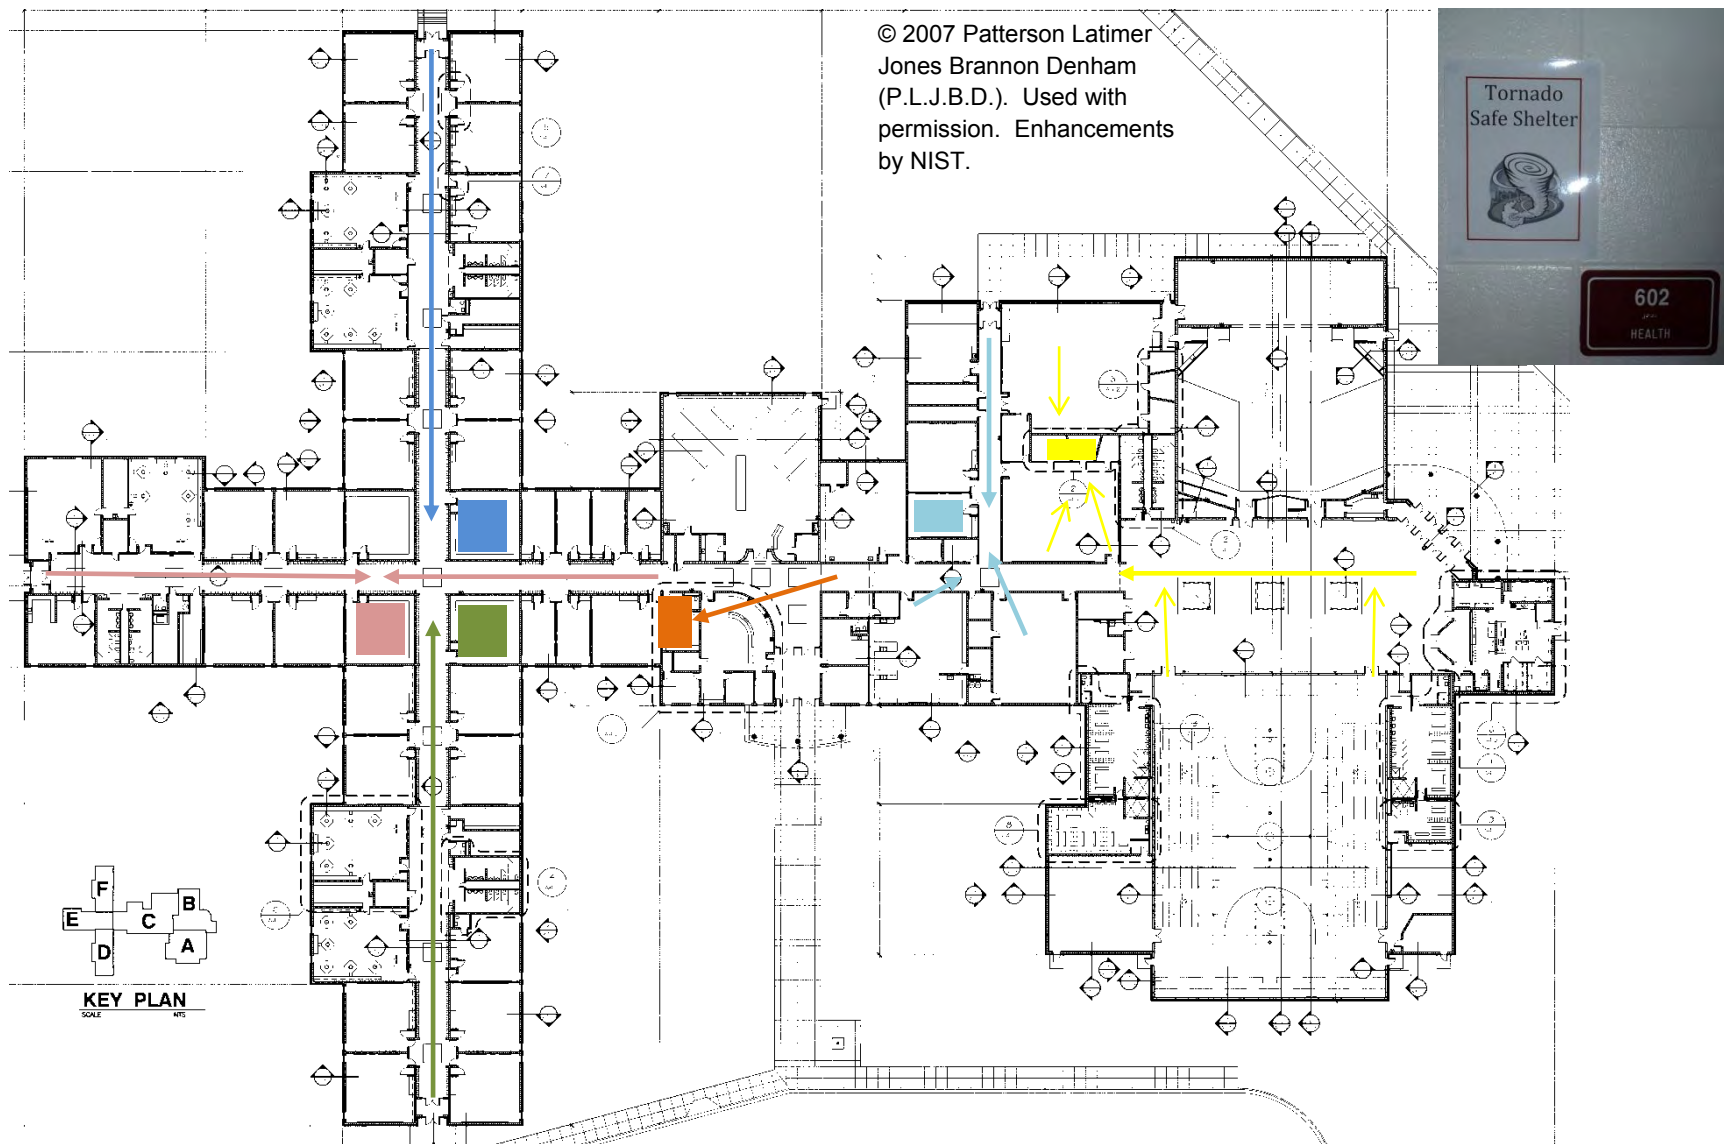
Figure 3–123. Locations of Tornado Safe Shelters (color blocks) in Joplin East Middle School and their associated, pre-planned tornado evacuation routes (arrows of corresponding color).

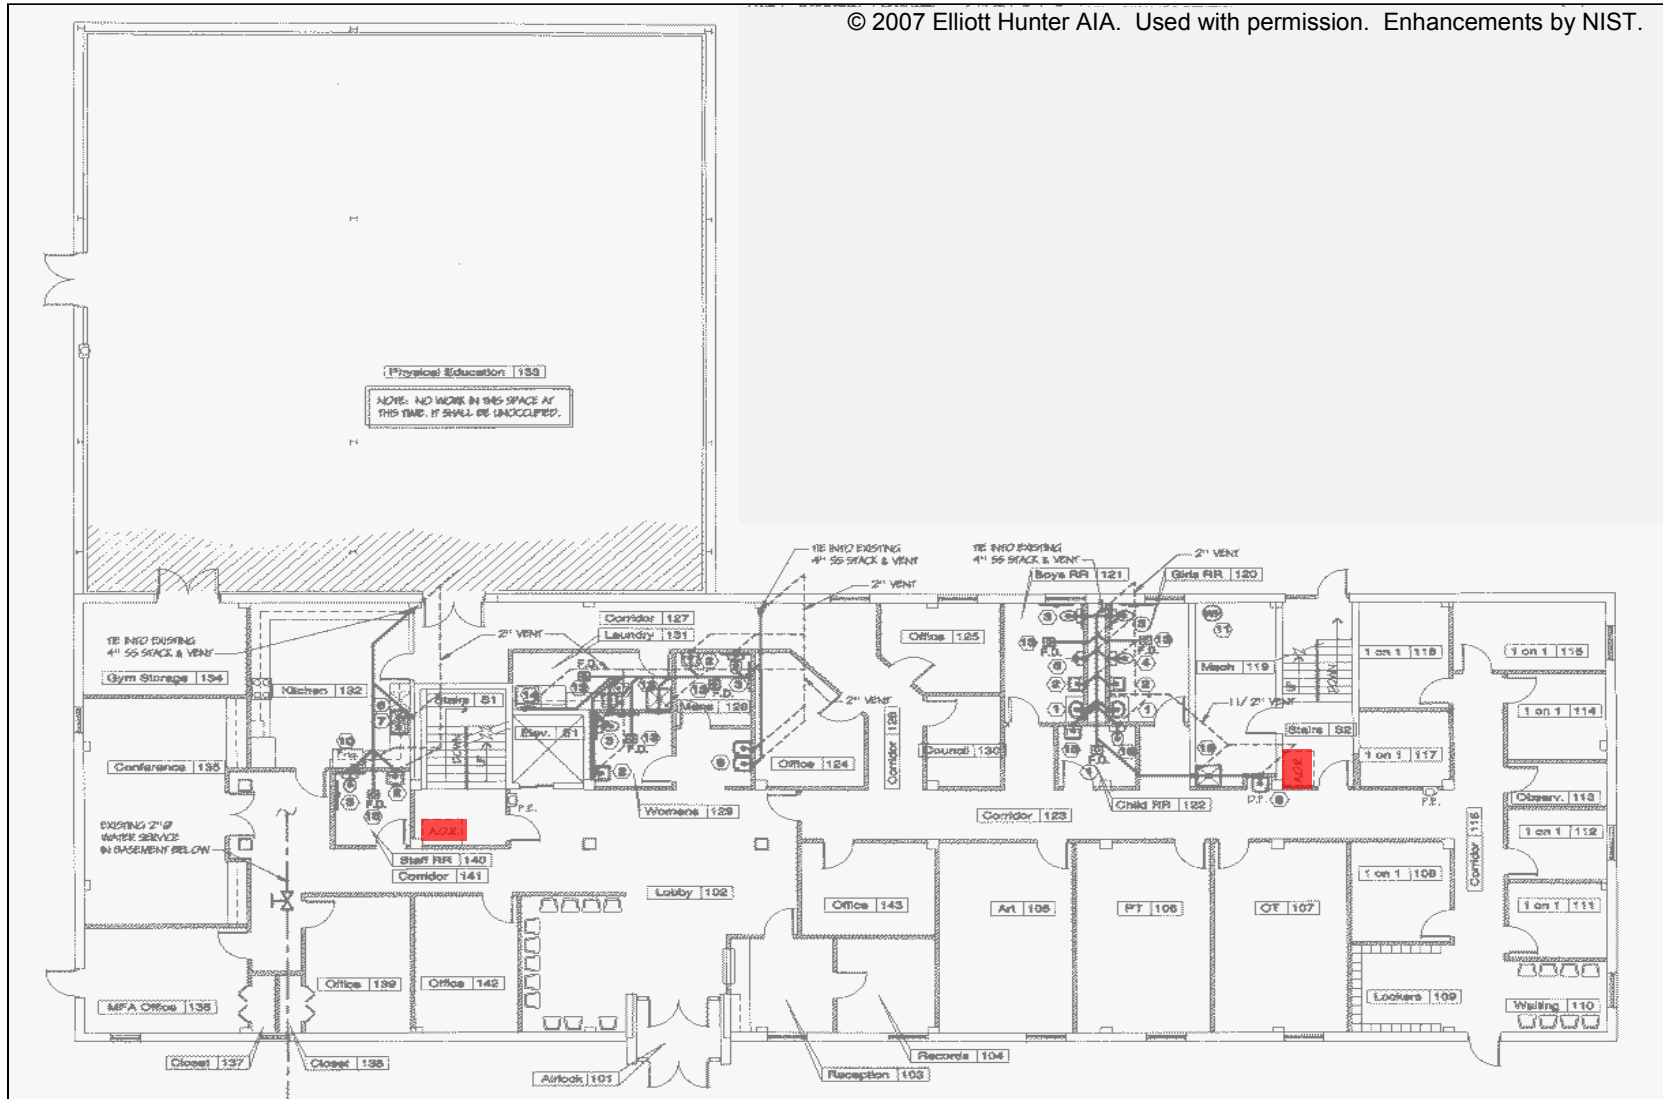
Figure 3–125. Locations of areas of refuge (AOR, red blocks) on the first floor of the Ozark Center for Autism building.

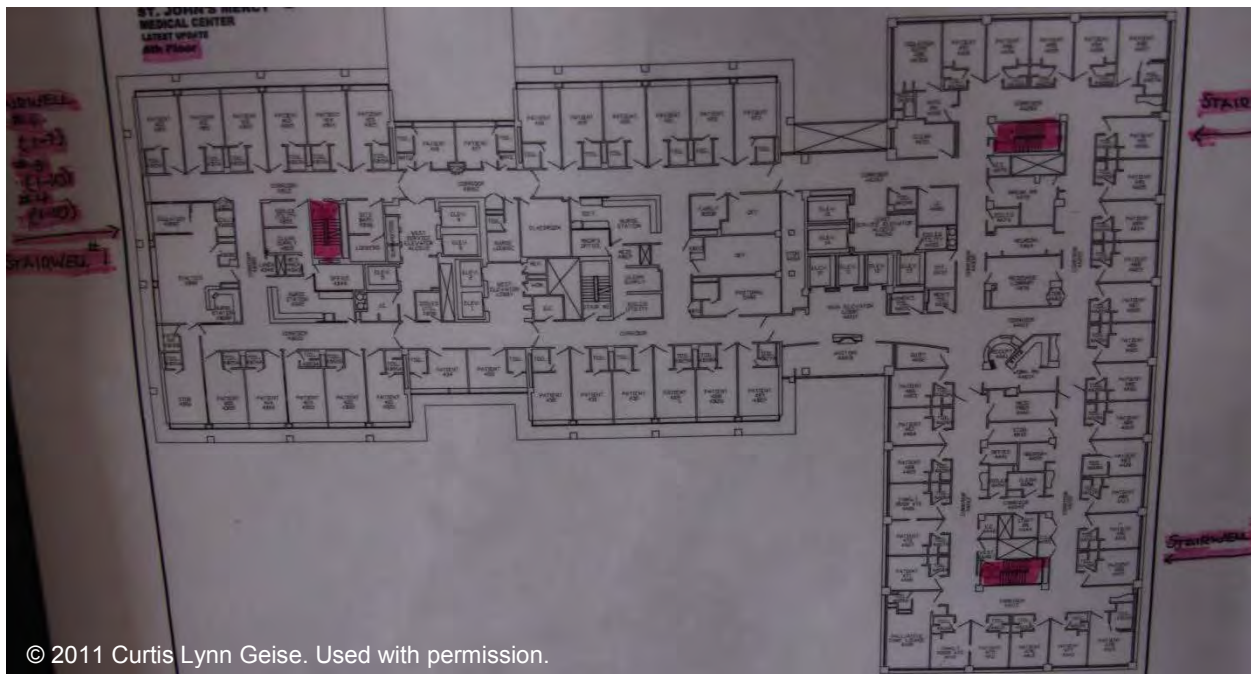
Figure 3–127. Typical floor plan of SJRMC’s East and West Towers (patient rooms along perimeter and hallway toward the center).
