Draft Final Report • National Institute of Standards and Technology (NIST)

Technical Investigation

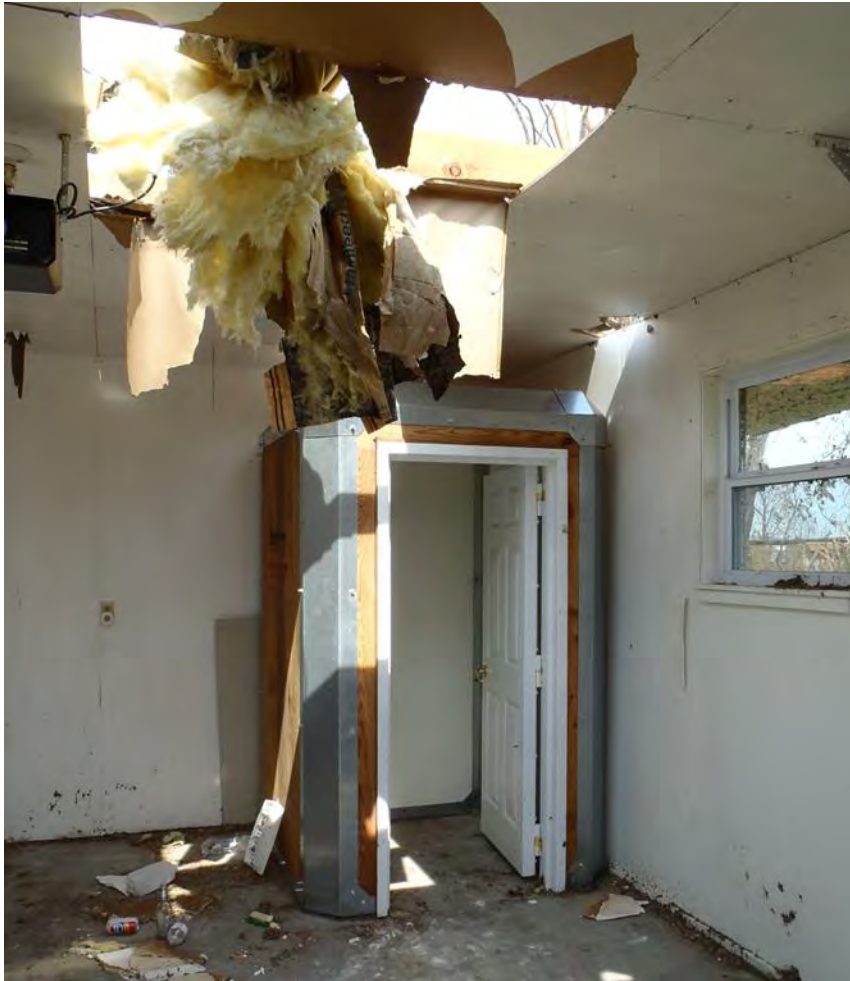
Figure 3–129. Above-ground Kevlar storm shelter bolted to concrete garage floor in residence that was damaged during the tornado.

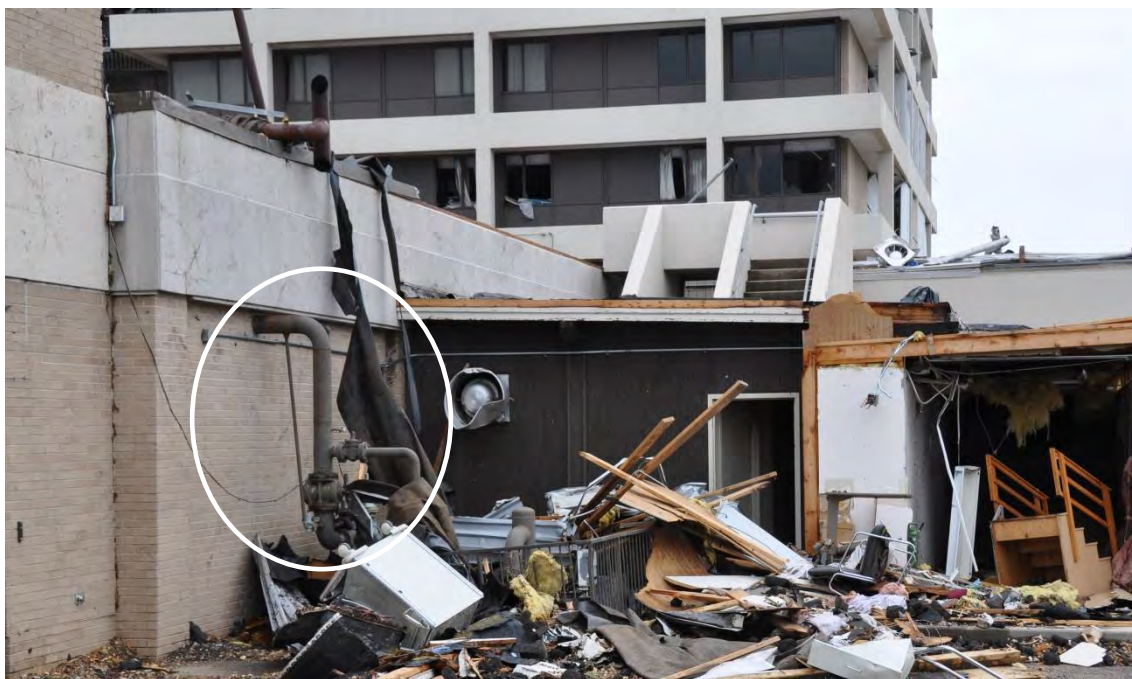
Figure 3–132. High–pressure gas reducer valve at SJRMC that was damaged and leaked.

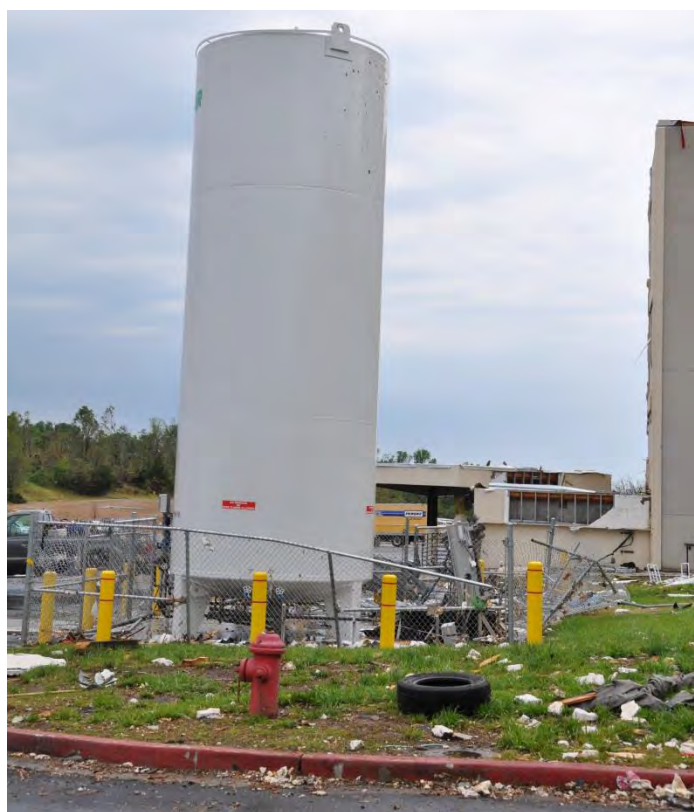
Figure 3–133. Liquid oxygen tank at SJRMC that leaked.

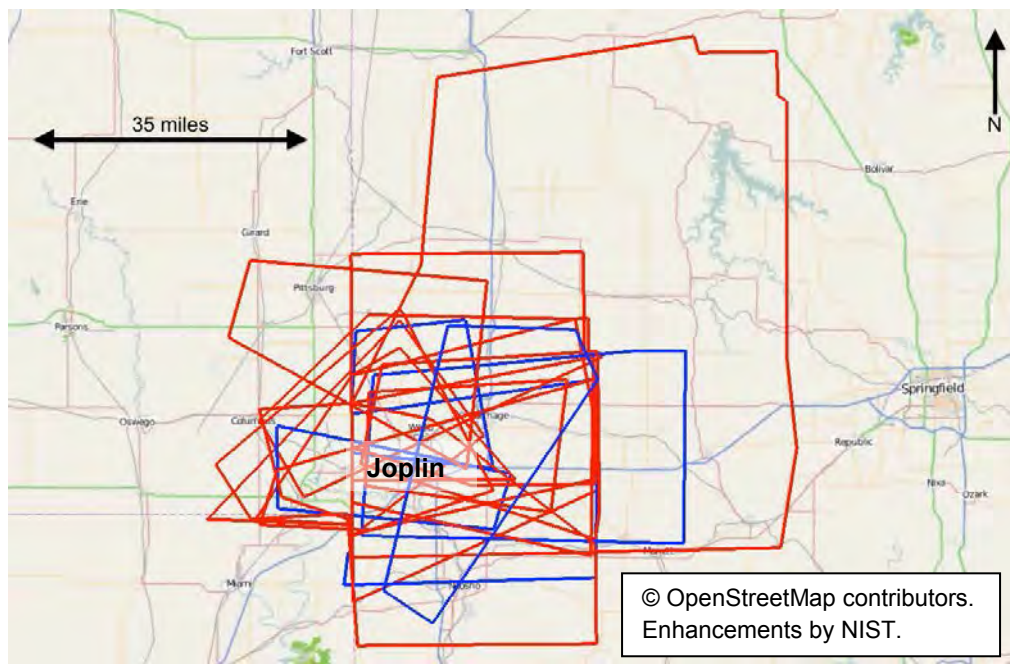
Figure 4-3. The polygons associated with the 18 tornado warnings issued by the NWS between July 1, 2005, and May 25, 2011 (false alarms shown in red, warnings followed by verified tornadoes shown in blue).

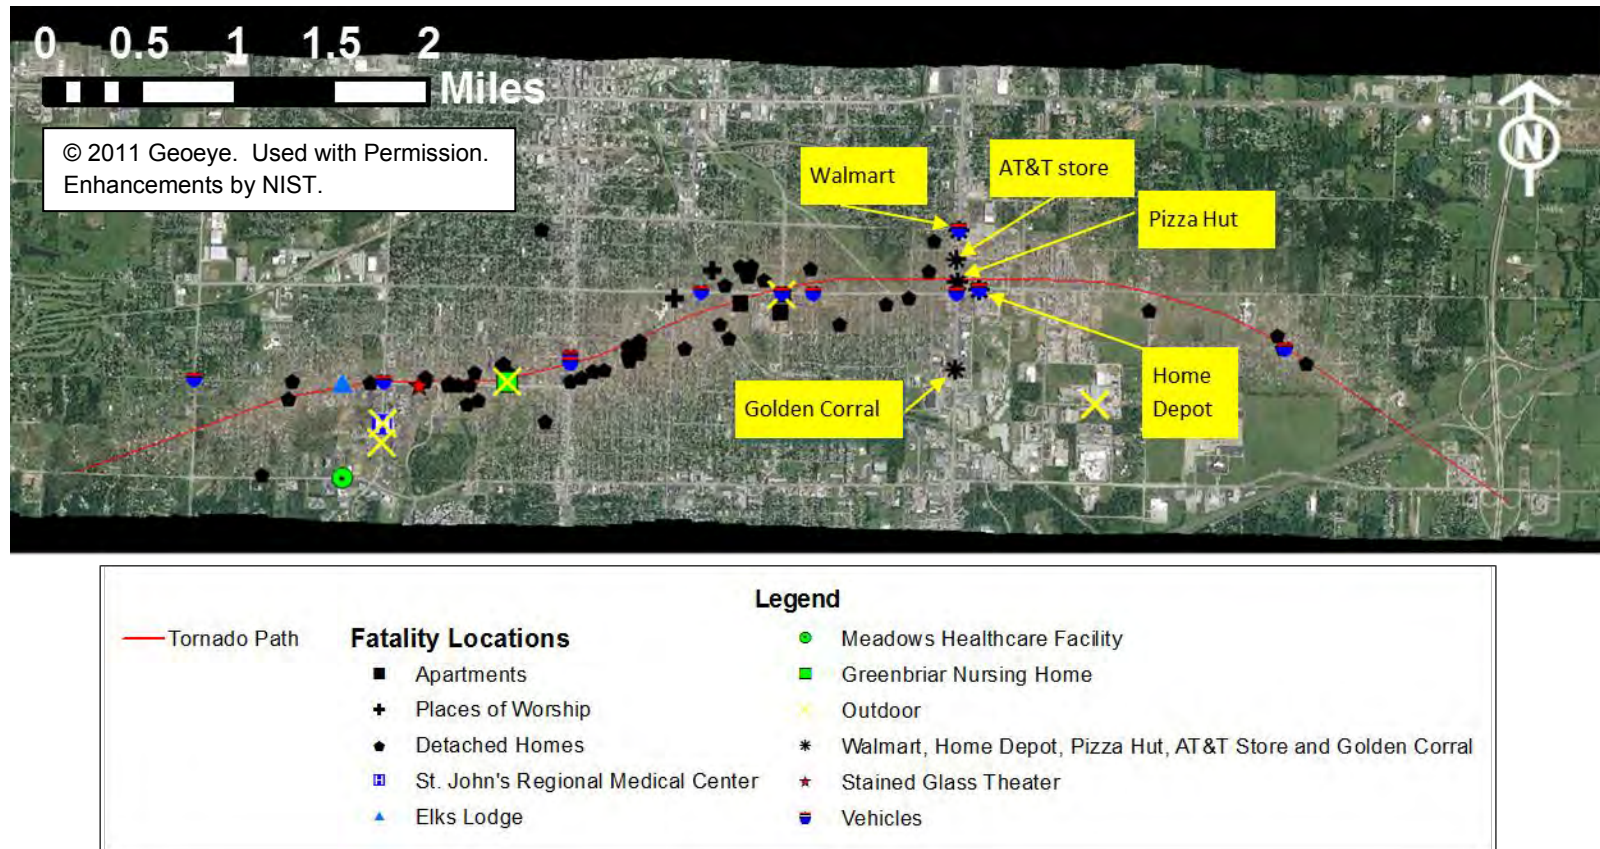
Figure 4–4. Locations of the 161 fatalities resulting from the May 22, 2011, Joplin tornado. Tornado estimated center track plotted in red.

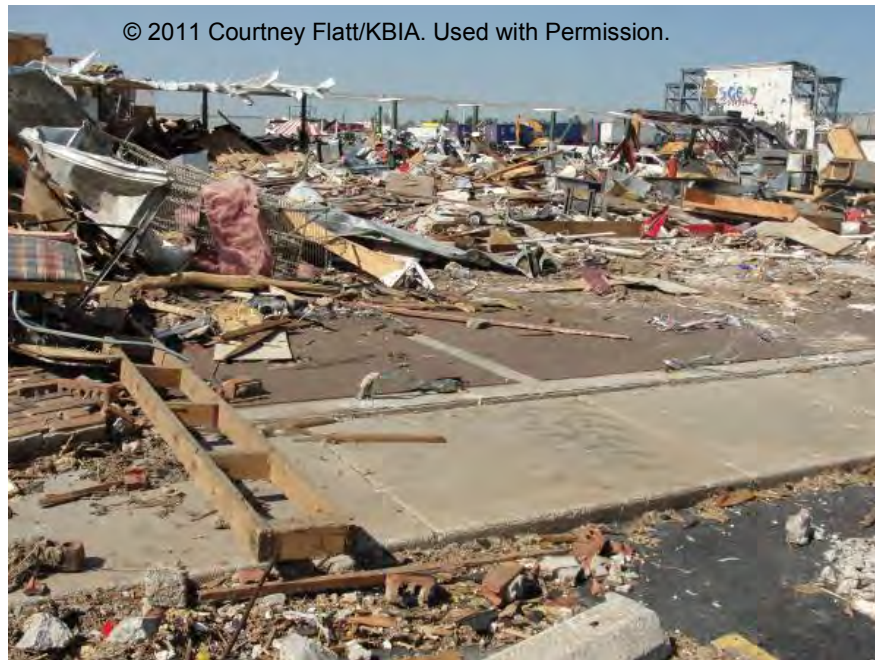
Figure 4–5. Joplin Elks Lodge #501 destroyed by the May 22, 2011, Joplin tornado.

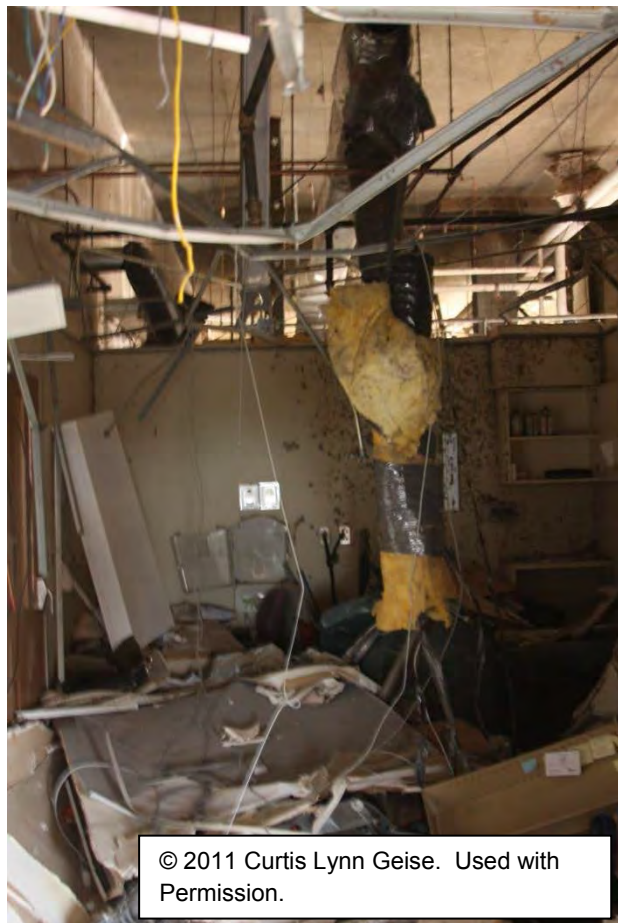
Figure 4-6. Damage to the interior of SJRMC.

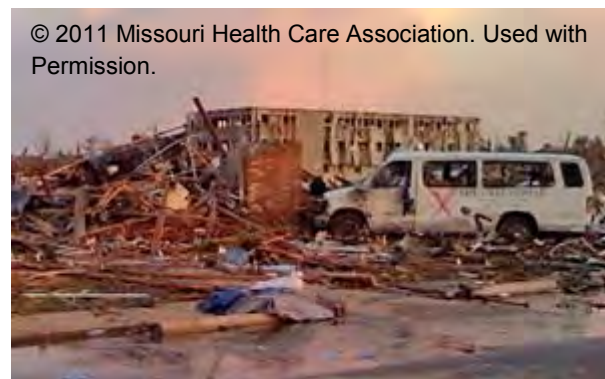
© 2011 Missouri Health Care Association. Used with Permission.

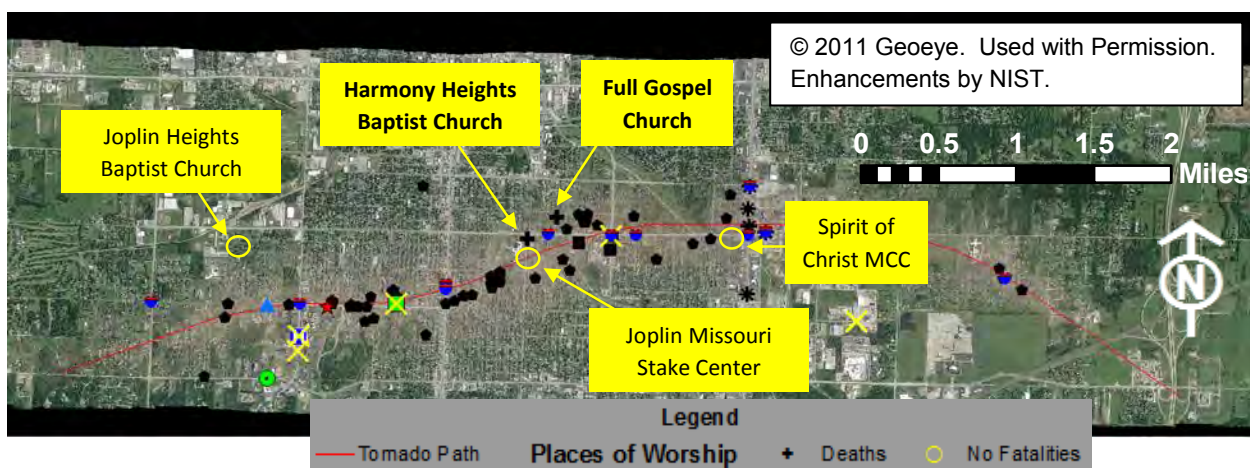
Figure 4–8. Locations of places of worship, denoted by black plus signs (+) where people died and yellow circles where there were no fatalities, along the tornado damage path (red line marks the estimated center line of the path).

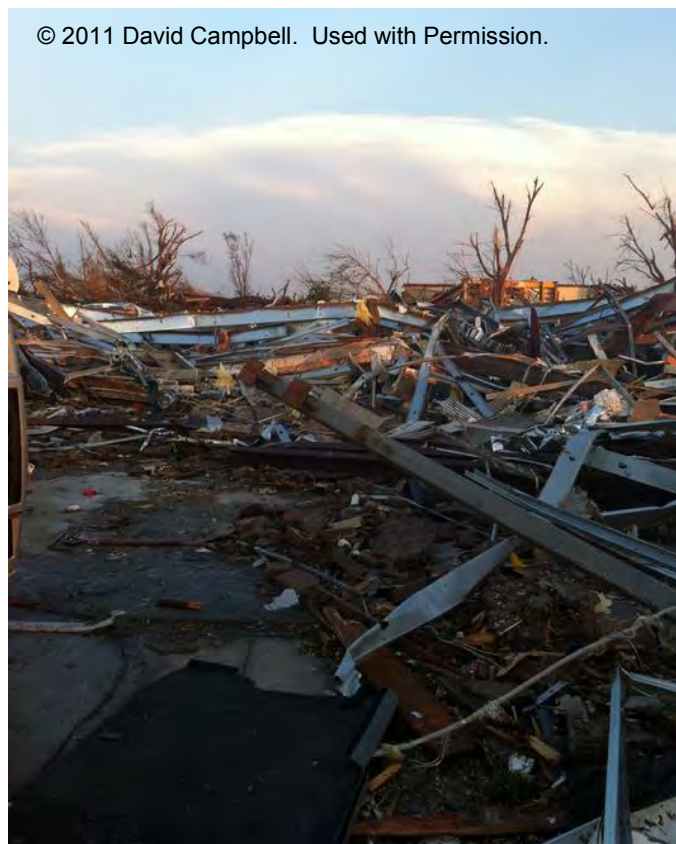
Figure 4-9. The AT&T store following the May 22, 2011, Joplin tornado.

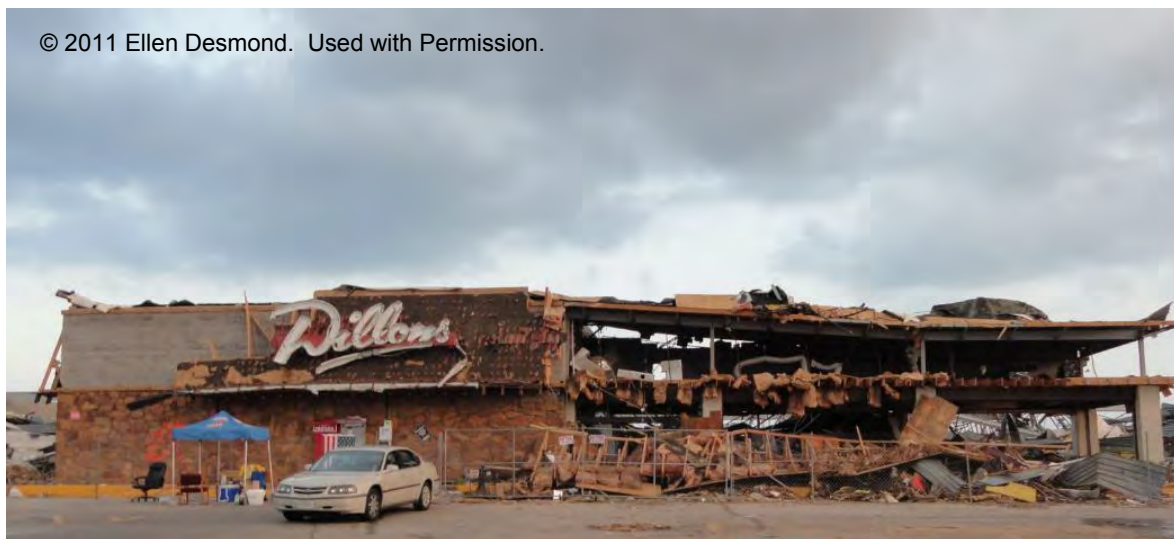
Figure 4–11. Damage to Dillon’s grocery inflicted by the May 22, 2011, Joplin tornado.

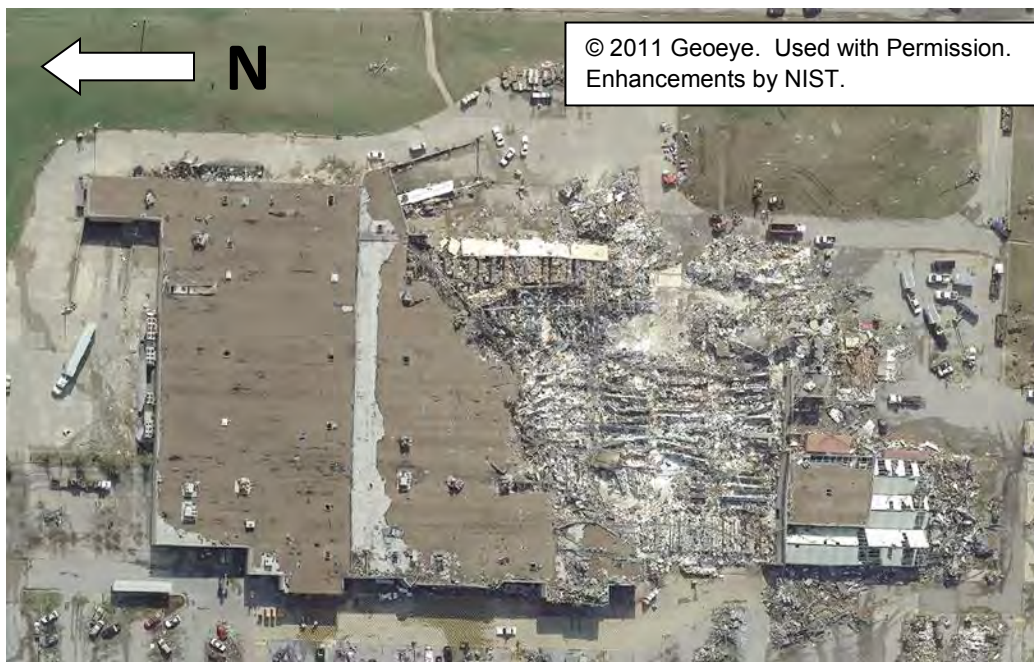
Figure 4-12. Aerial photo of the tornado-damaged Walmart Store #59, showing the collapsed south half and uncollapsed north half of the building.

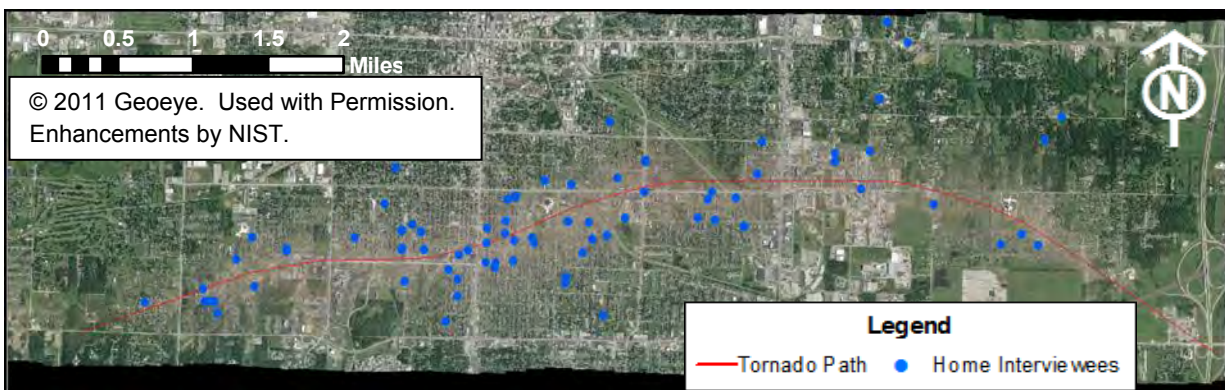
Figure 4-13. Geographic locations of 104 of the 109 NIST interviewees who were located at home when the tornado hit Joplin. The red line indicates the estimated center track of the tornado.

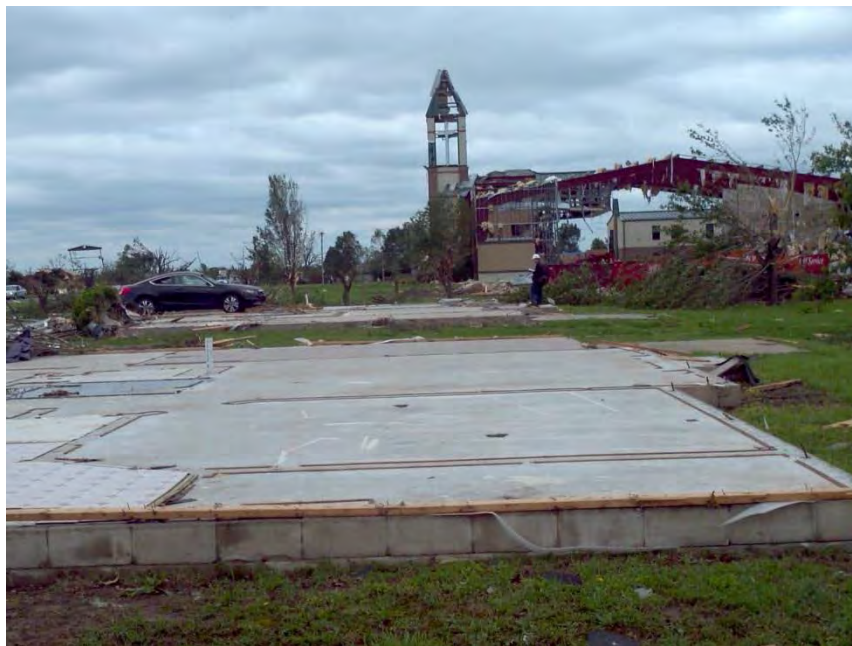
Figure 4-14. Demolished home located within the tornado damage path in Joplin.

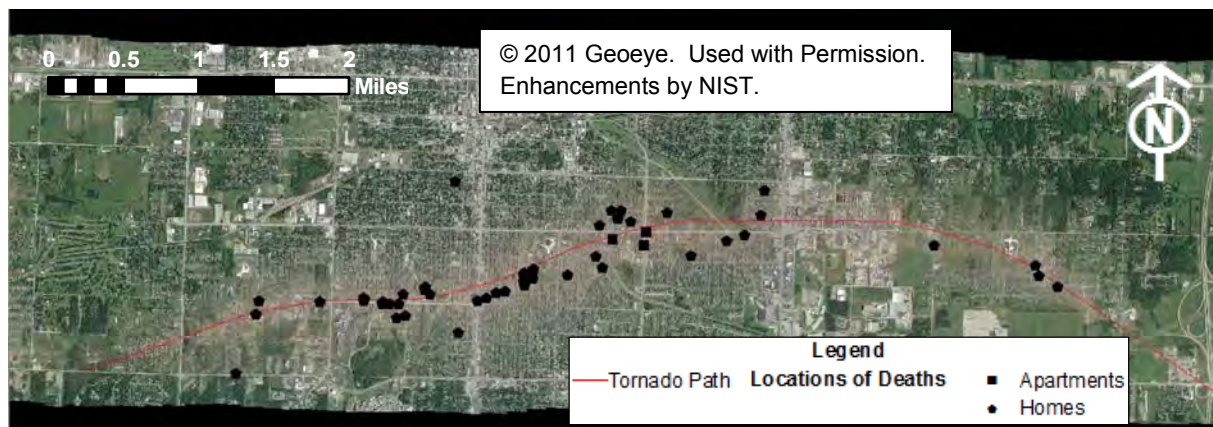
Figure 4–15. The geographic locations of deaths in homes and apartments in Joplin. Detached homes are designated by pentagon shapes and apartments by square shapes, with the red line indicating the estimated center track of the tornado.

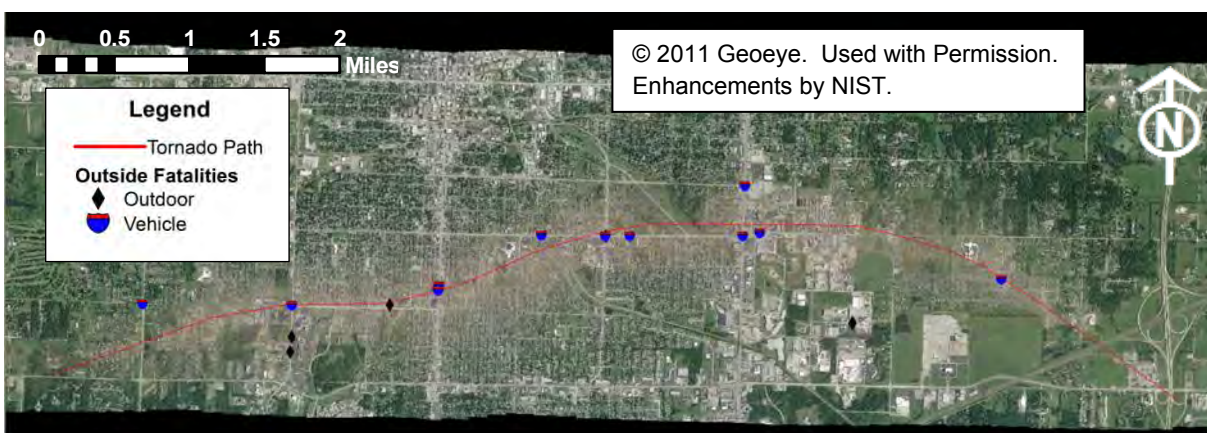
Figure 4–17. The geographic locations of deaths that occurred in vehicles (indicated by the red and blue highway signs) and outdoors (black diamonds) when the storm hit. The red line is the estimated center track of the tornado. Note: Multiple deaths occurring at the same location are represented by only one symbol.

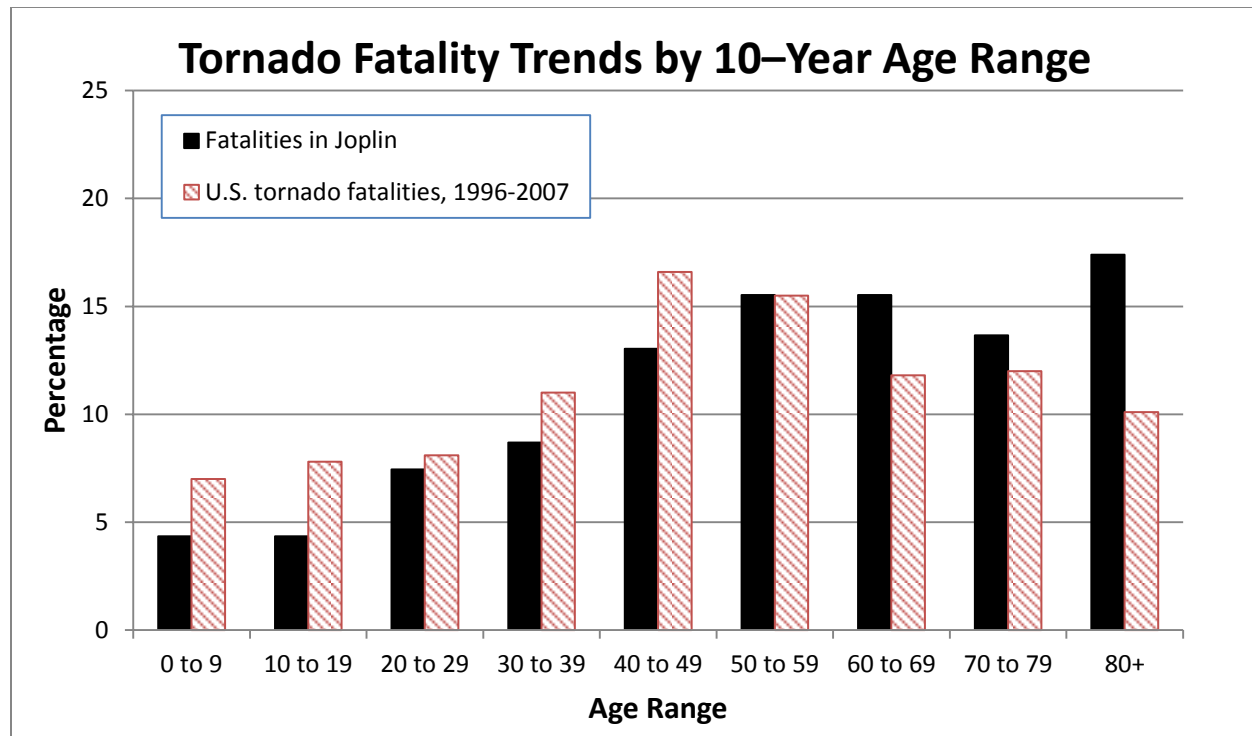
Figure 4–18. Comparison, by age, of the 161 fatalities from the May 22, 2011, Joplin tornado with U.S. tornado fatalities from 1996 through 2007 (Simmons and Sutter 2011).

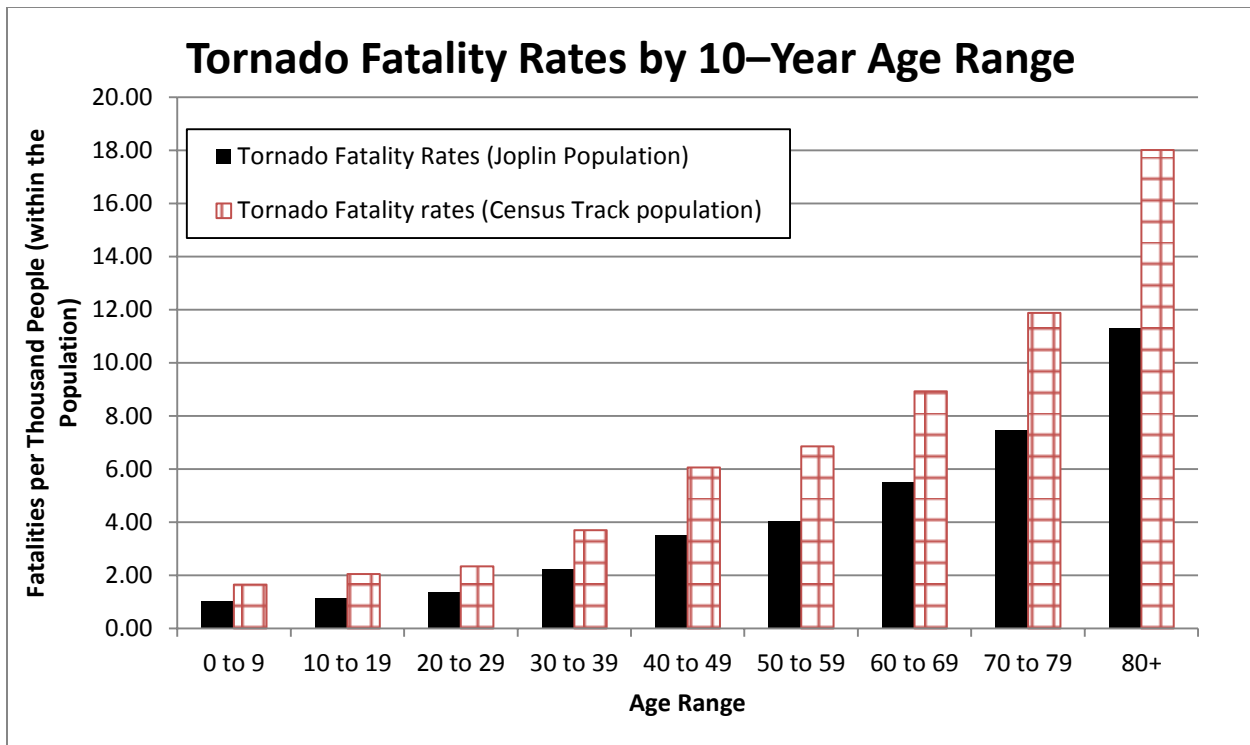
Figure 4–19. Comparison of fatality rates per thousand people within two populations: Population 1 – the entire population of Joplin and Population 2 – the population of the areas within Joplin most affected by the tornado (U.S. Census Bureau 2010).

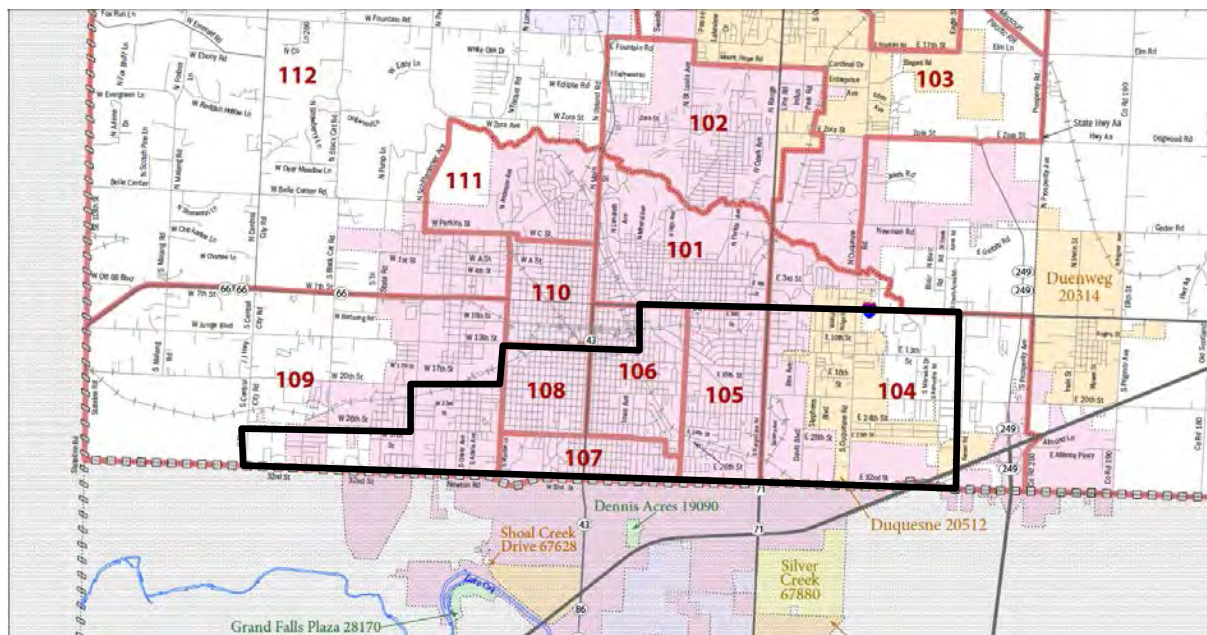
Source: http://www2.census.gov/geo/maps/dc10map/tract/st29_mo/c29097_jasper/DC10CT_C29097_001.pdf.

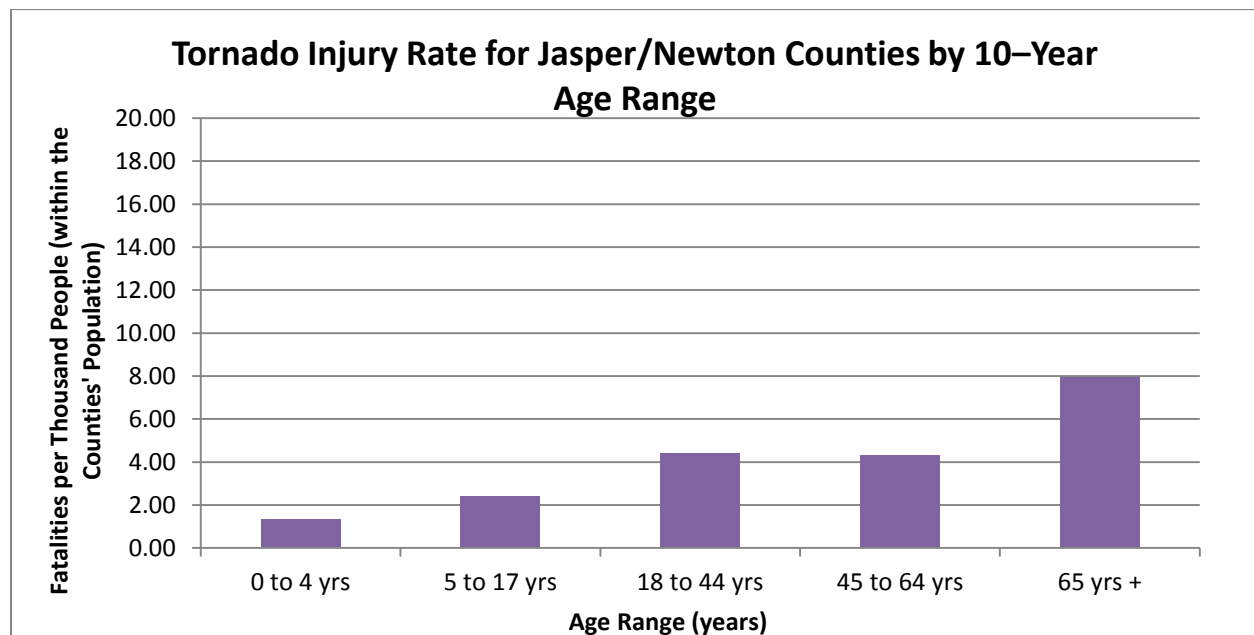
Figure 4–21. Tornado–related injury rates by 10–year age range for residents of Jasper and Newton Counties (U.S. Census Bureau 2010).

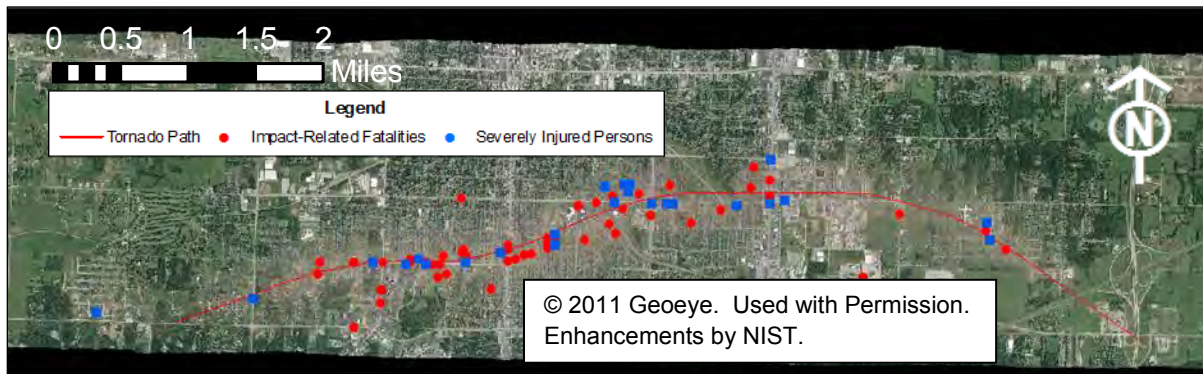
Figure 4–22. Geographic locations of the 154 impact-related fatalities (in red) and 35 severely injured persons (in blue) included in this analysis.

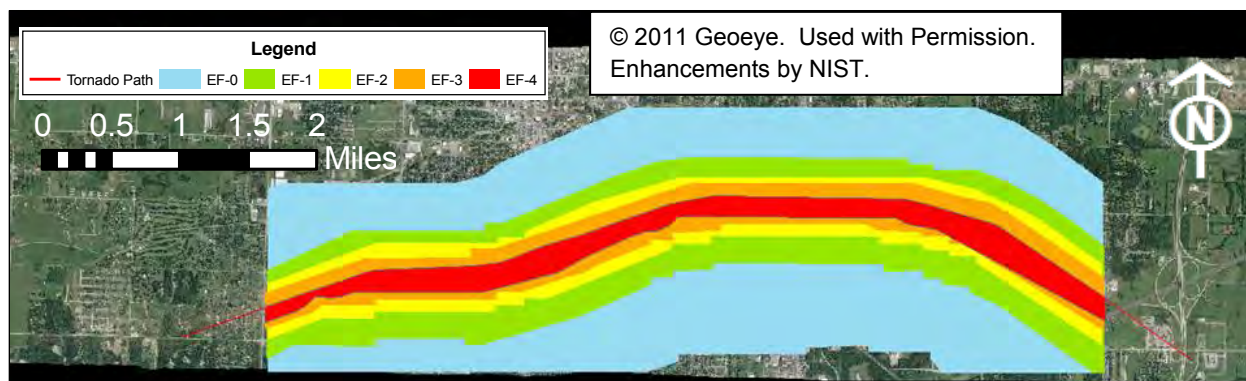
Figure 4-24. The location of the five EF-Scale polygons overlaid on the aerial photo of the estimated tornado center track (red line).

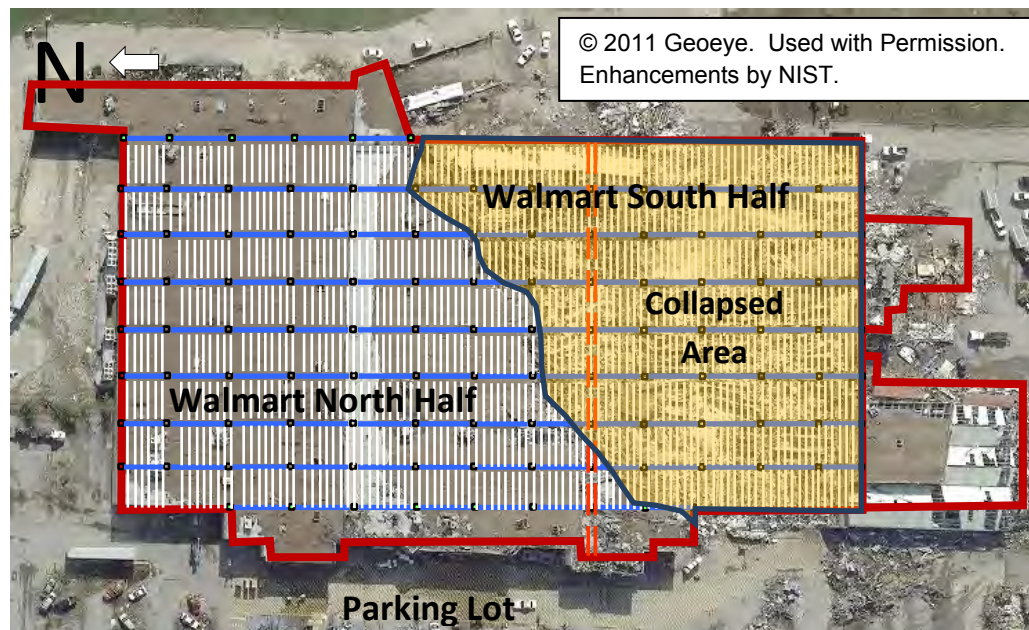
Figure 4–25. Overhead view of tornado damage to Walmart Store #59.

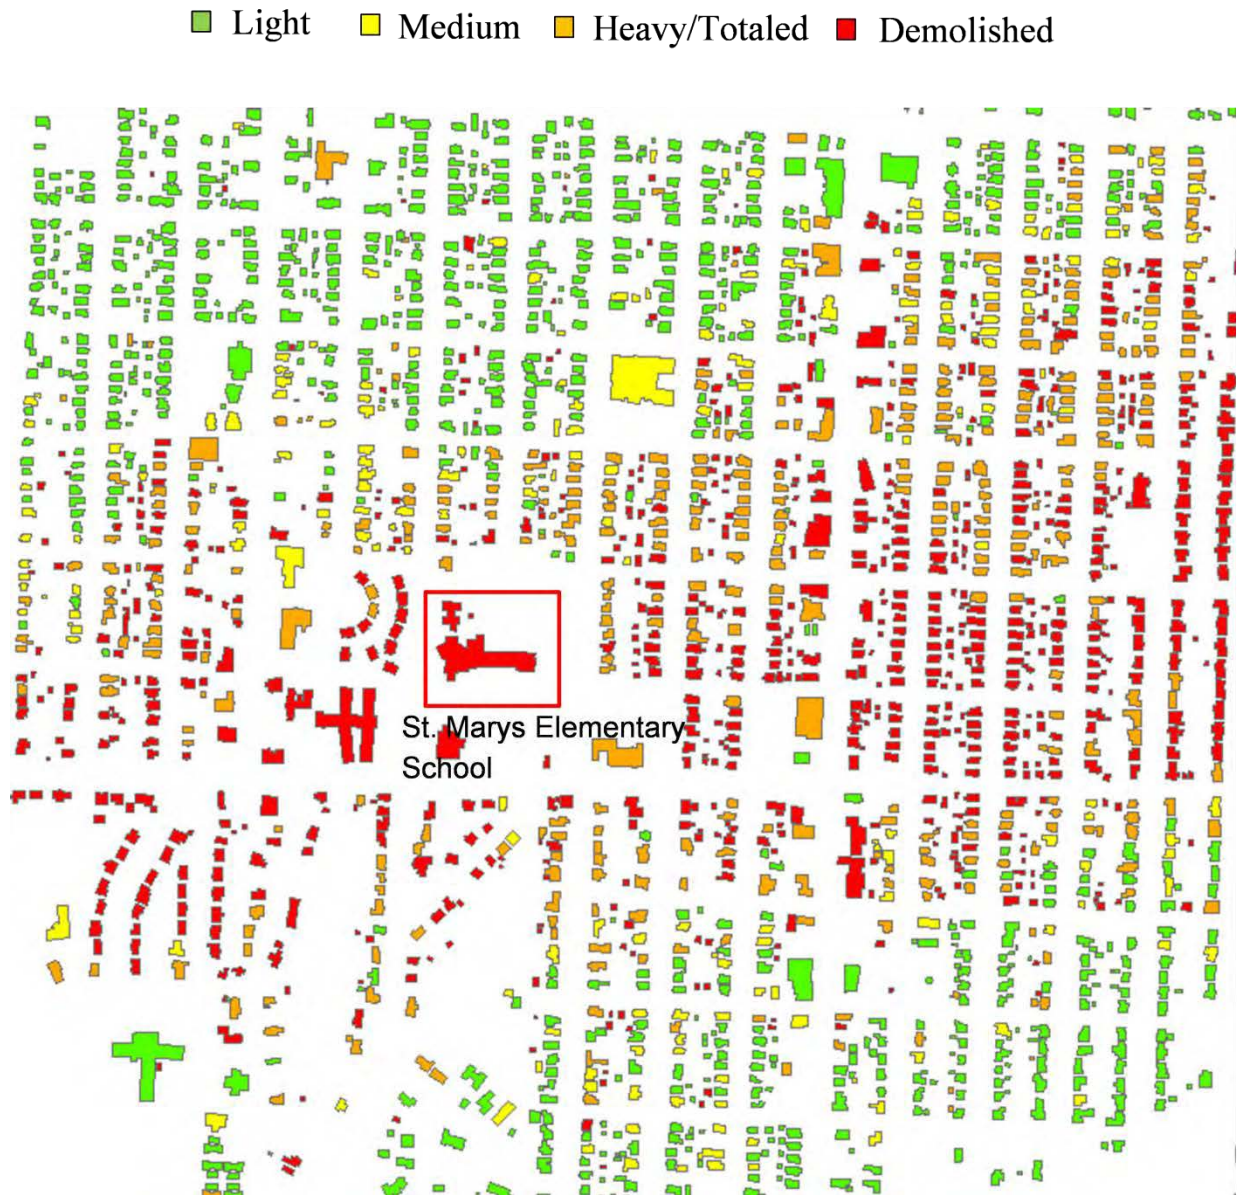
Data Source: Pictometry®. Used with Permission.

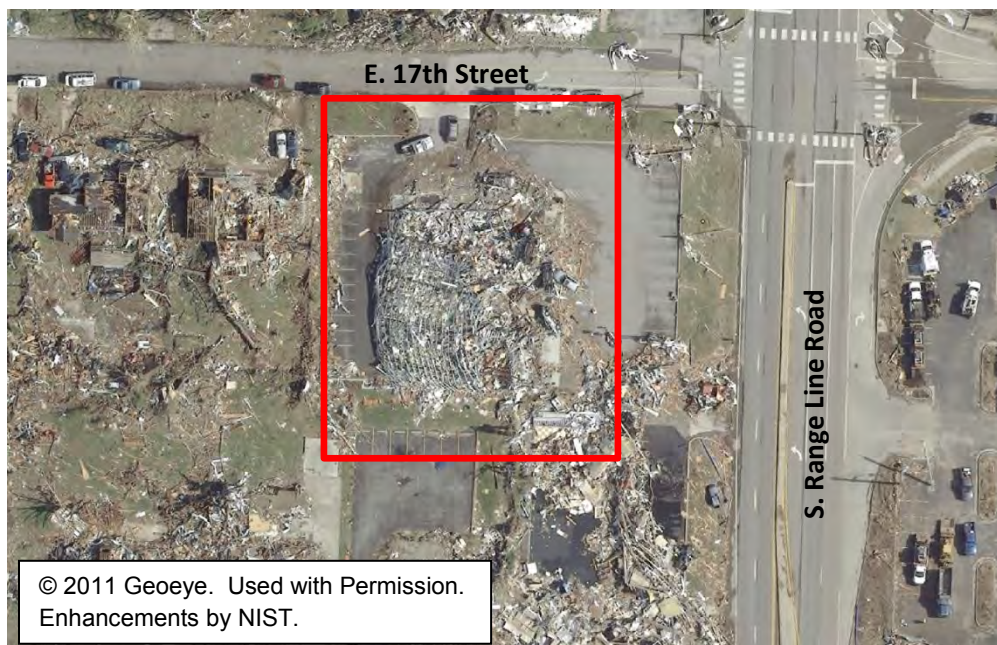
Figure 4–27. Aerial photo showing the AT&T store demolished by the storm (outlined in red).

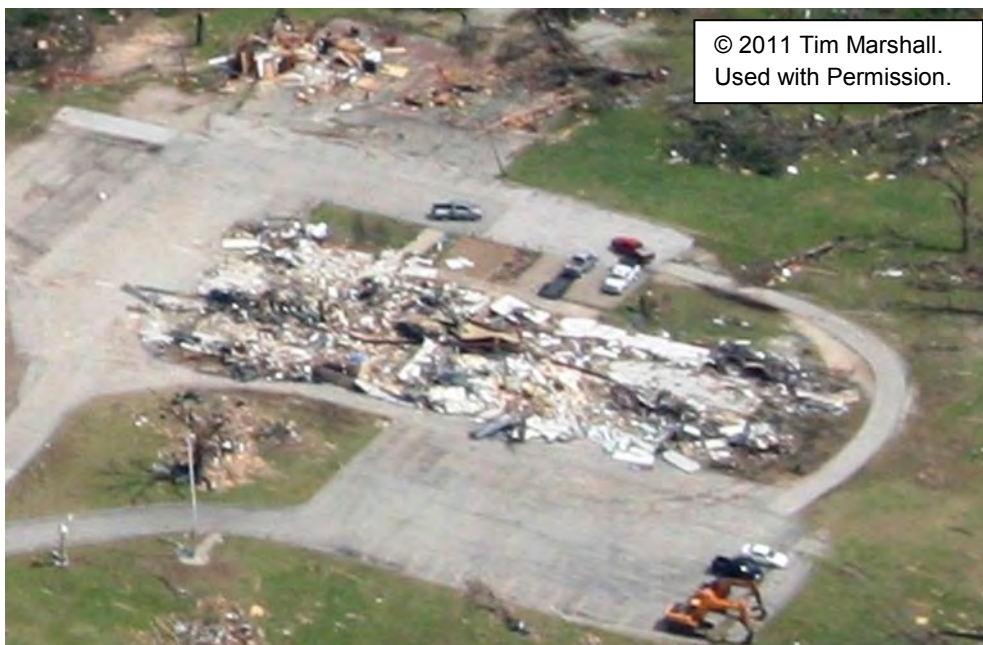
Figure 4–28. Tornado damage to the Joplin Elks Lodge.

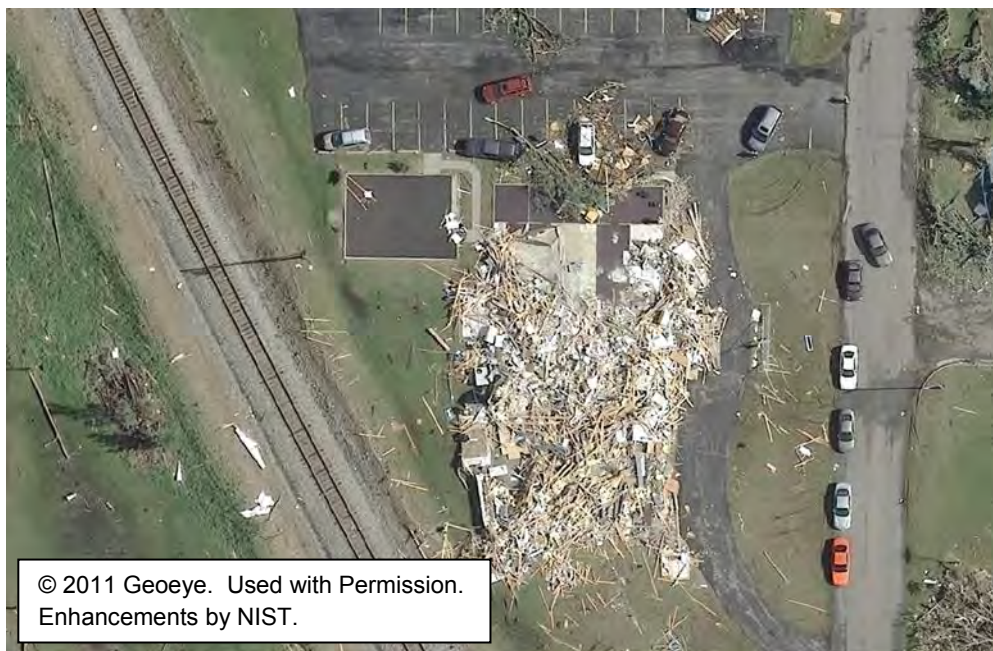
Figure 4–29. Aerial photo showing damage to the Full Gospel Church building.

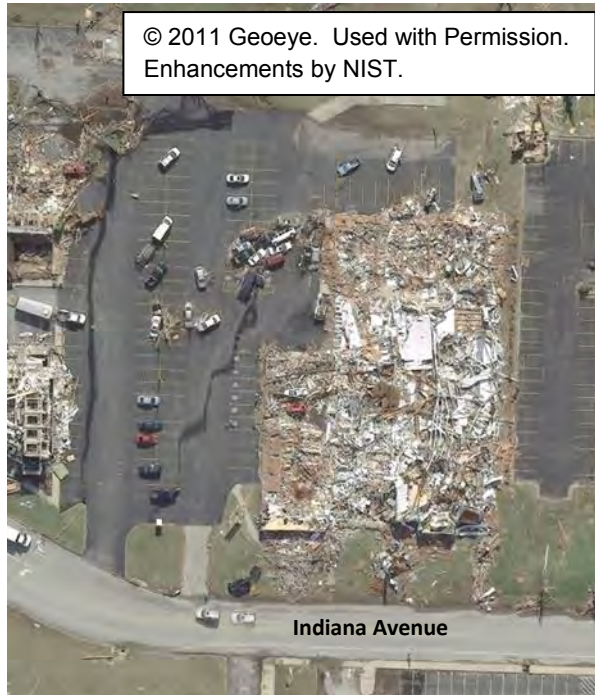
Figure 4–30. Aerial photo showing damage to Harmony Heights Baptist Church.

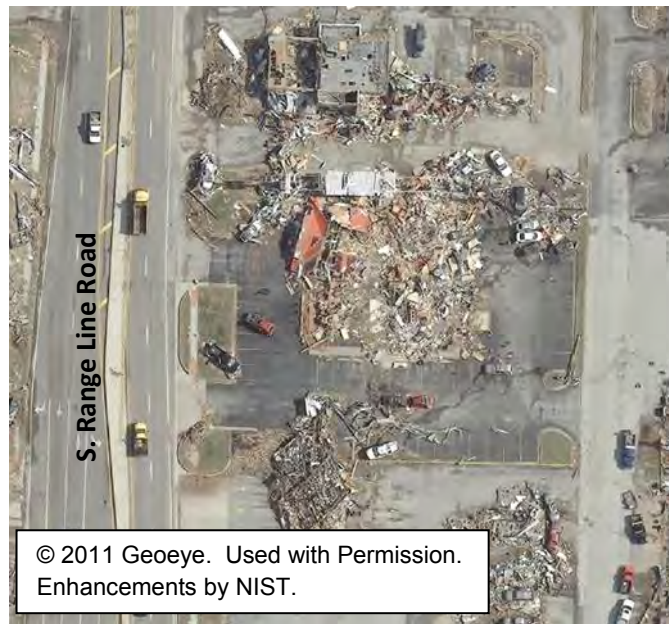
Figure 4–31. Aerial photo showing damage to the Joplin Pizza Hut.

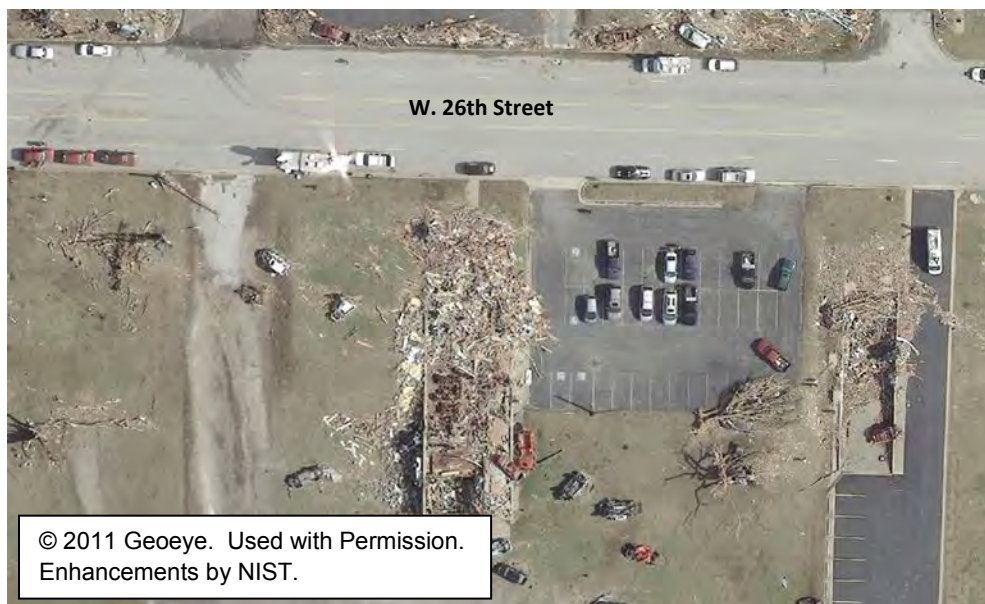
Figure 4–32. Aerial photo showing damage to the Stained Glass Theater.

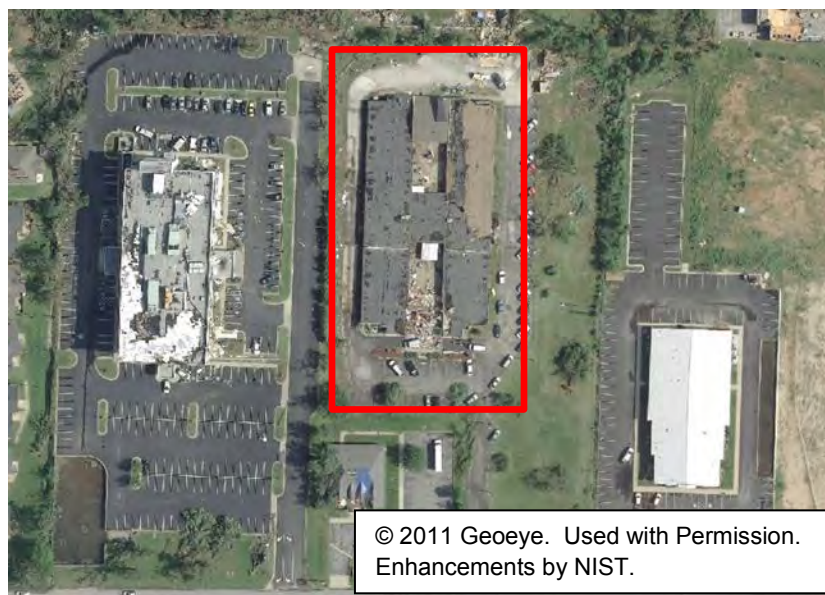
In all of the demolished buildings, the persons killed or severely injured were located above ground. Only one of the eight buildings discussed in this section, the Stained Glass Theater building, contained an underground space or basement that was available to patrons. In that structure, no evidence was found that any of those killed were located in the basement at the time the tornado hit. Additionally, there was one individual in the severely injured sample (provided by the CDC) who was located above ground in the entrance or doorway area of the theater when injured.

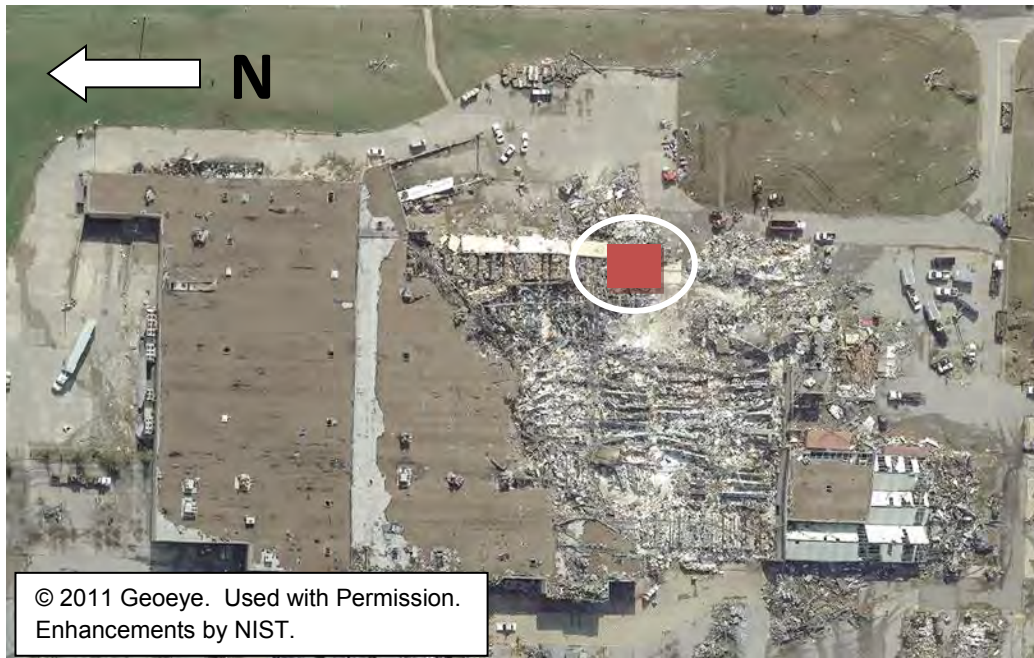
Figure 4–34. Aerial photo showing damage to Walmart Store #59, including the red box (circled in white) to indicate the store’s refuge area.

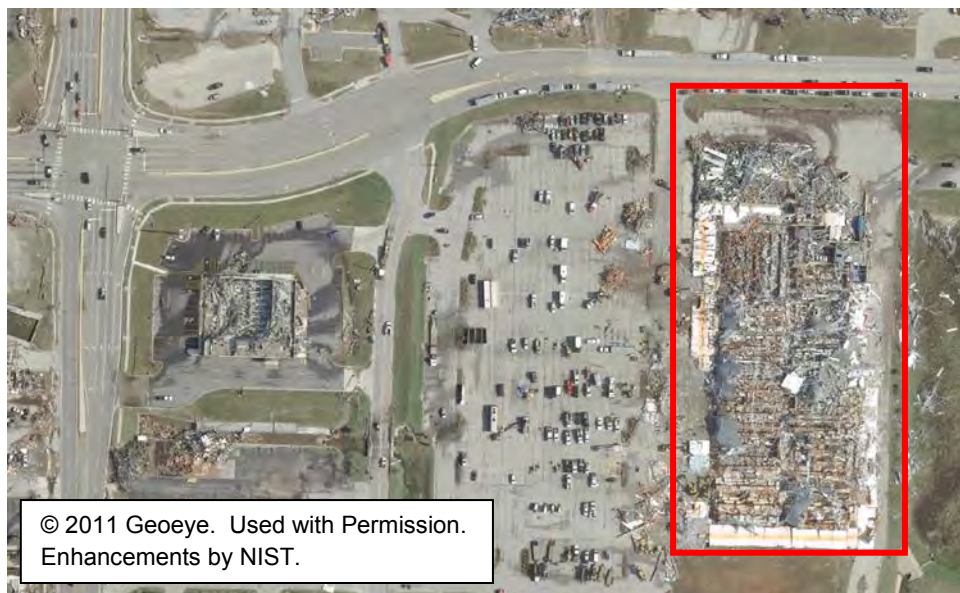
Figure 4-35.
Aerial photo showing damage to the Home Depot (outlined in red).
