Draft Final Report • National Institute of Standards and Technology (NIST)

Technical Investigation

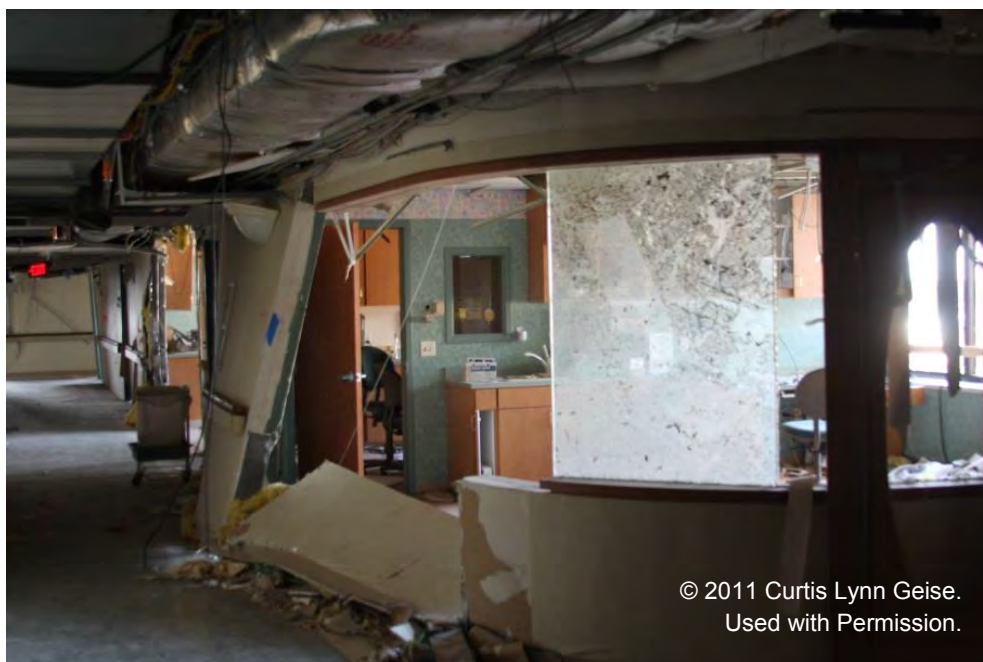
© 2011 Curtis Lynn Geise.
Used with Permission.

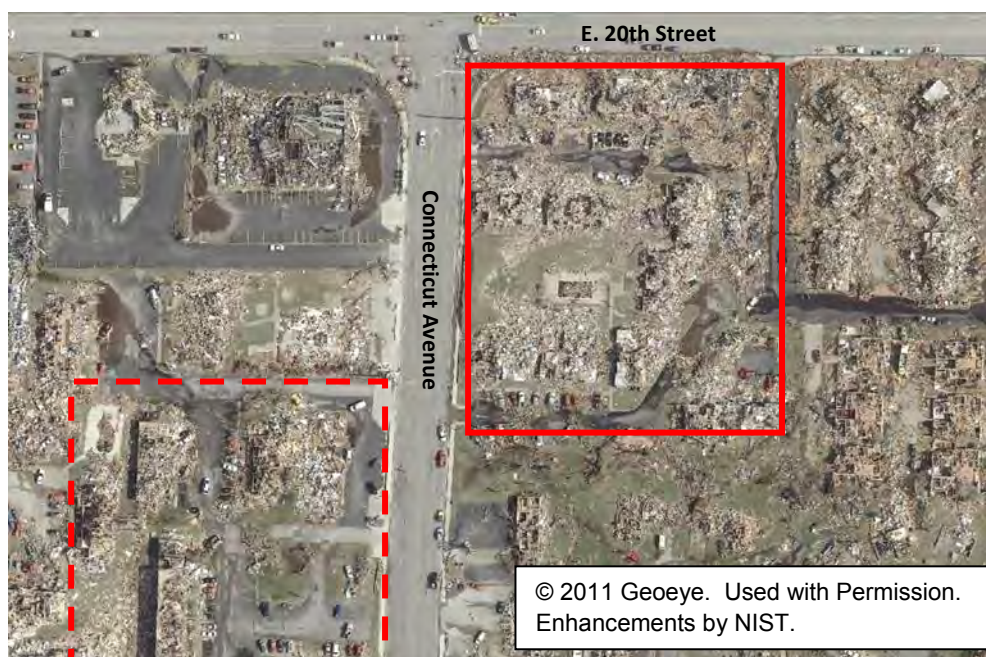
Figure 4–37. Aerial photo showing damage to two apartment complexes in Joplin at 2001 Connecticut Avenue (outlined by solid red line) and 2034 Connecticut Avenue (within dotted line).

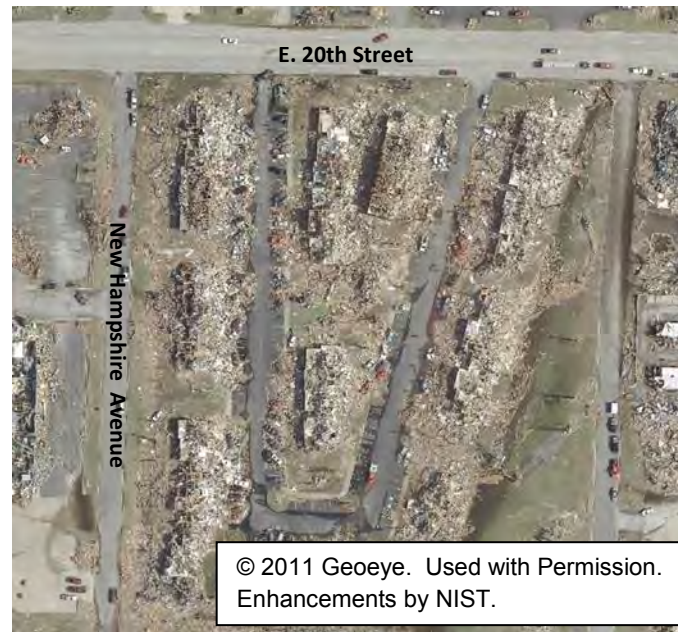
Figure 4–38. Aerial photo showing damage to the Hampshire Terrace apartments.

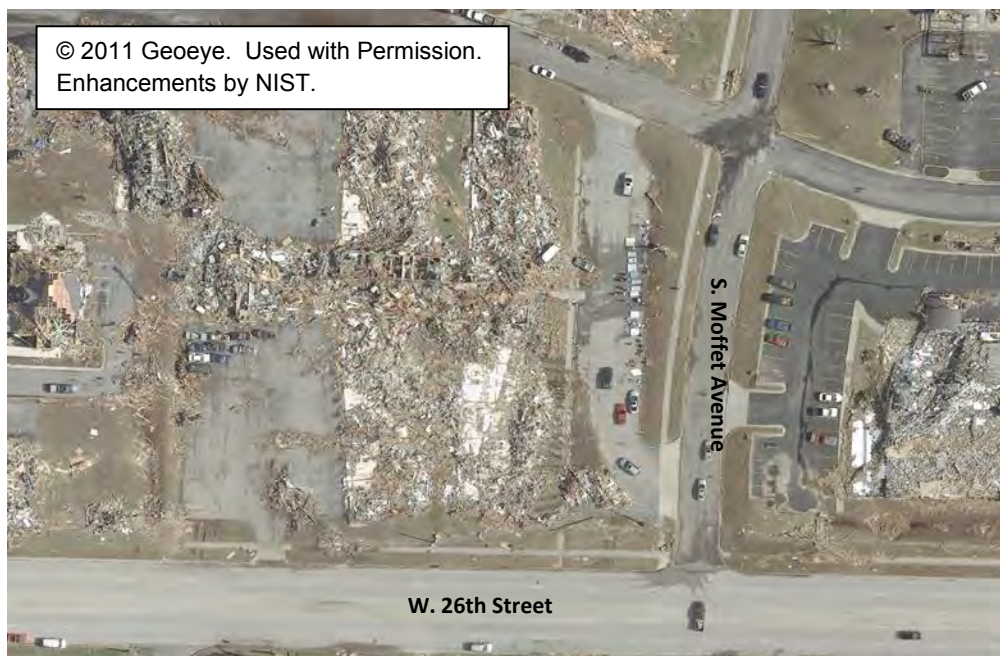
Figure 4–39. Aerial photo showing damage to the Greenbriar Nursing Home.

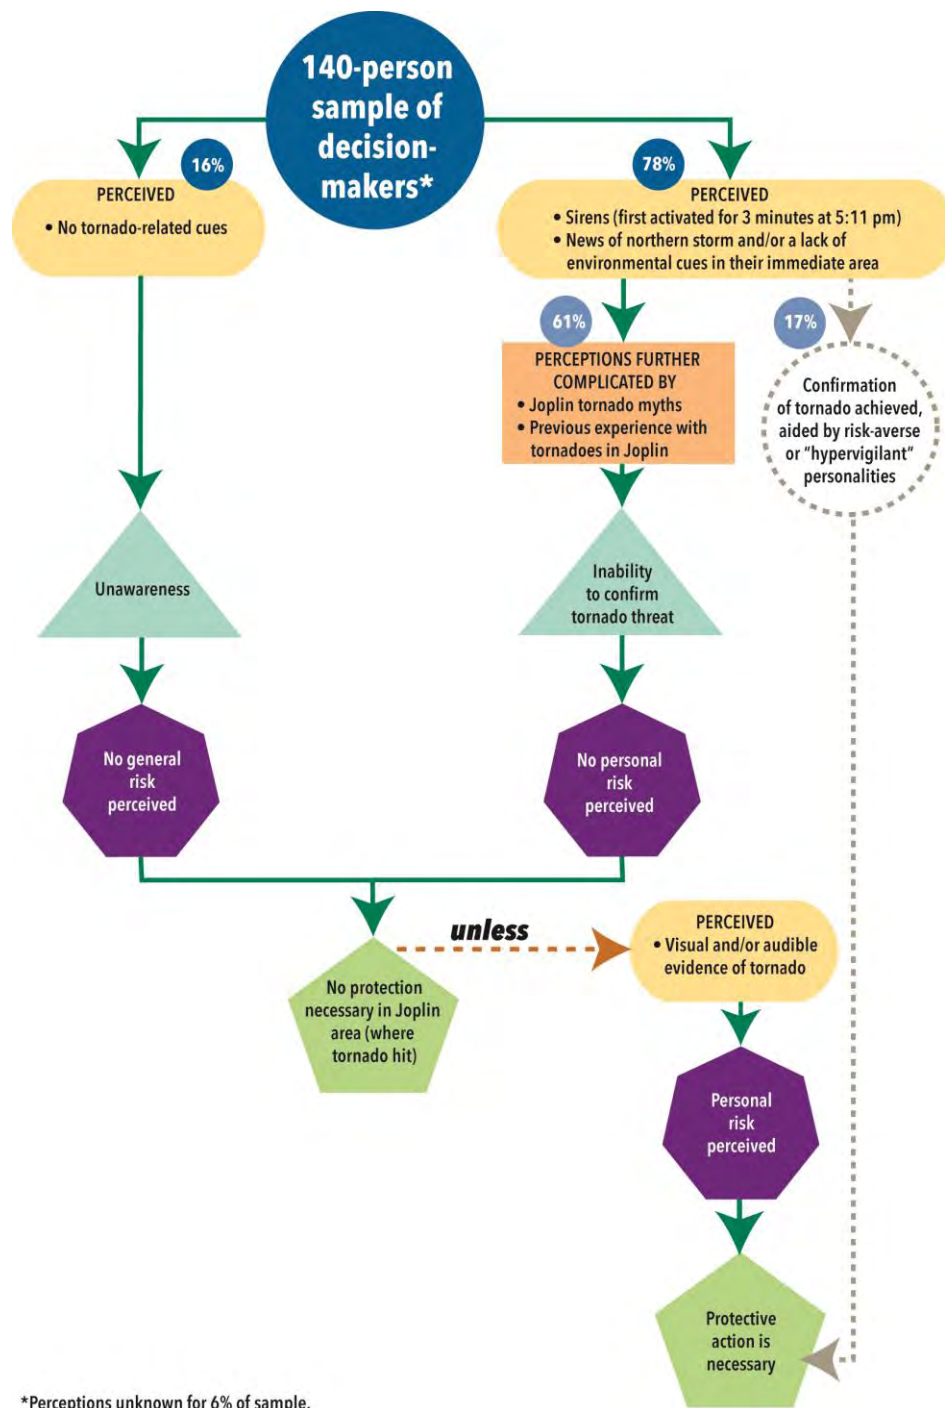
Figure 4–41. A model depicting protective–action decision–making in the May 22, 2011, Joplin tornado.

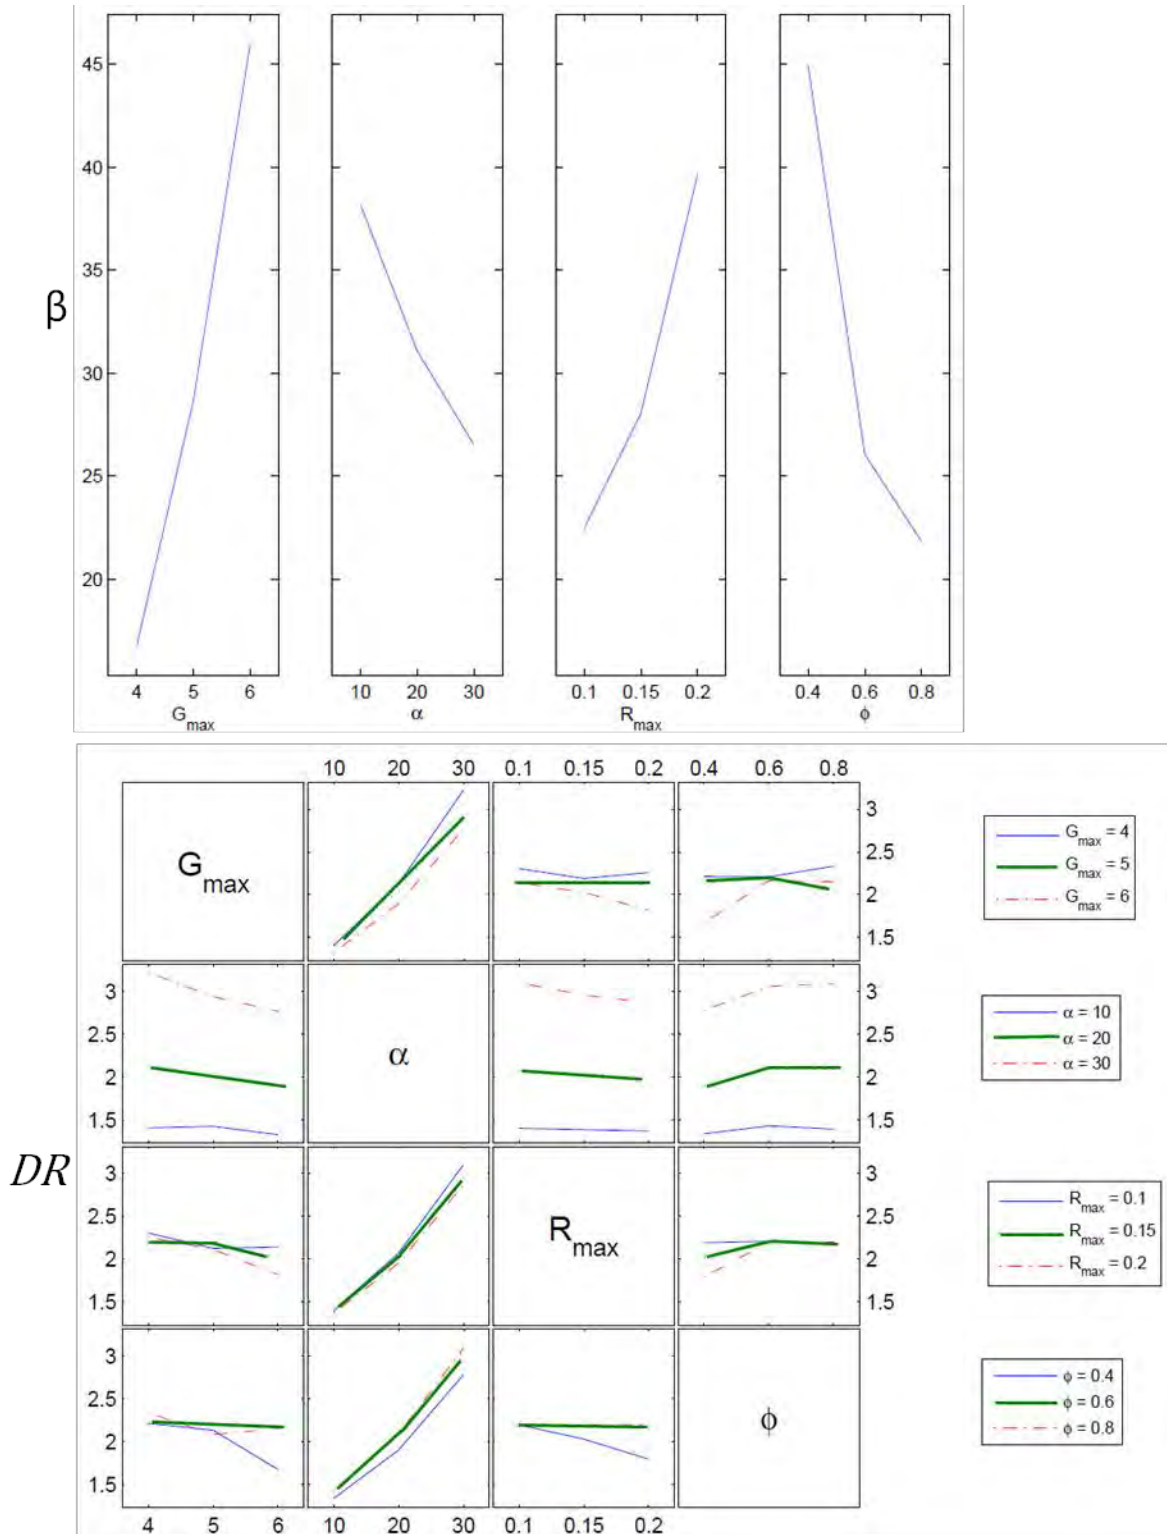
Figure D-1. Main (top) and interaction (bottom) effects plots for input and output parameters.

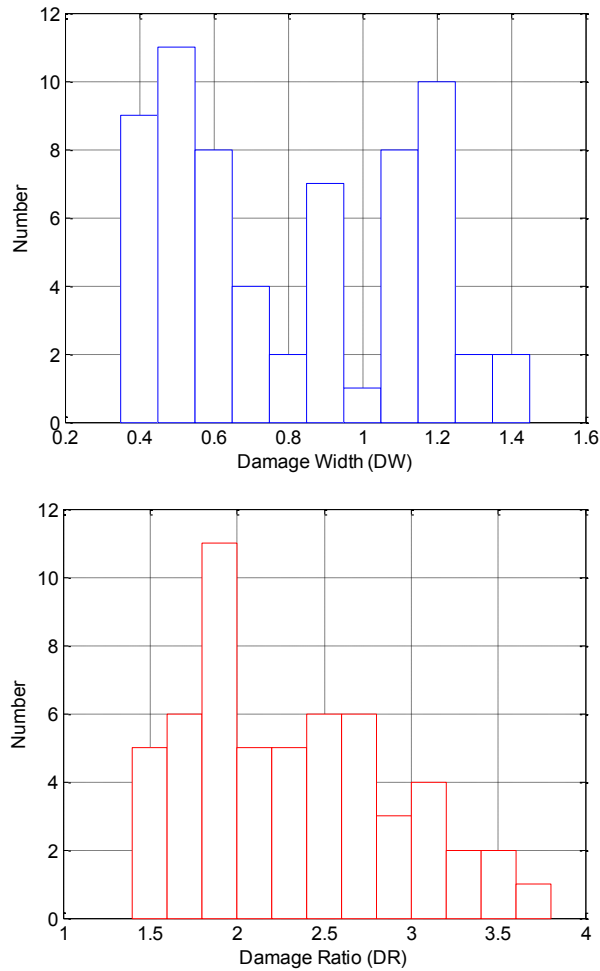
Figure D-2. Histograms showing values of DW and DR for $X = 2.1$ miles.

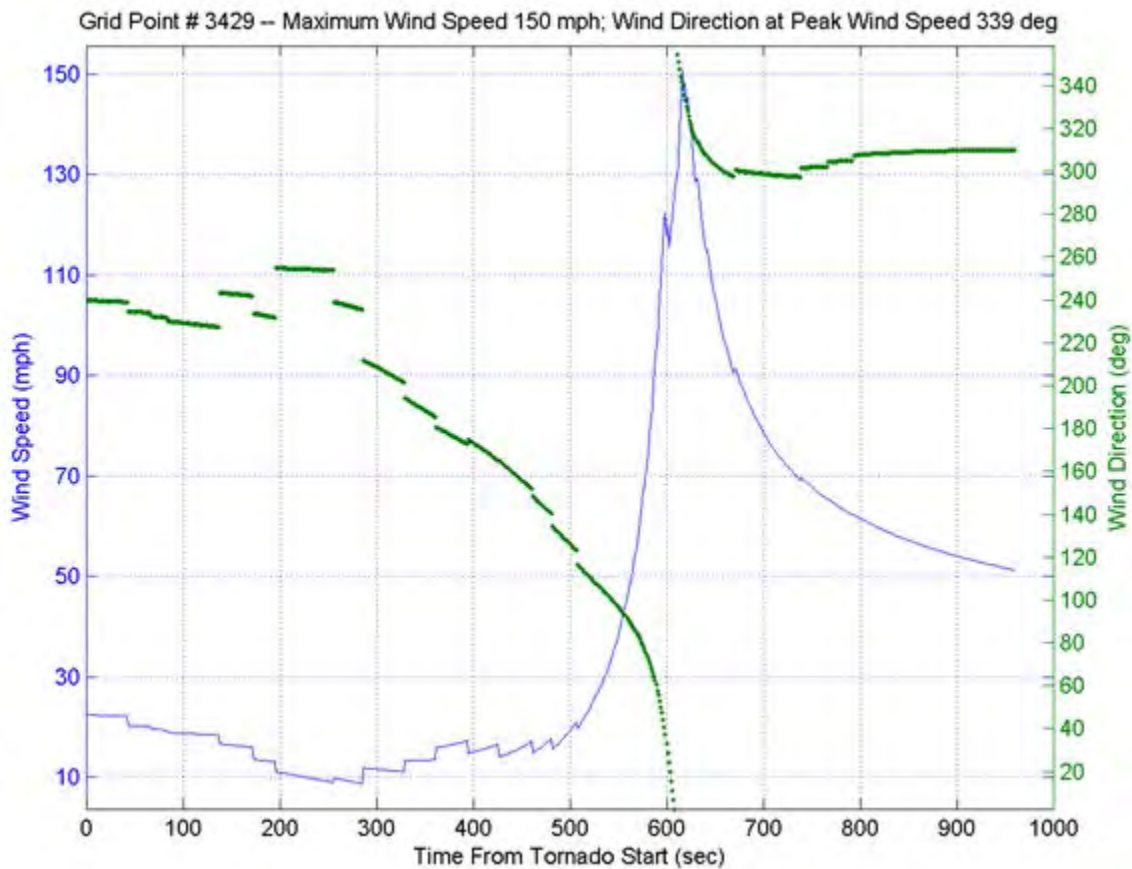
Figure E-1. Time History for Near WalMart (Grid Point # 3429)
